Processing Record for this file: (Make notes here unique for this file)

Loading from 2014-04-01 - 2014-05-01 Data taken from DMF, untarred, unzipped and renamed back to original file names

Project/Platform/Site: maomaoscs1

ARM Climate Research Facility
Contact: S.R. Springston (631) 344-4477, srs@bnl.gov

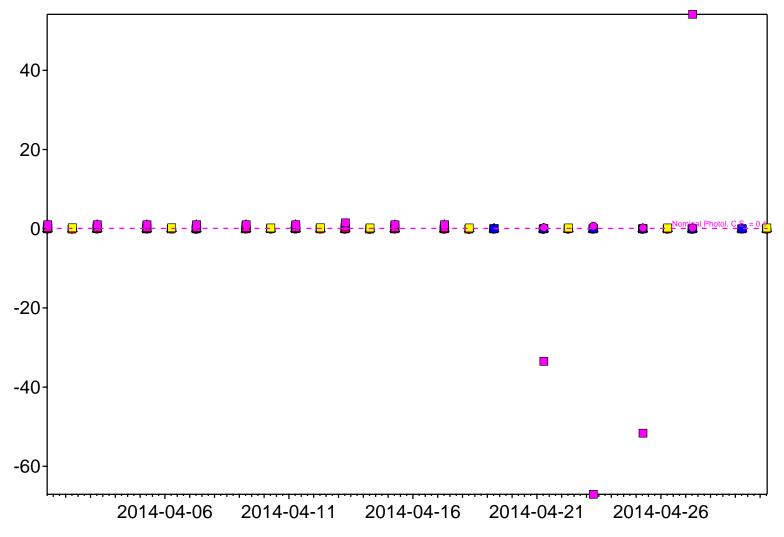
Ground NO_x Analyzer Calibration Data

```
O - NO Channel; \triangle - NO<sub>x</sub> Channel; \square - NO<sub>y</sub> Channel Zero Air Equivalent Signal (ppbv) S.A. #1 (calibrated sig/dilution conc: [SA#1] = 20.8 ppbv) S.A. #2 (calibrated sig/dilution conc: [SA#2] = 82.86 ppbv) GPT + SA #2 (NO: frac titr., NO<sub>x</sub>: Photol. C.E. (nom=0.1), NO<sub>y</sub>: Mo C.E. (nom=1.03)) HNO<sub>3</sub> cal. (calibrated sig/perm conc: [HNO<sub>3</sub>] = 68.9 ppbv)
```

NO2 signal is problematic. The photolysis cell continued to deteriorate and did not even have 5% efficiency. As such, no data is reported.
