Processing Record for this file: (Make notes here unique for this file)

Loading from flight 140310a Data taken from NOx CPU c:\data\NOx

AAF 3-Channel NO_x Analyzer Parsed NOy Channel Data

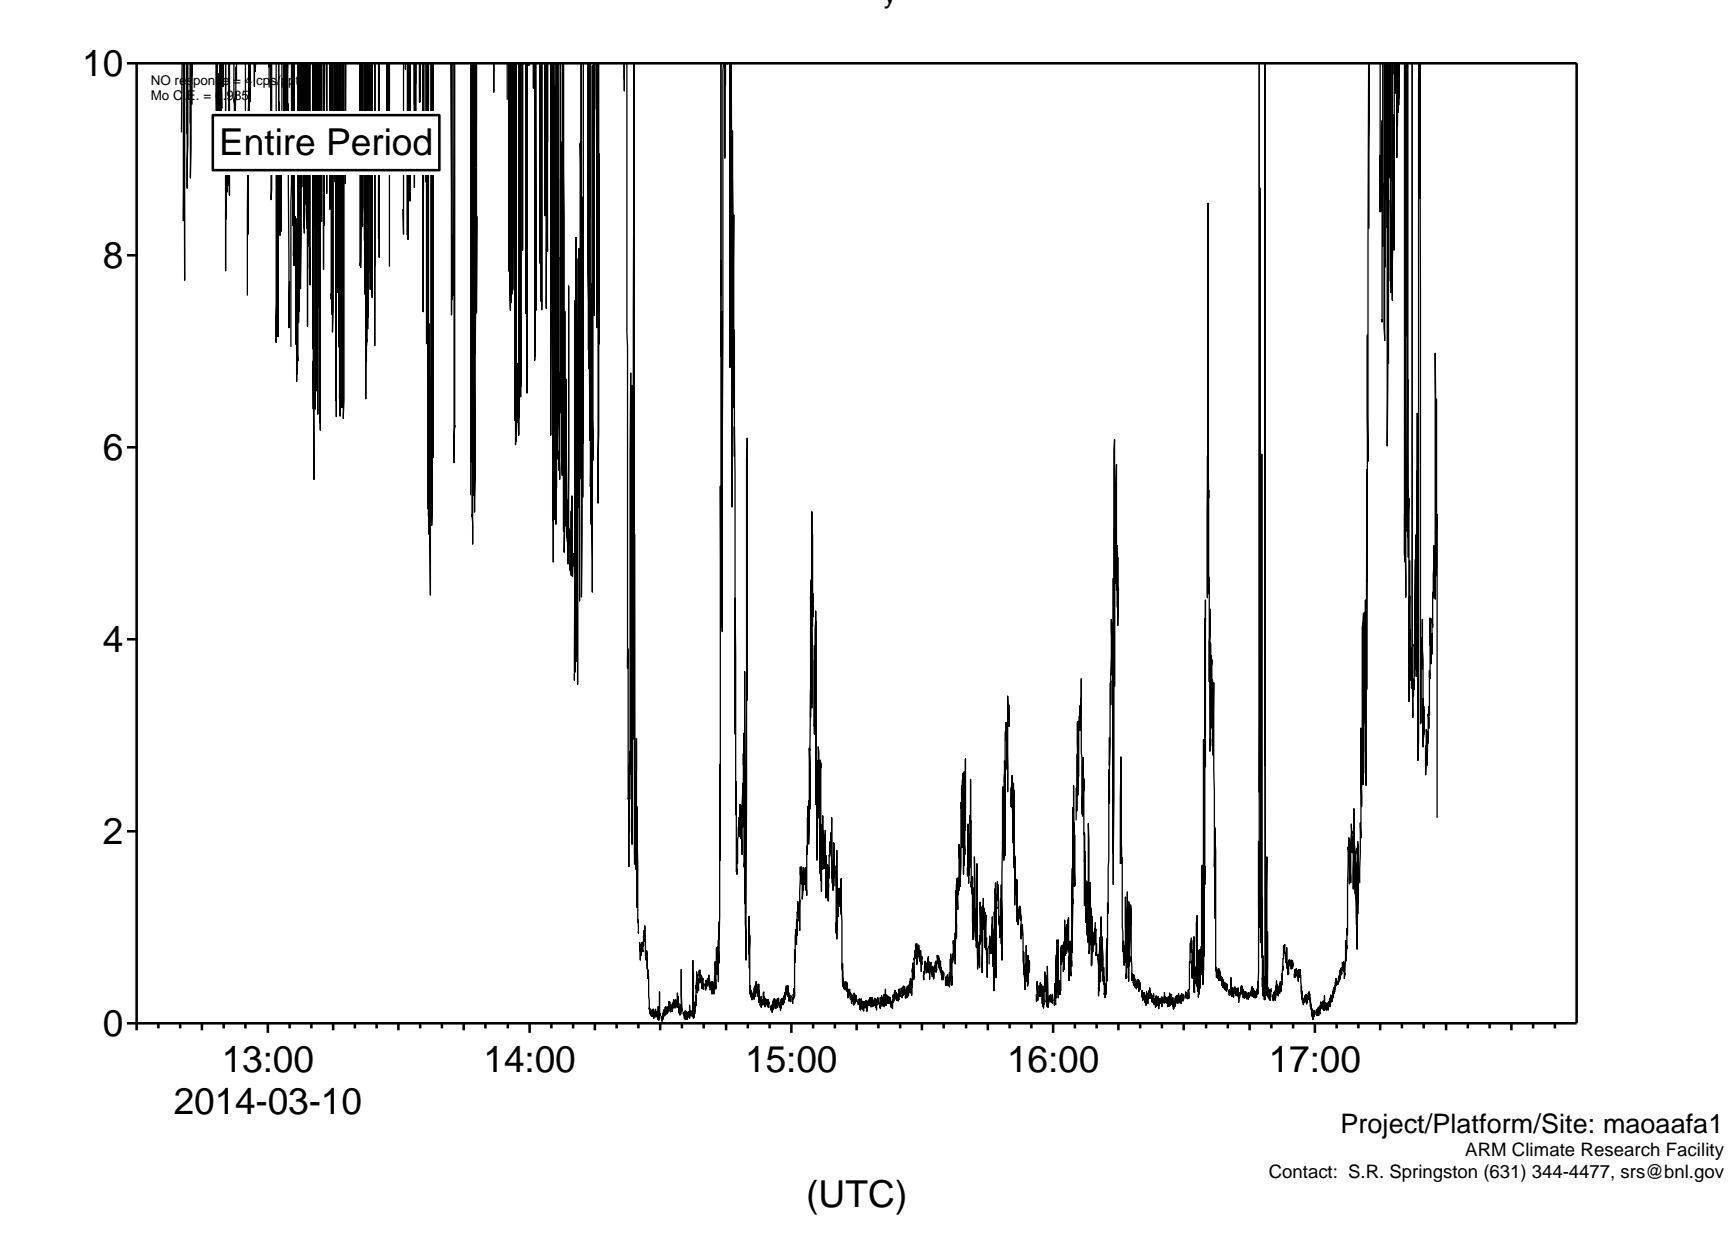
AAF 3-Channel NO_x Analyzer Processed NO_y Channel Data

[NO_y] (ppbv)

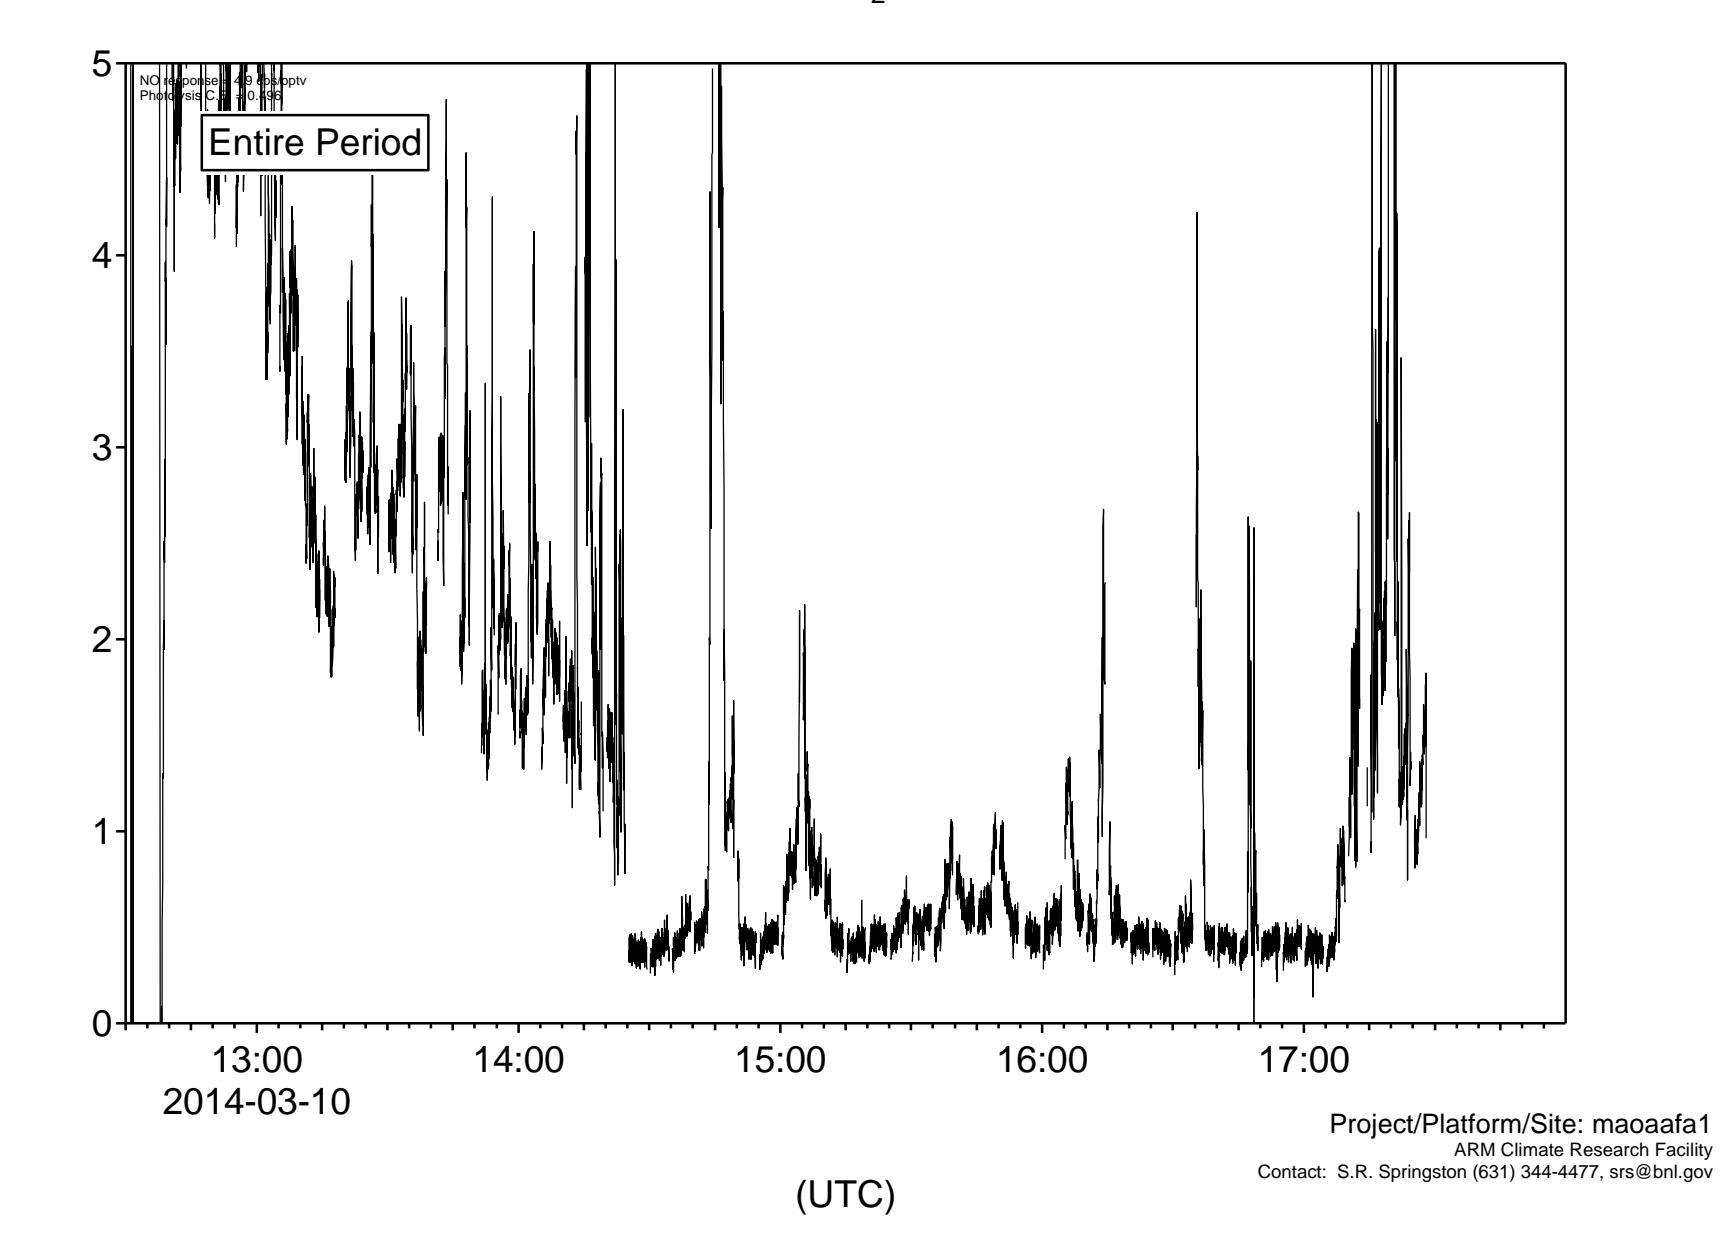
AAF 3-Channel NO_x Analyzer Processed NO_2 Channel Data

[NO₂] (ppbv)

To attempt to lower the NO2 background, on 3/4/2014, the NO2 photolysis cell was disassembled and cleaned. The parts were inspected and no visible dirt was observed. The white ODM teflon had a distinct acrid odor. All parts were wiped down with ChemWipes and D.I. water. Odor indectable after cleaning. Unit was reassembled. However, the offset remains. Vendor being consulted. Offset appears very consistent and will be subtracted later.

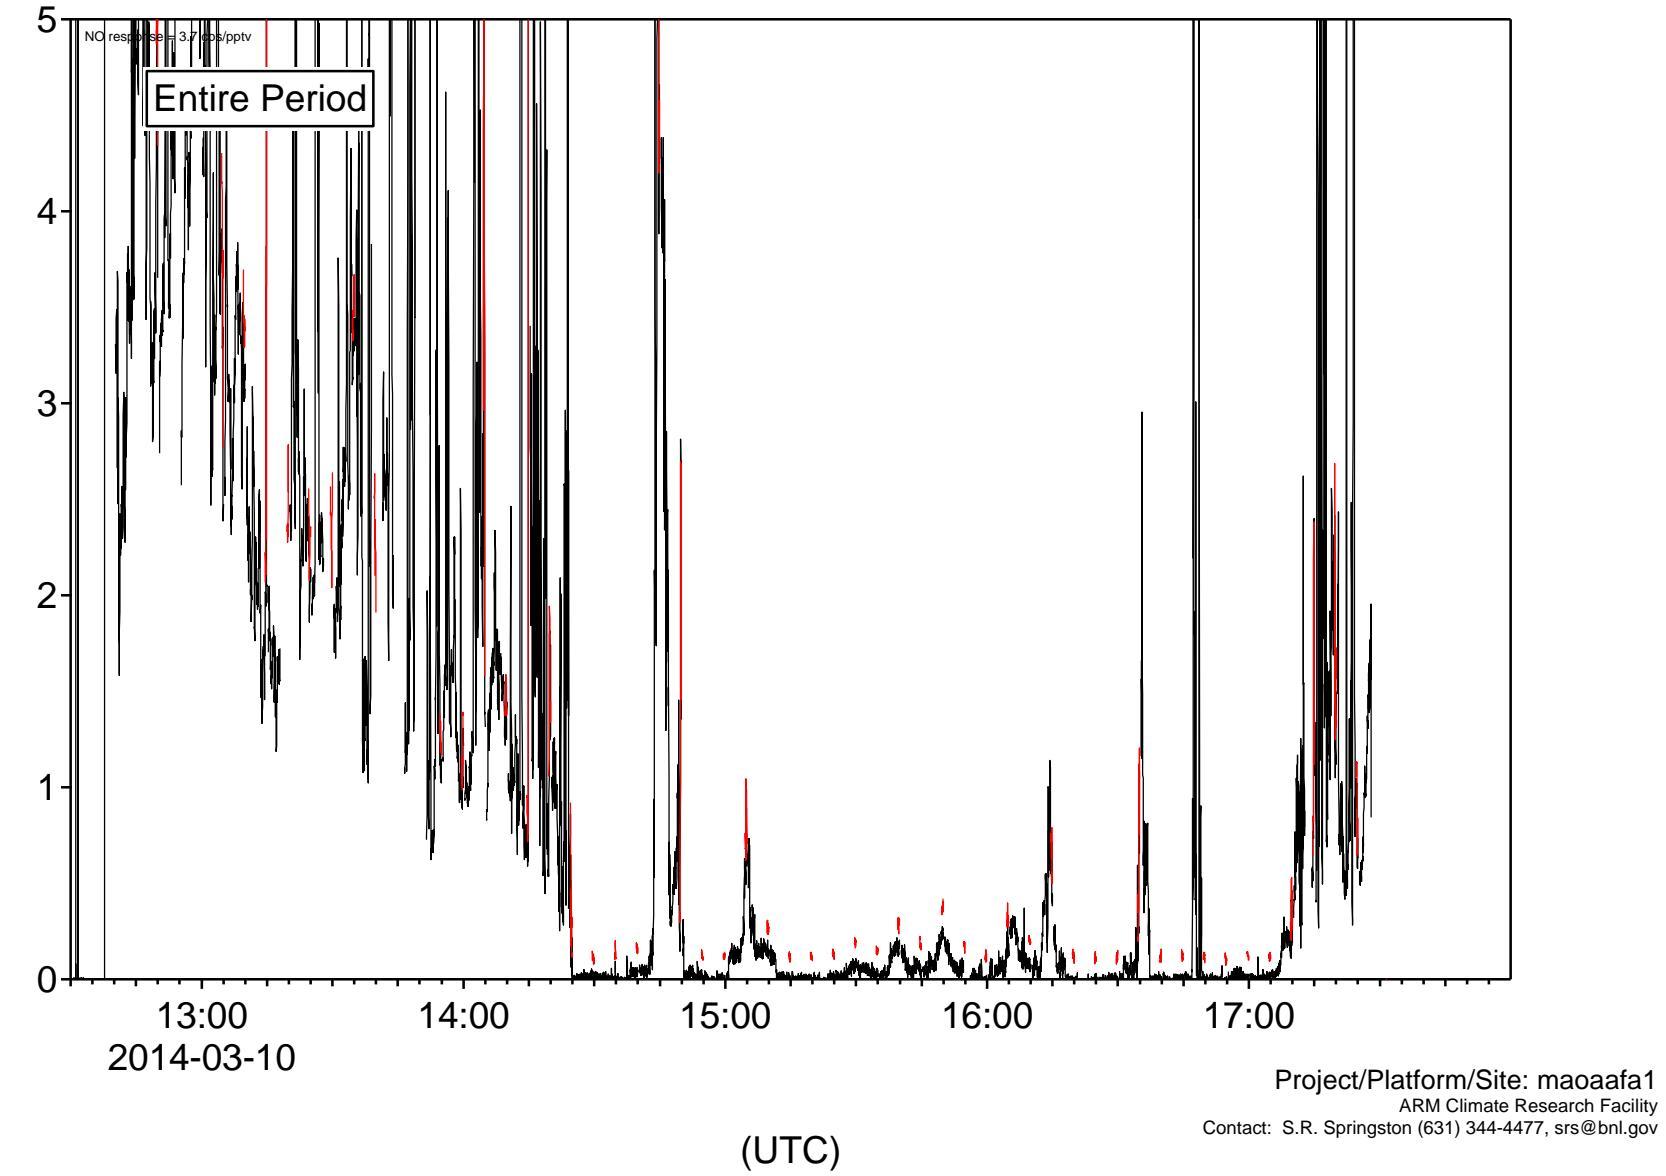
AAF 3-Channel NO_x Analyzer Processed NO Channel Data

(vddd) [ON]

It has been observed that the NO/NO2 ratios do not appear reasonable at low levels (<500 pptv). The zero on the NO channel appears erroneously high. This affects both the NO and the NO2 results at low values. These data are only preliminary.
