Processing Record for this file:  
(Make notes here unique for this file)

Loading 3/1 - 4/1/2014  
Data loaded directly from DMF

Project/Platform/Site: maomaoscs1  
ARM Climate Research Facility  
Contact: S.R. Springston (631) 344-4477, srs@bnl.gov

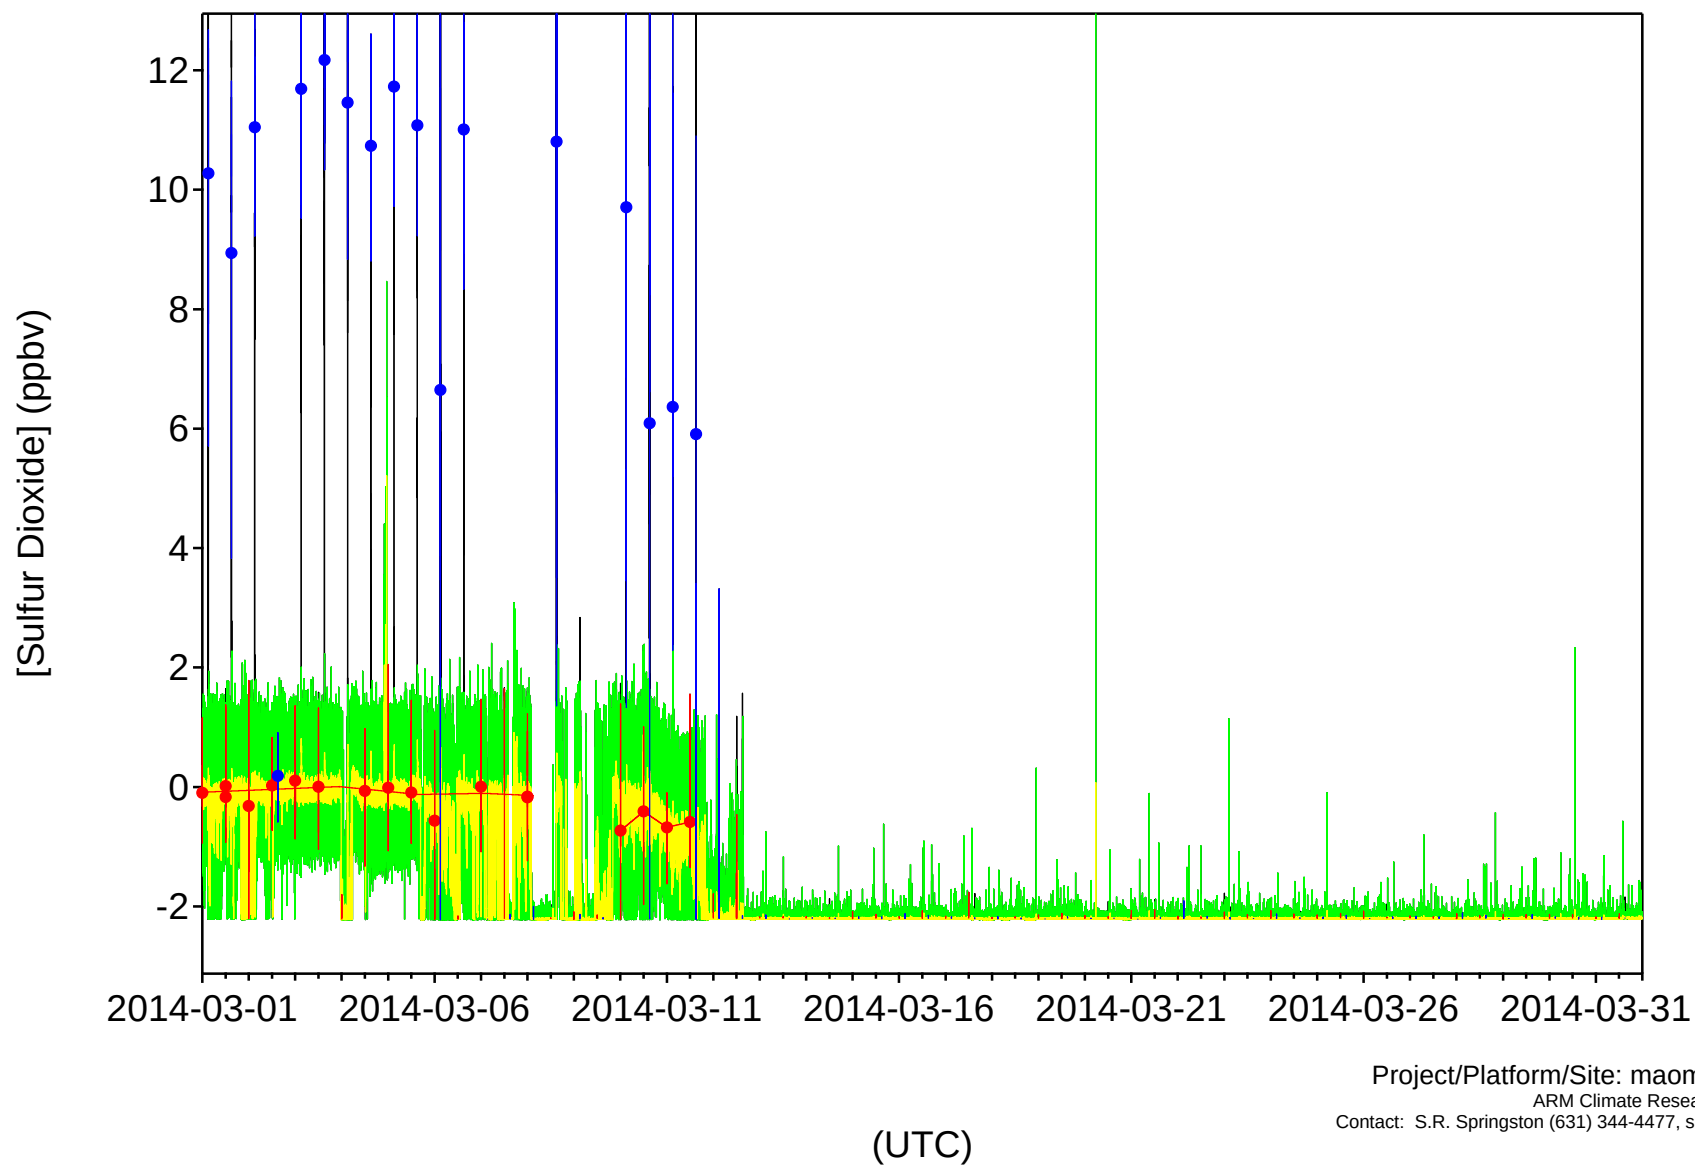
# TEI Model 43i-TLE Pulsed Fluorescence SO<sub>2</sub> Analyzer

Processed SO<sub>2</sub> data normally. These data are taken with a ~10-s time constant on the instrument.

During the beginning of the month, the instrument flash lamp failed, at first intermittently and then completely. The data grew increasingly noisy. The ambient signal appeared near background when the instrument was functioning. No valid data reported after 2014-03-08 01:49 and several shorter period prior to this.
