Loading 2015-02-01 - 2015-03-01  
Data loaded from DMF (detarred, unzipped and names restored)

# TEI Model 49i UV Photometric Ozone Analyzer

Project/Platform/Site: maomaoscs1  
ARM Climate Research Facility  
Contact: S.R. Springston (631) 344-4477, srs@bnl.gov

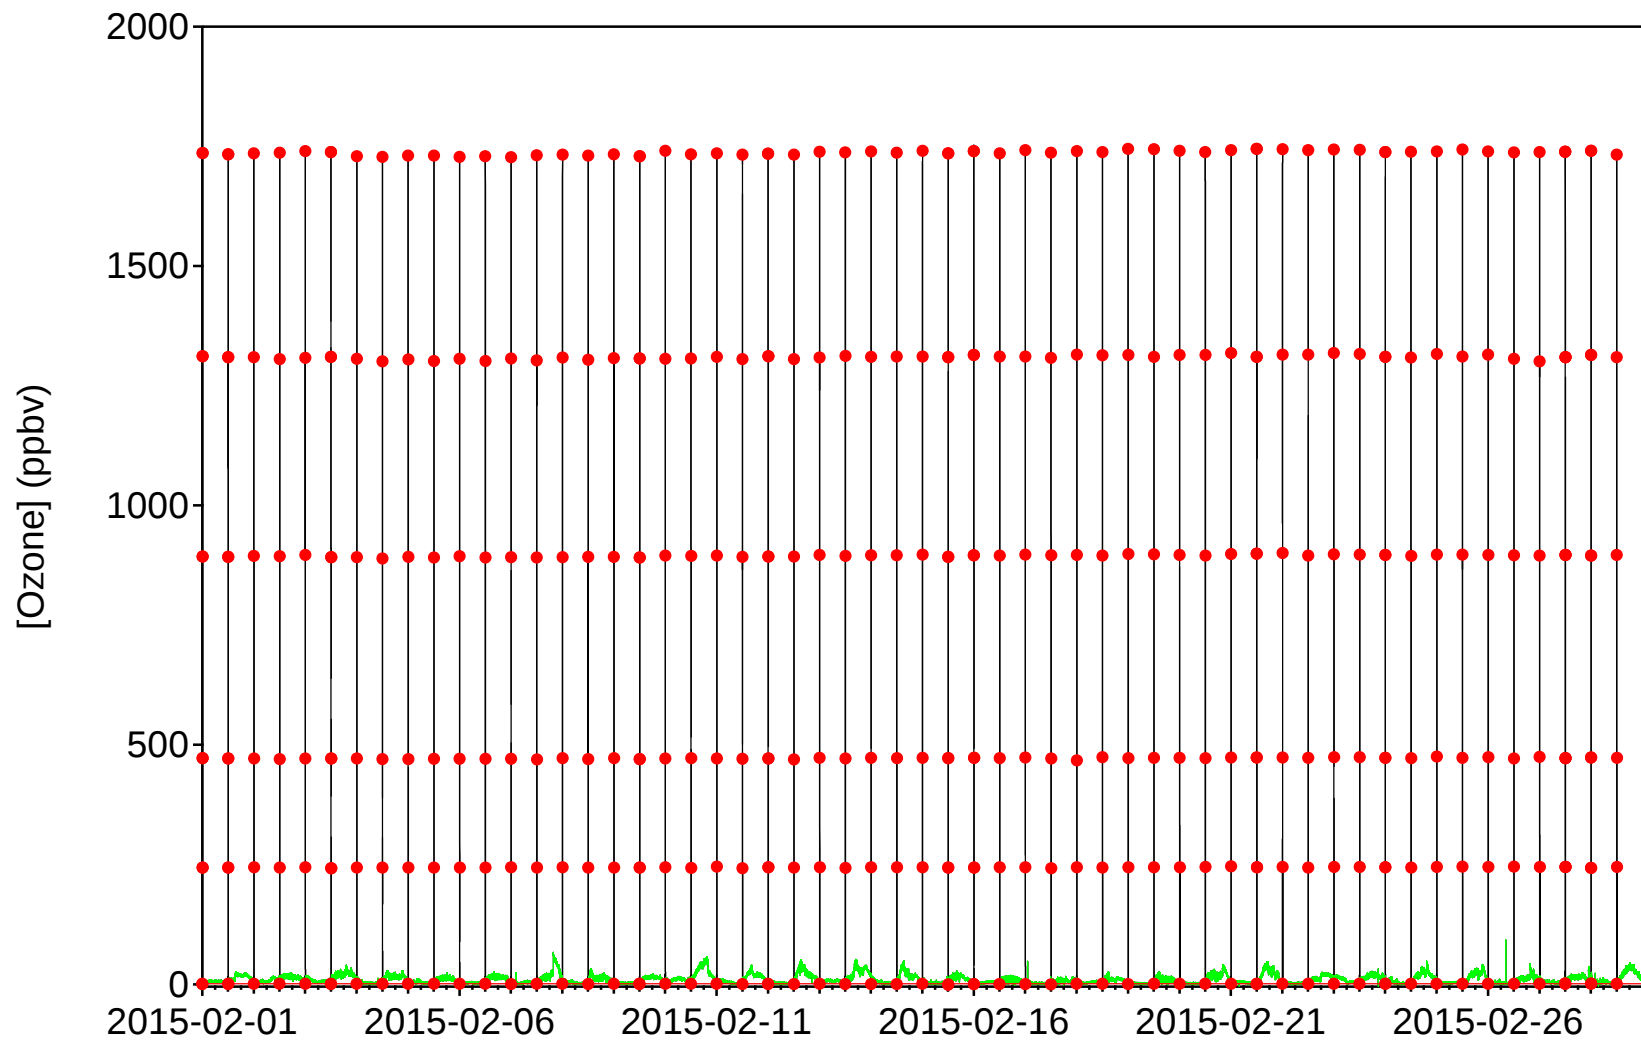
Several short (4-s) data spikes of unknown origin.

Data appear normal and reliable. Internal calibrations consistent and very stable.
