Loading from flight 140916a  
Data taken from NOx CPU c:\data\NOx

AAF 3-Channel NO<sub>x</sub> Analyzer  
Parsed NO<sub>y</sub> Channel Data

Project/Platform/Site: maoaafa1  
ARM Climate Research Facility  
Contact: S.R. Springston (631) 344-4477, srs@bnl.gov

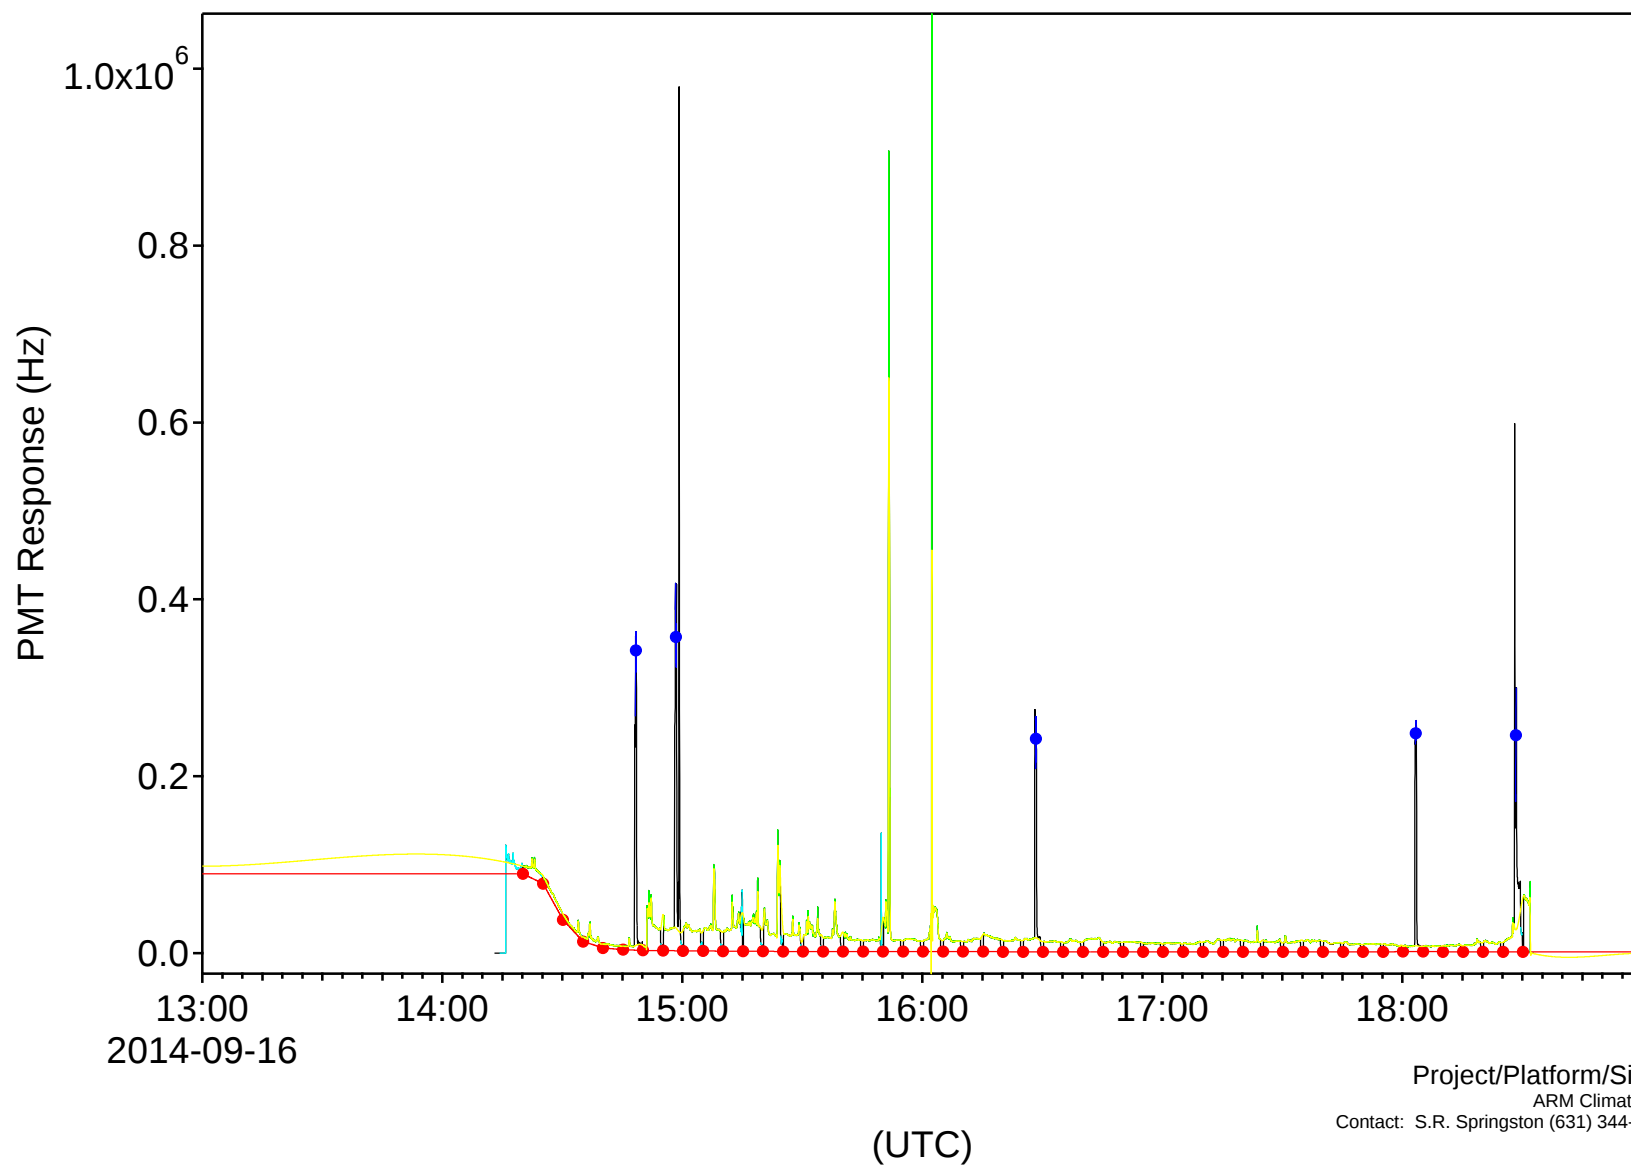
AAF 3-Channel NO<sub>x</sub> Analyzer  
Parsed NO<sub>x</sub> Channel Data

It has been observed that the NO/NO<sub>2</sub> ratios do not appear reasonable at low levels (<500 pptv). There seems to be a constant artifact in the NOx channel. This makes the NO<sub>2</sub> reported high and should not be used directly. These data are only preliminary.

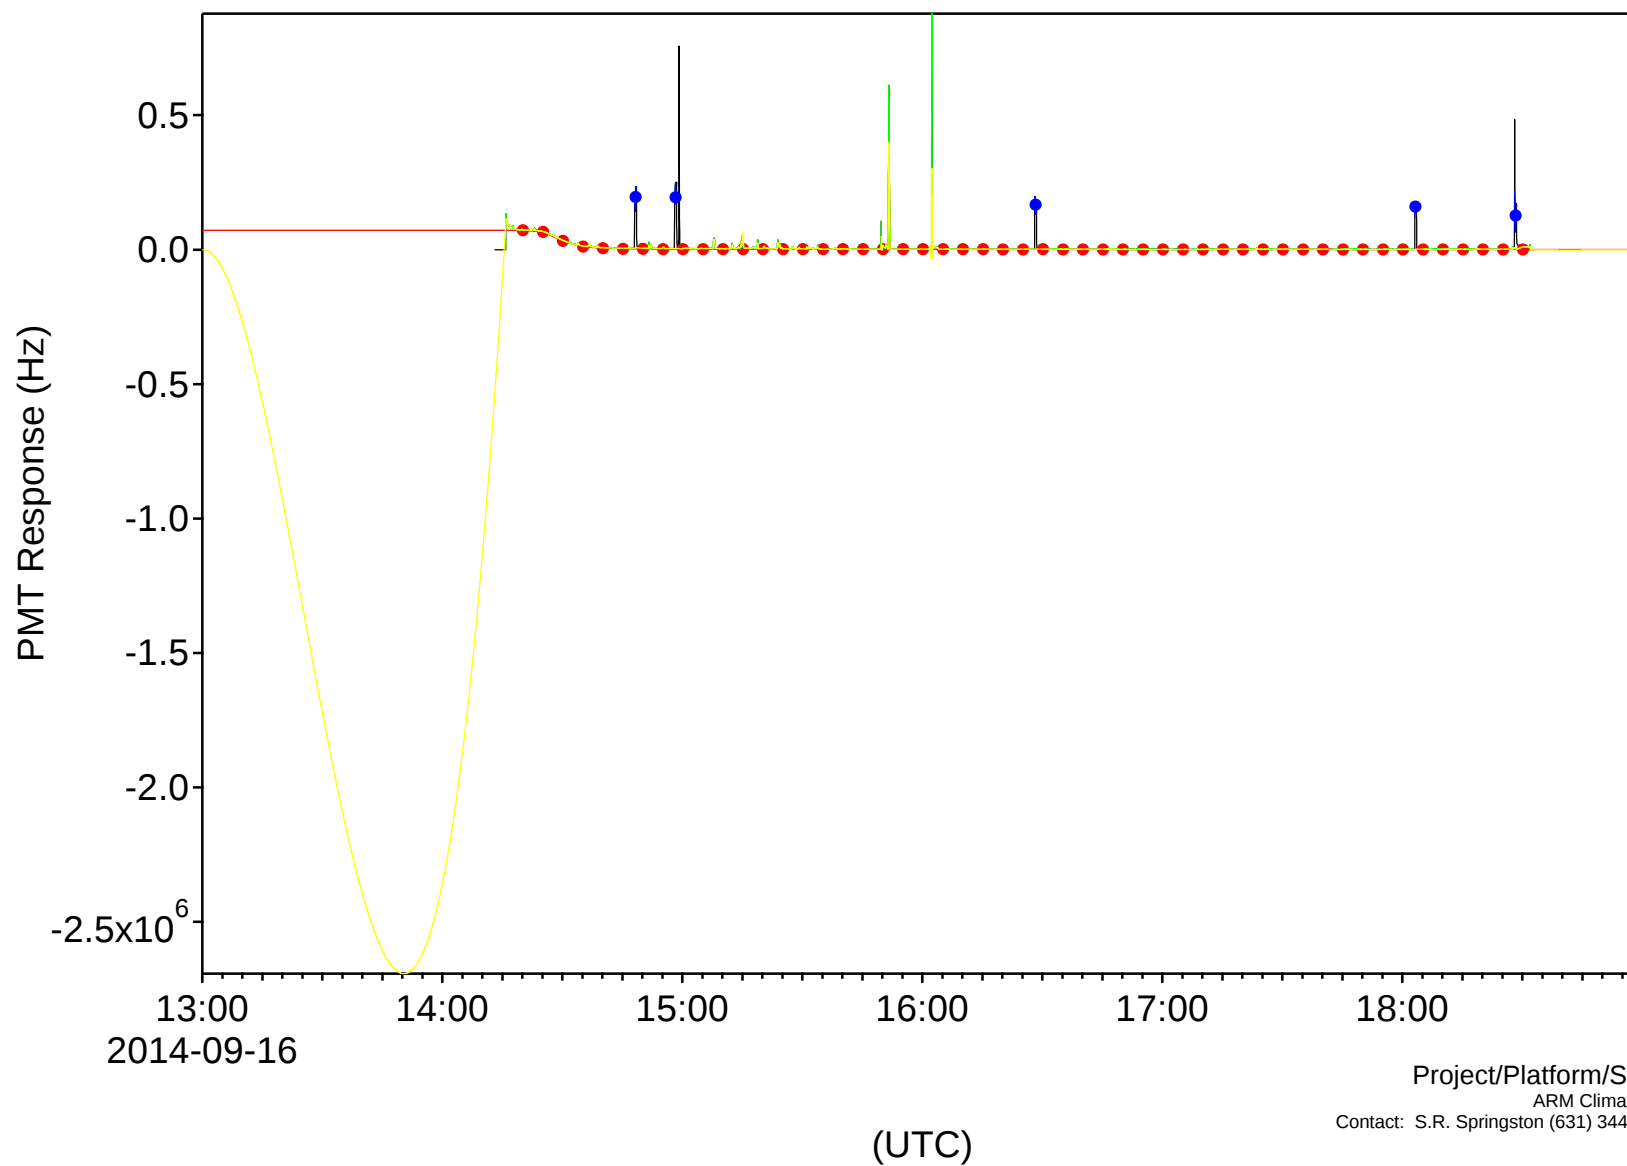
AAF 3-Channel NO<sub>x</sub> Analyzer  
Parsed NO Channel Data

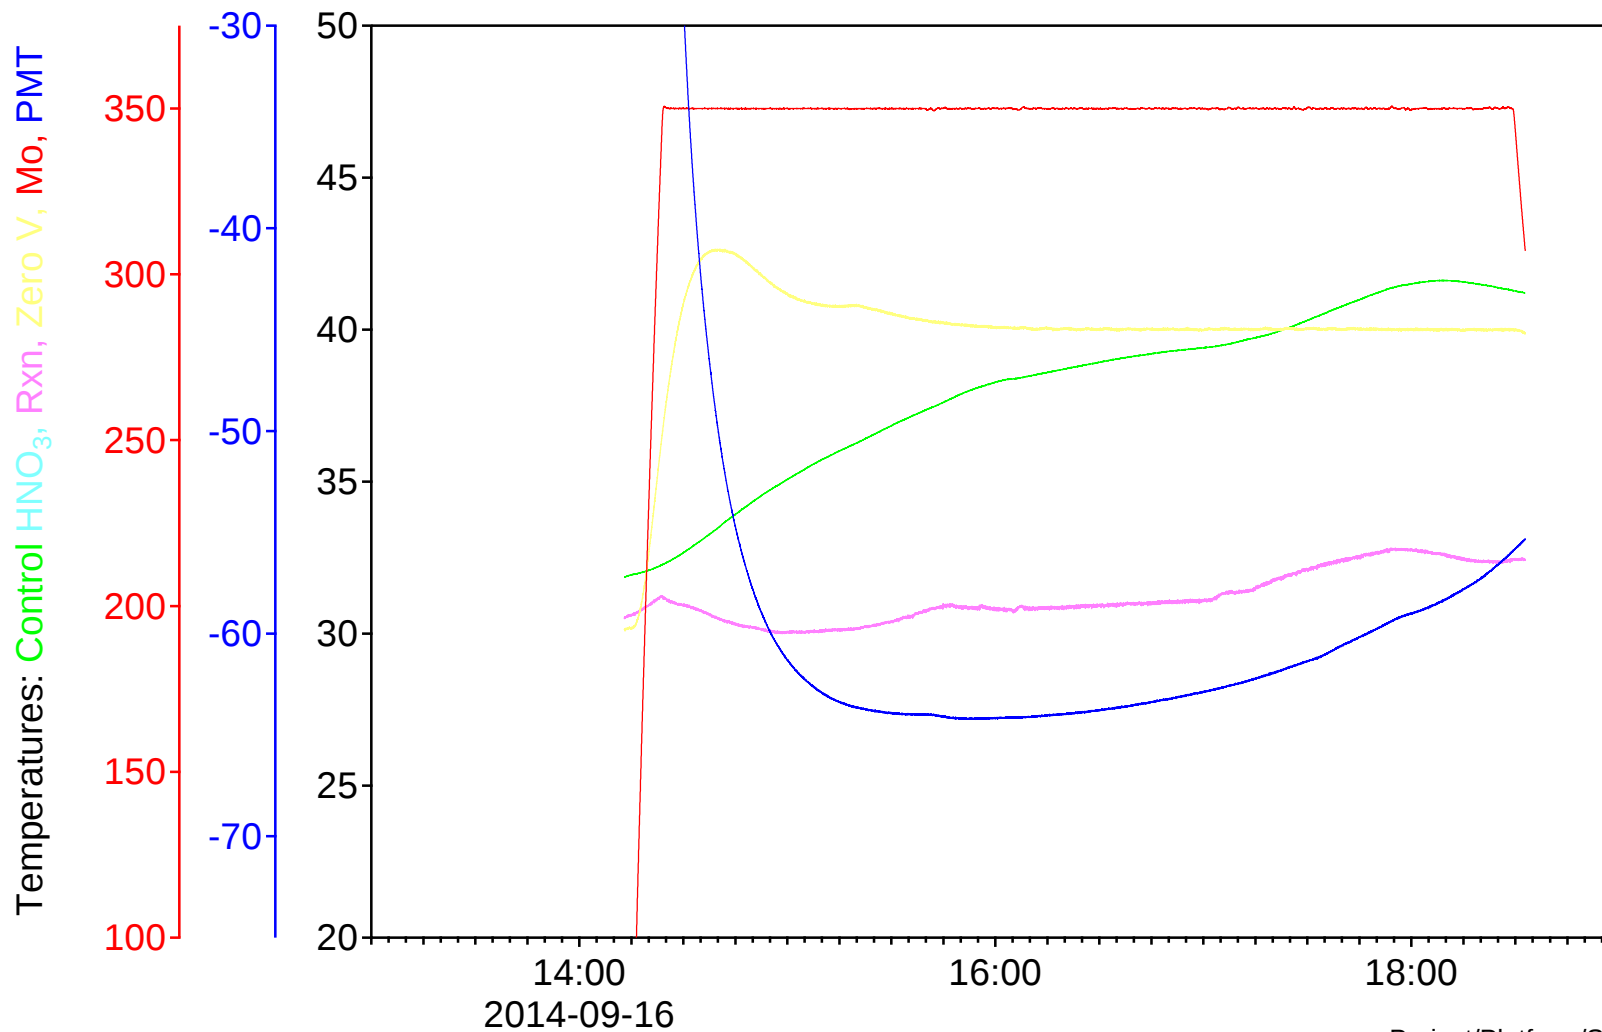
AAF 3-Channel NO<sub>x</sub> Analyzer  
Housekeeping T  
Temperatures

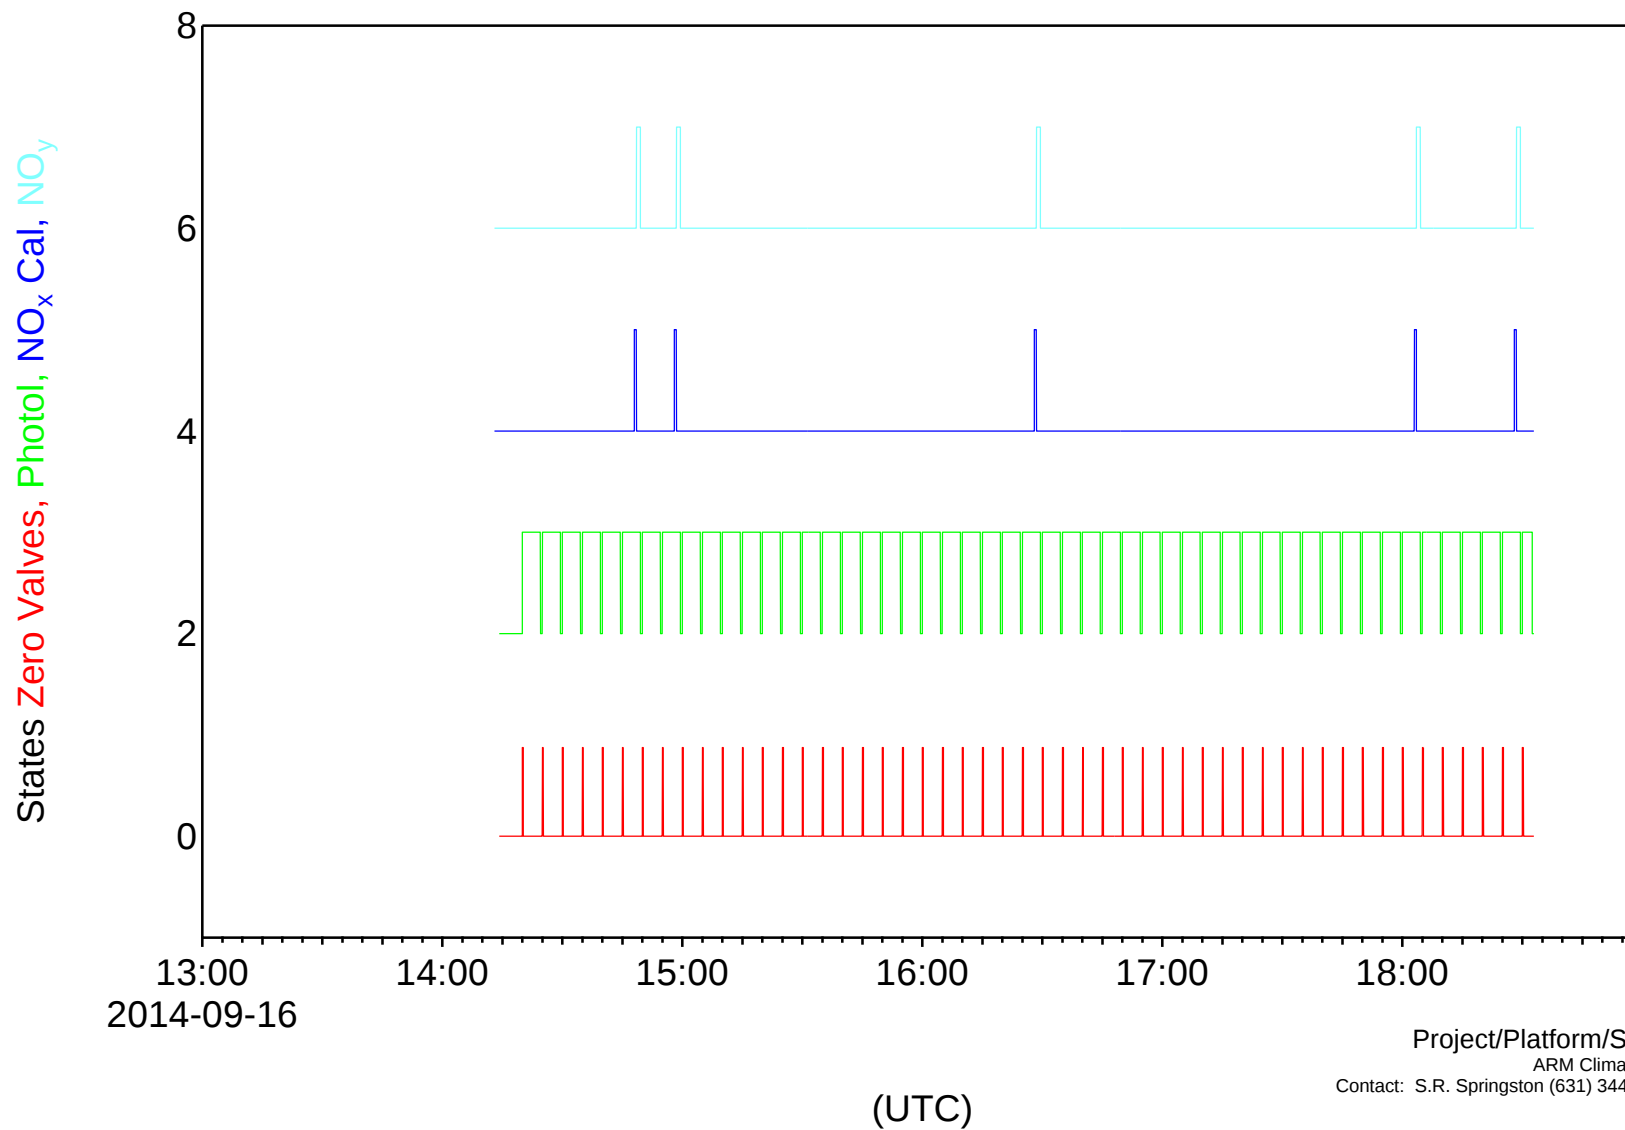
AAF 3-Channel NO<sub>x</sub> Analyzer  
Housekeeping 5  
Zeros/Photol/SAs

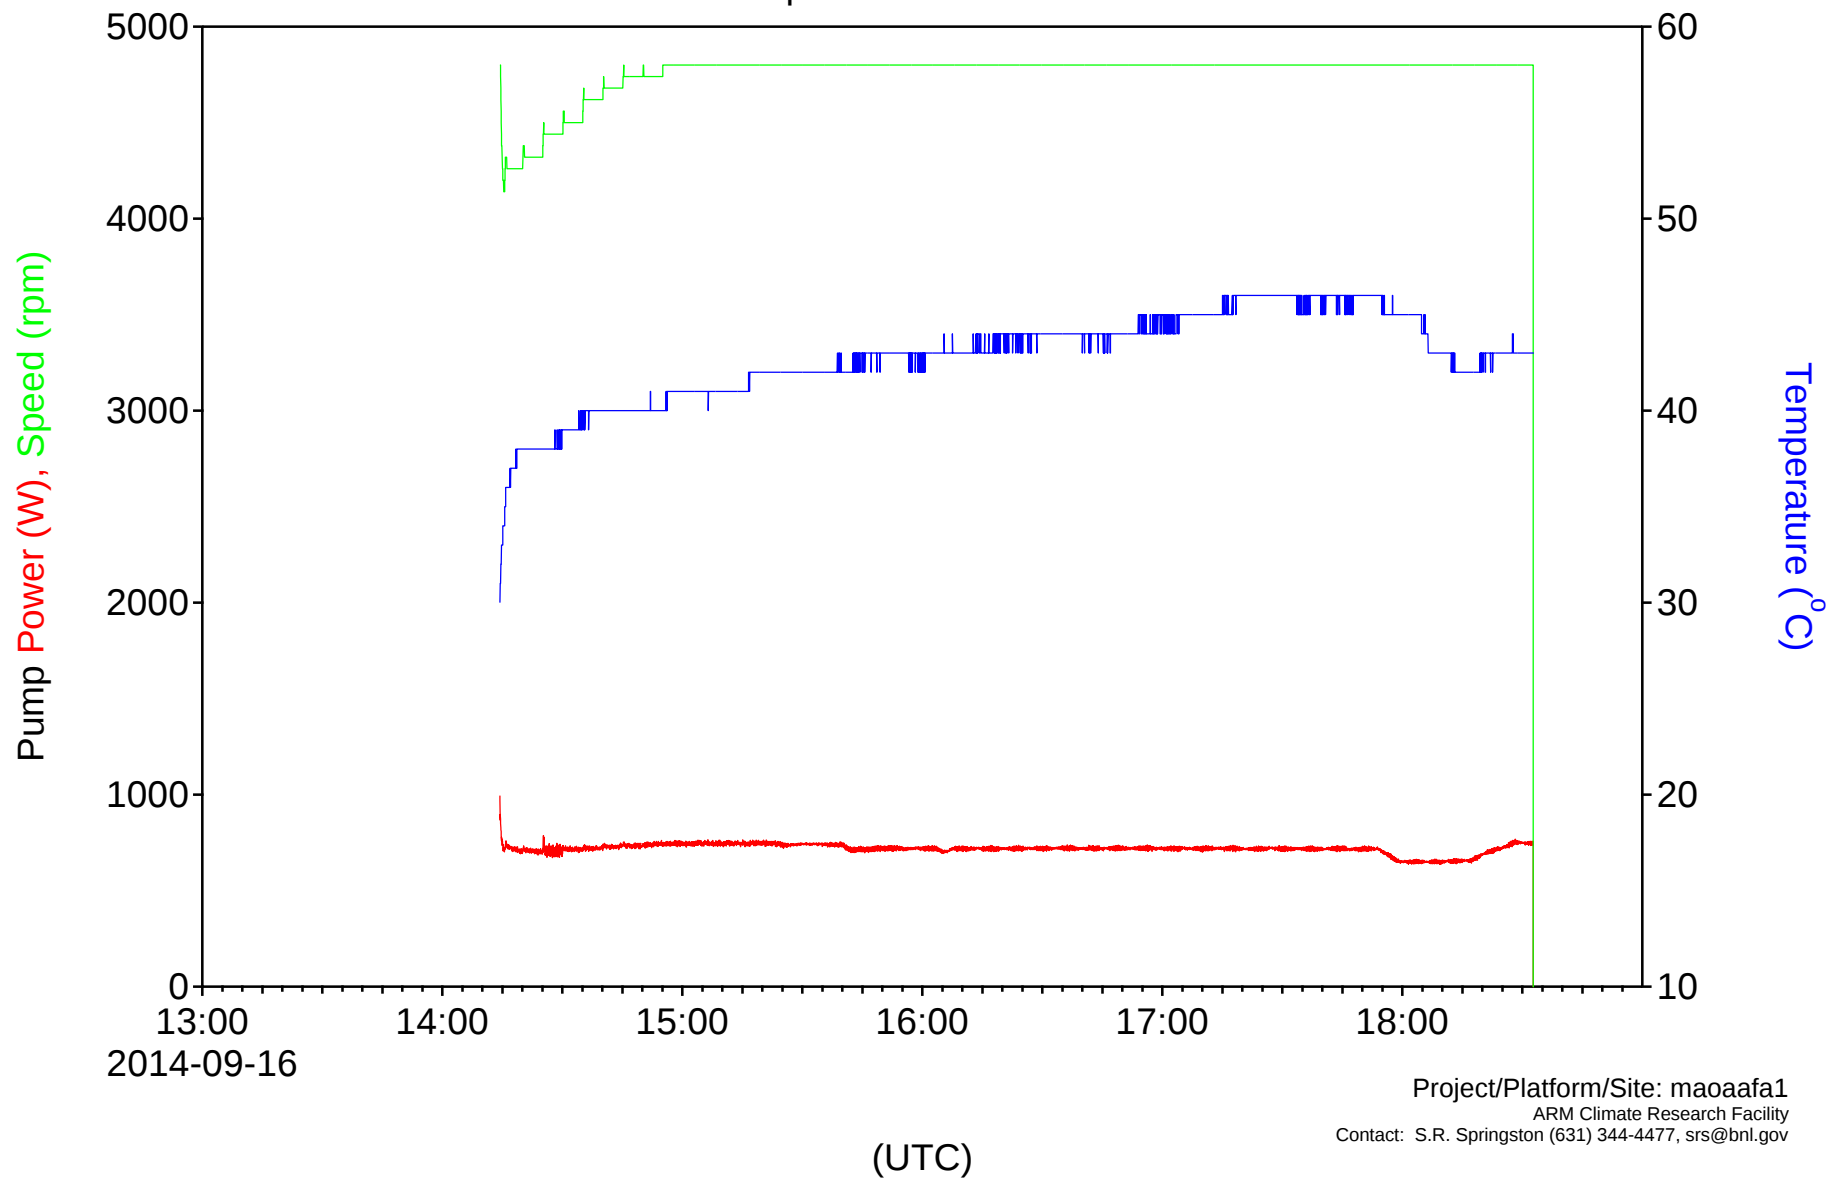
AAF 3-Channel NO<sub>x</sub> Analyzer  
Housekeeping 4  
Pump

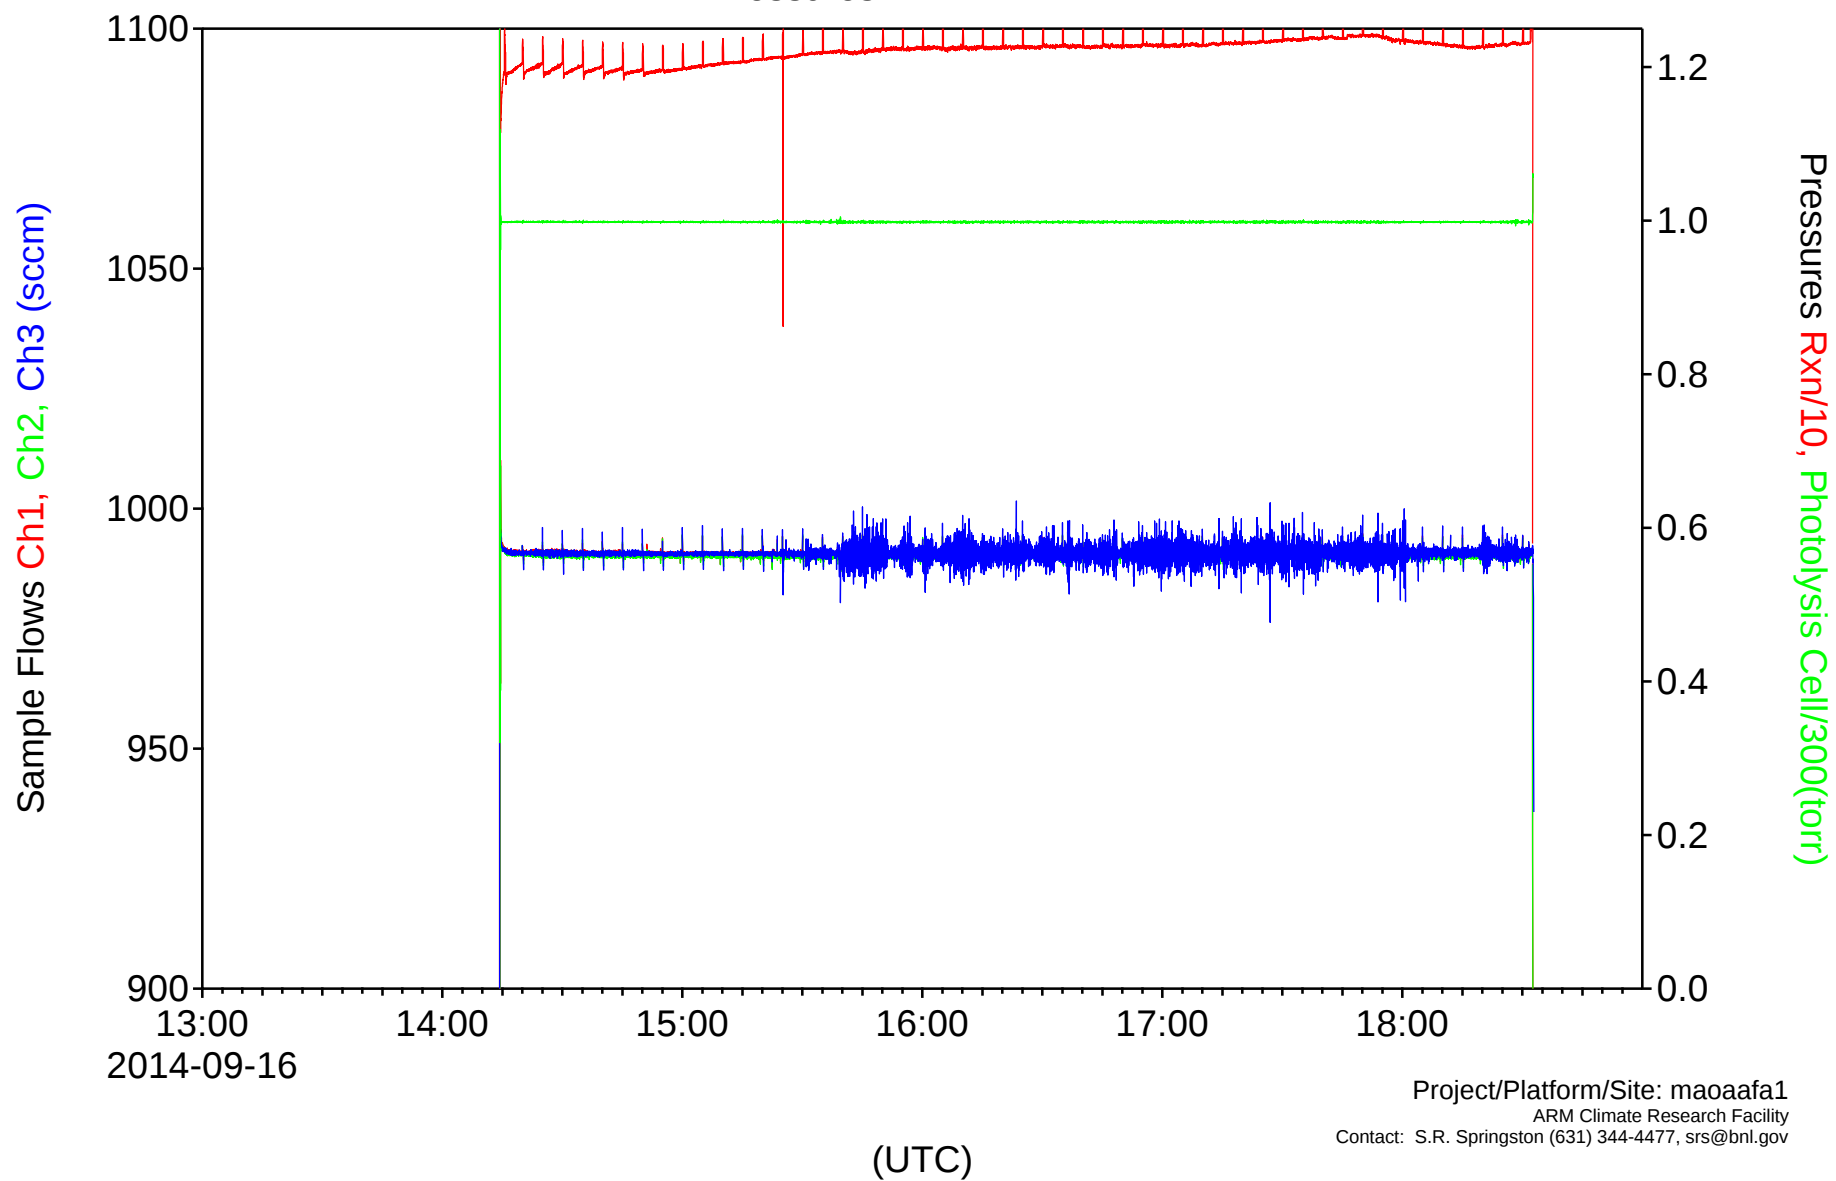
AAF 3-Channel NO<sub>x</sub> Analyzer  
Housekeeping 3  
Pressures

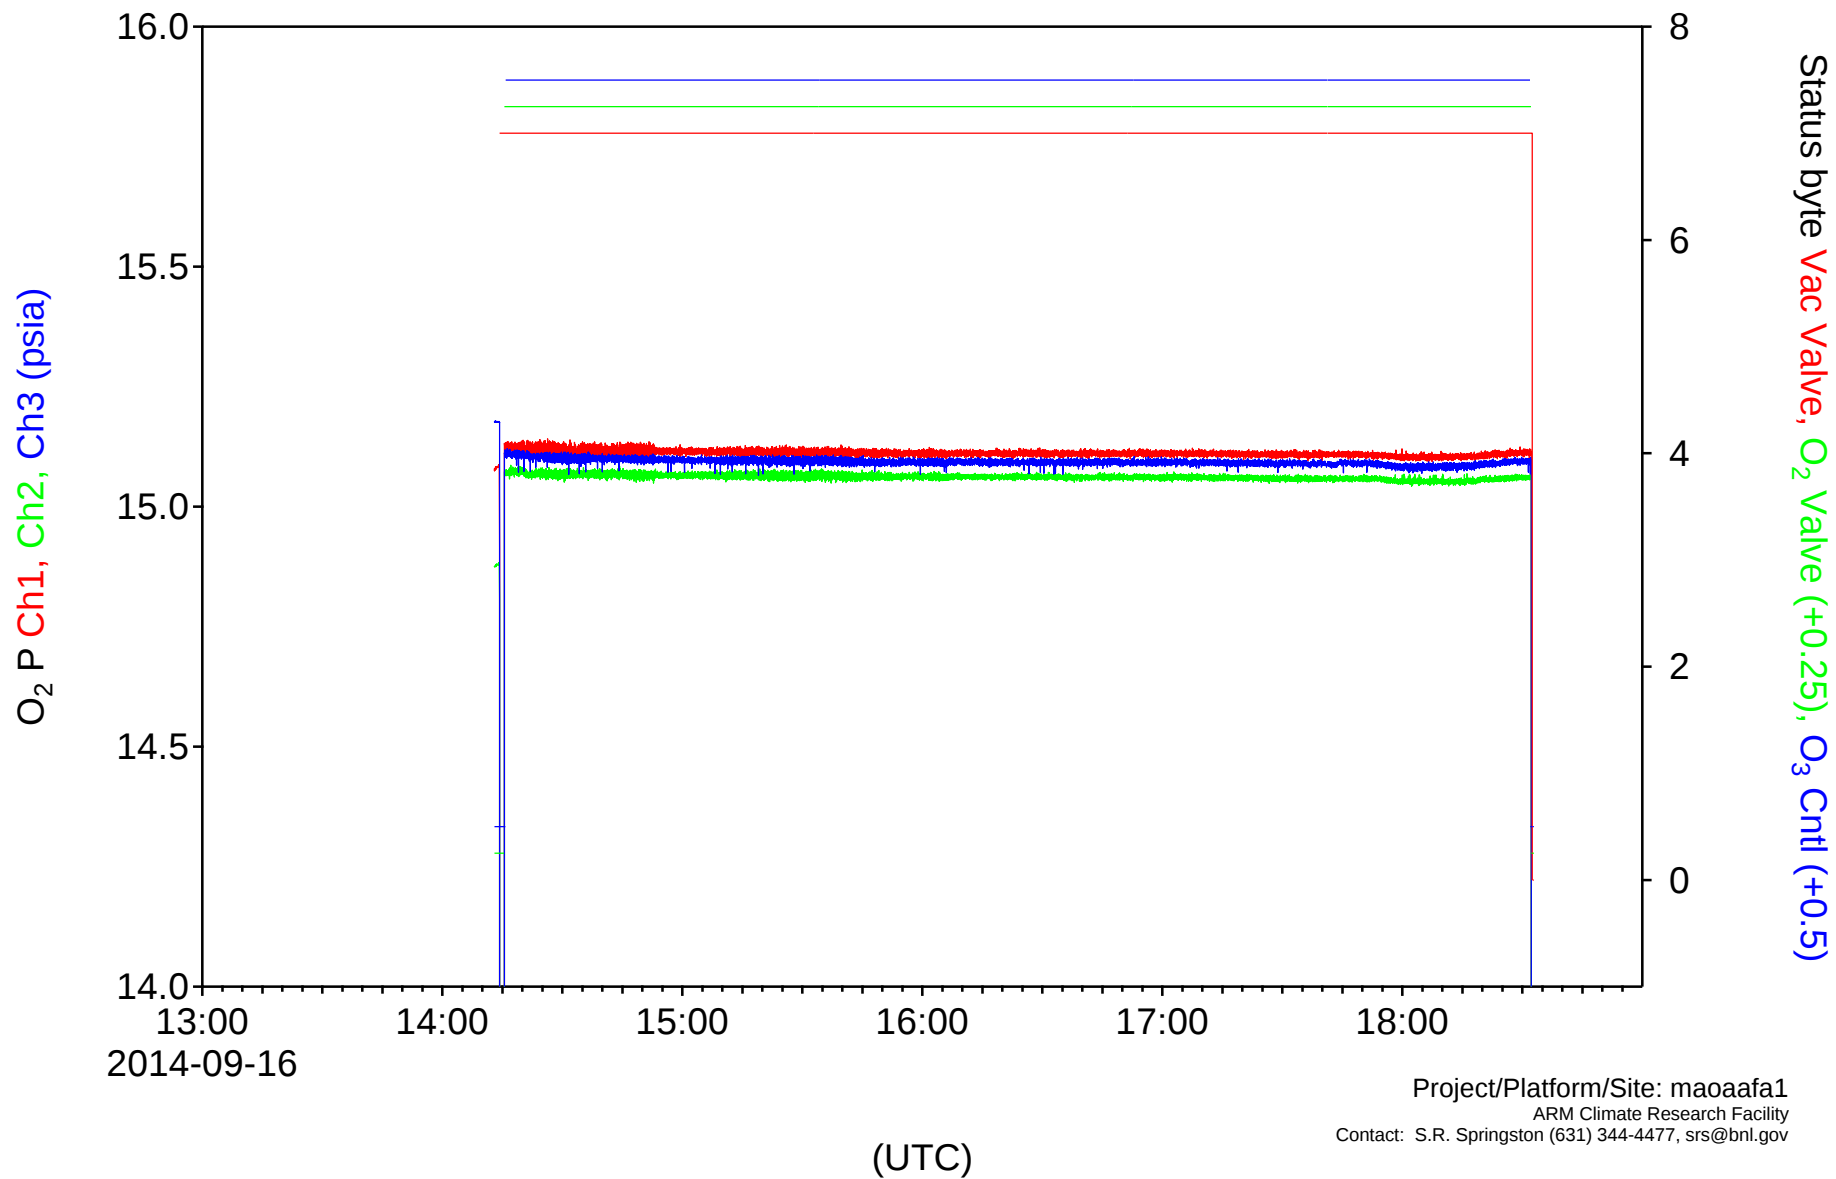
AAF 3-Channel NO<sub>x</sub> Analyzer  
Housekeeping 2  
Ozonizer

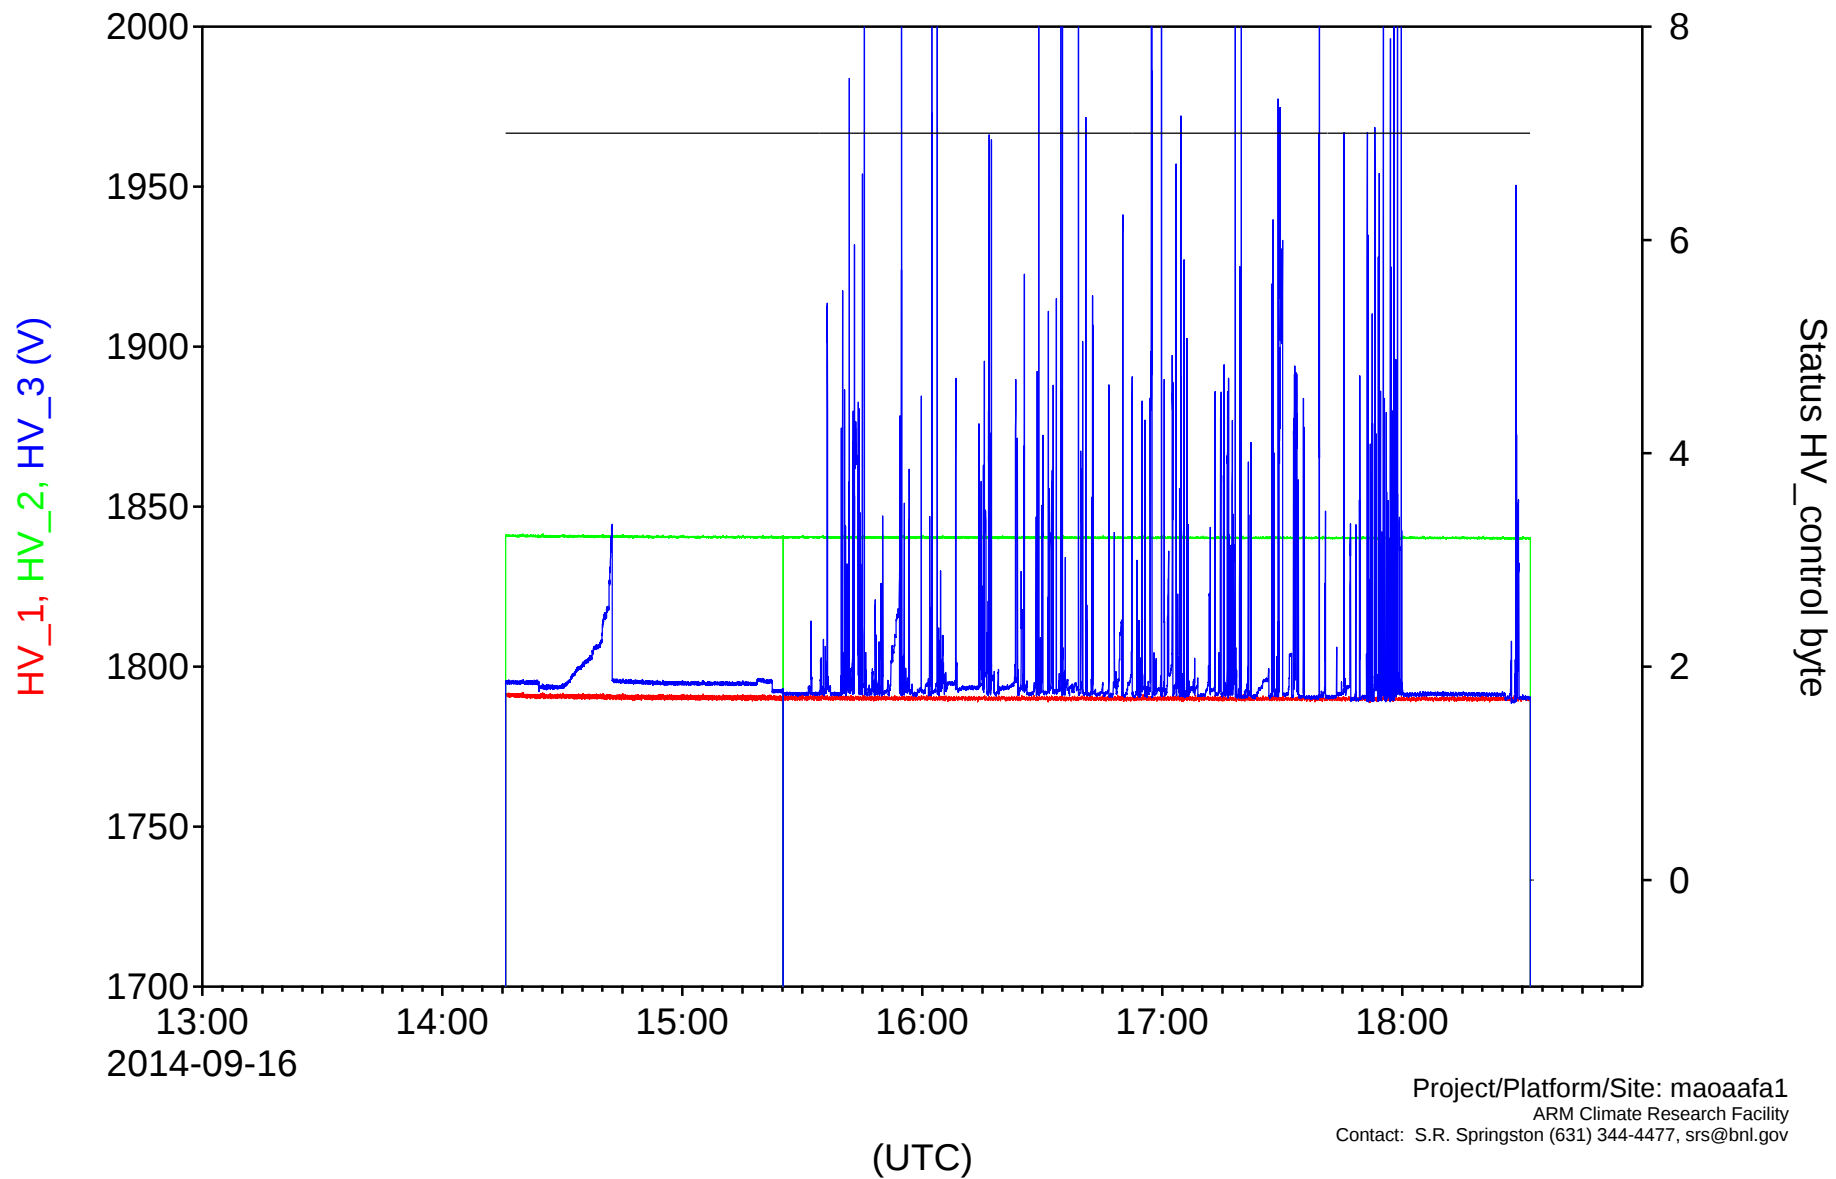
AAF 3-Channel NO<sub>x</sub> Analyzer  
Housekeeping 1  
PMT HV

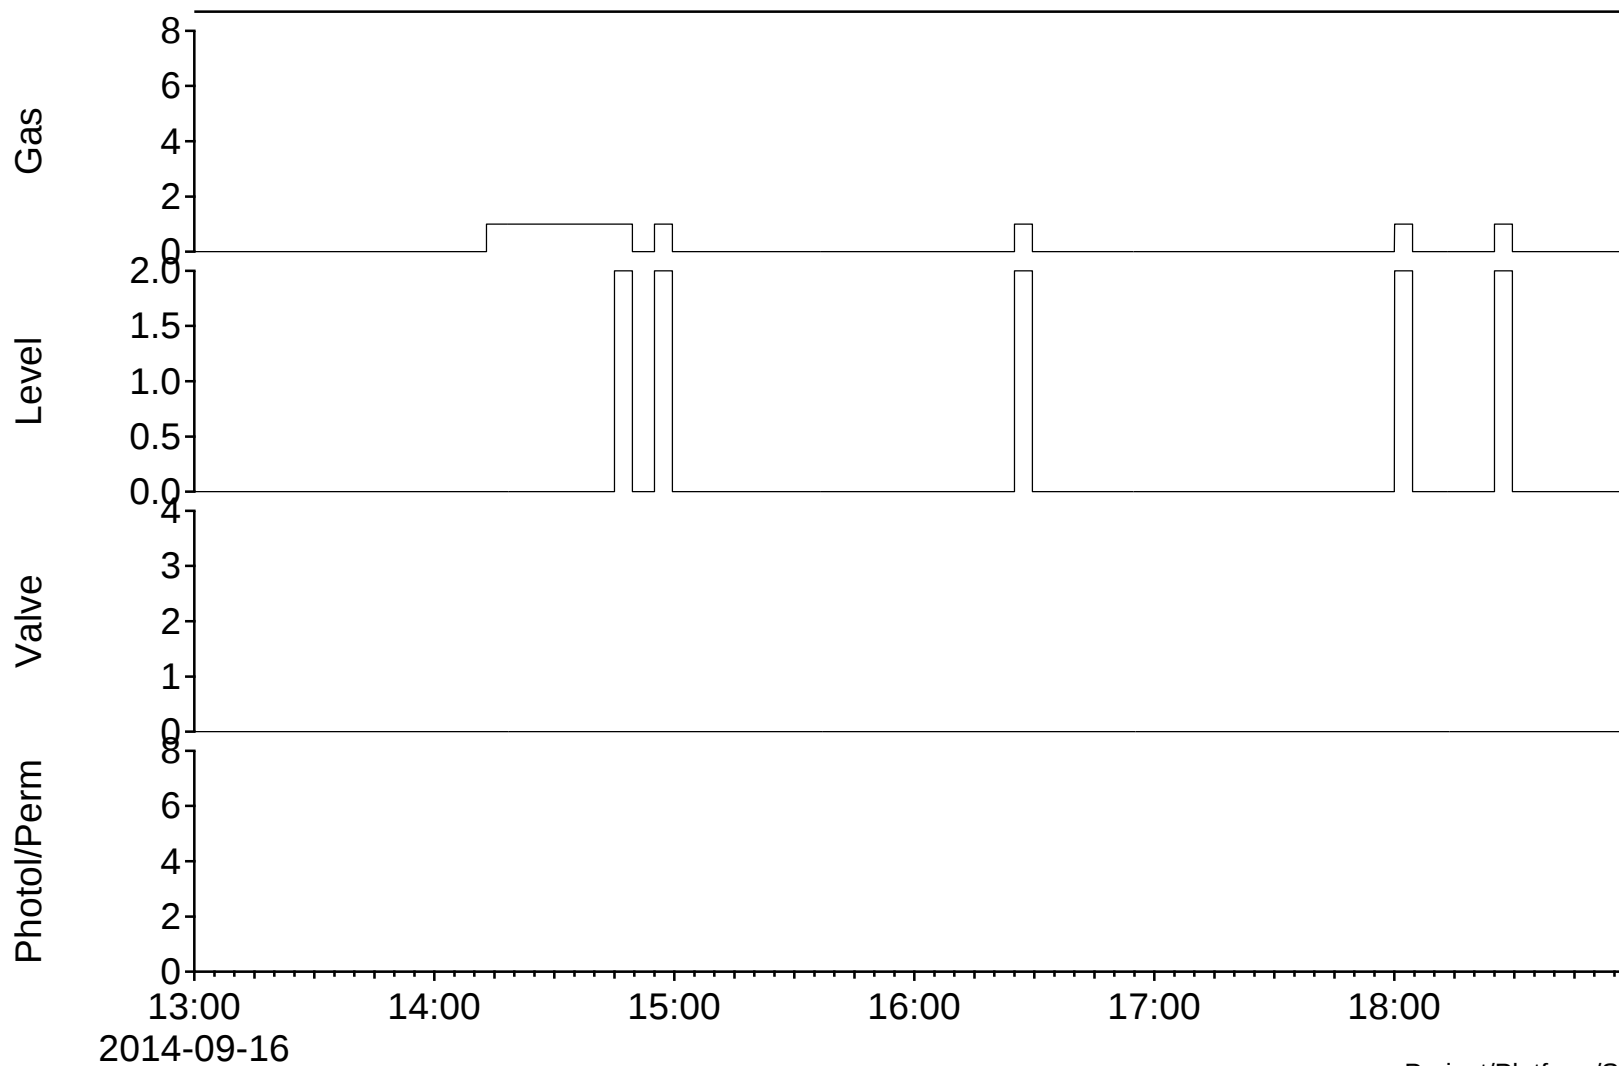
# AAF TEI 146i Calibrator State

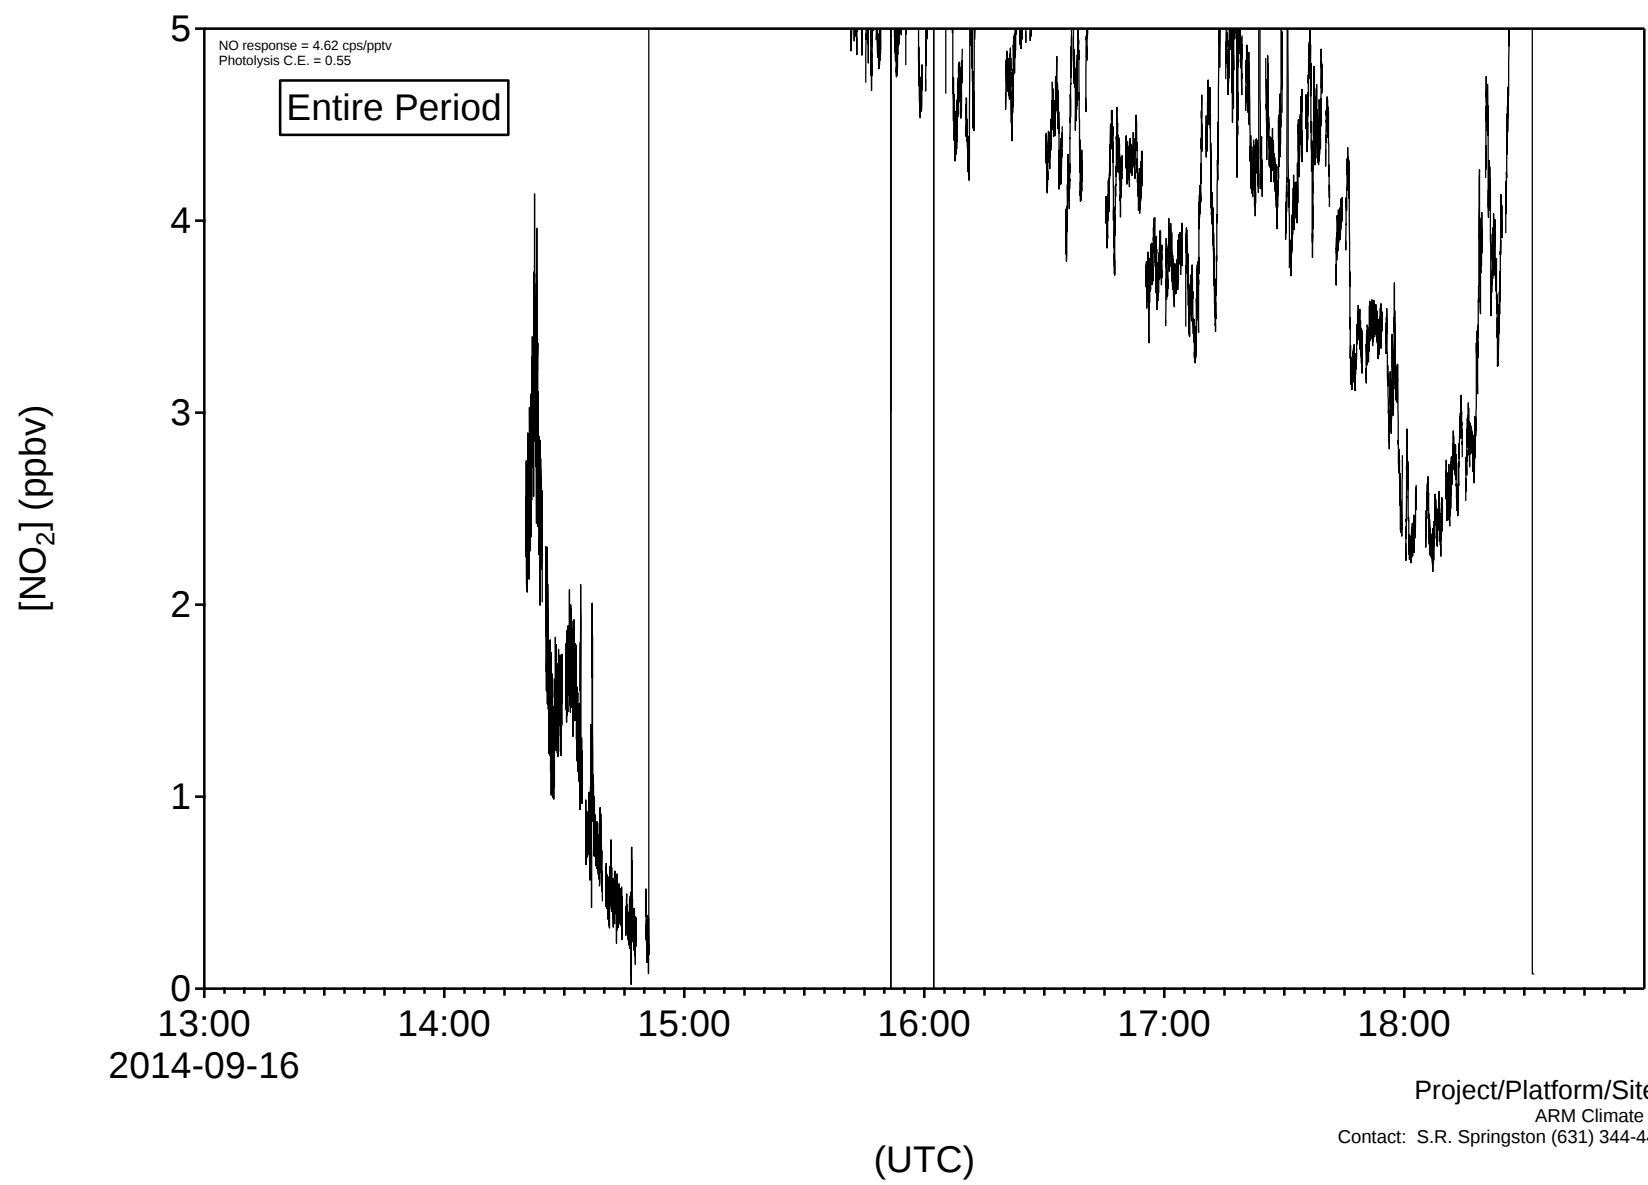
AAF 3-Channel NO<sub>x</sub> Analyzer  
Processed NO<sub>2</sub> Channel Data

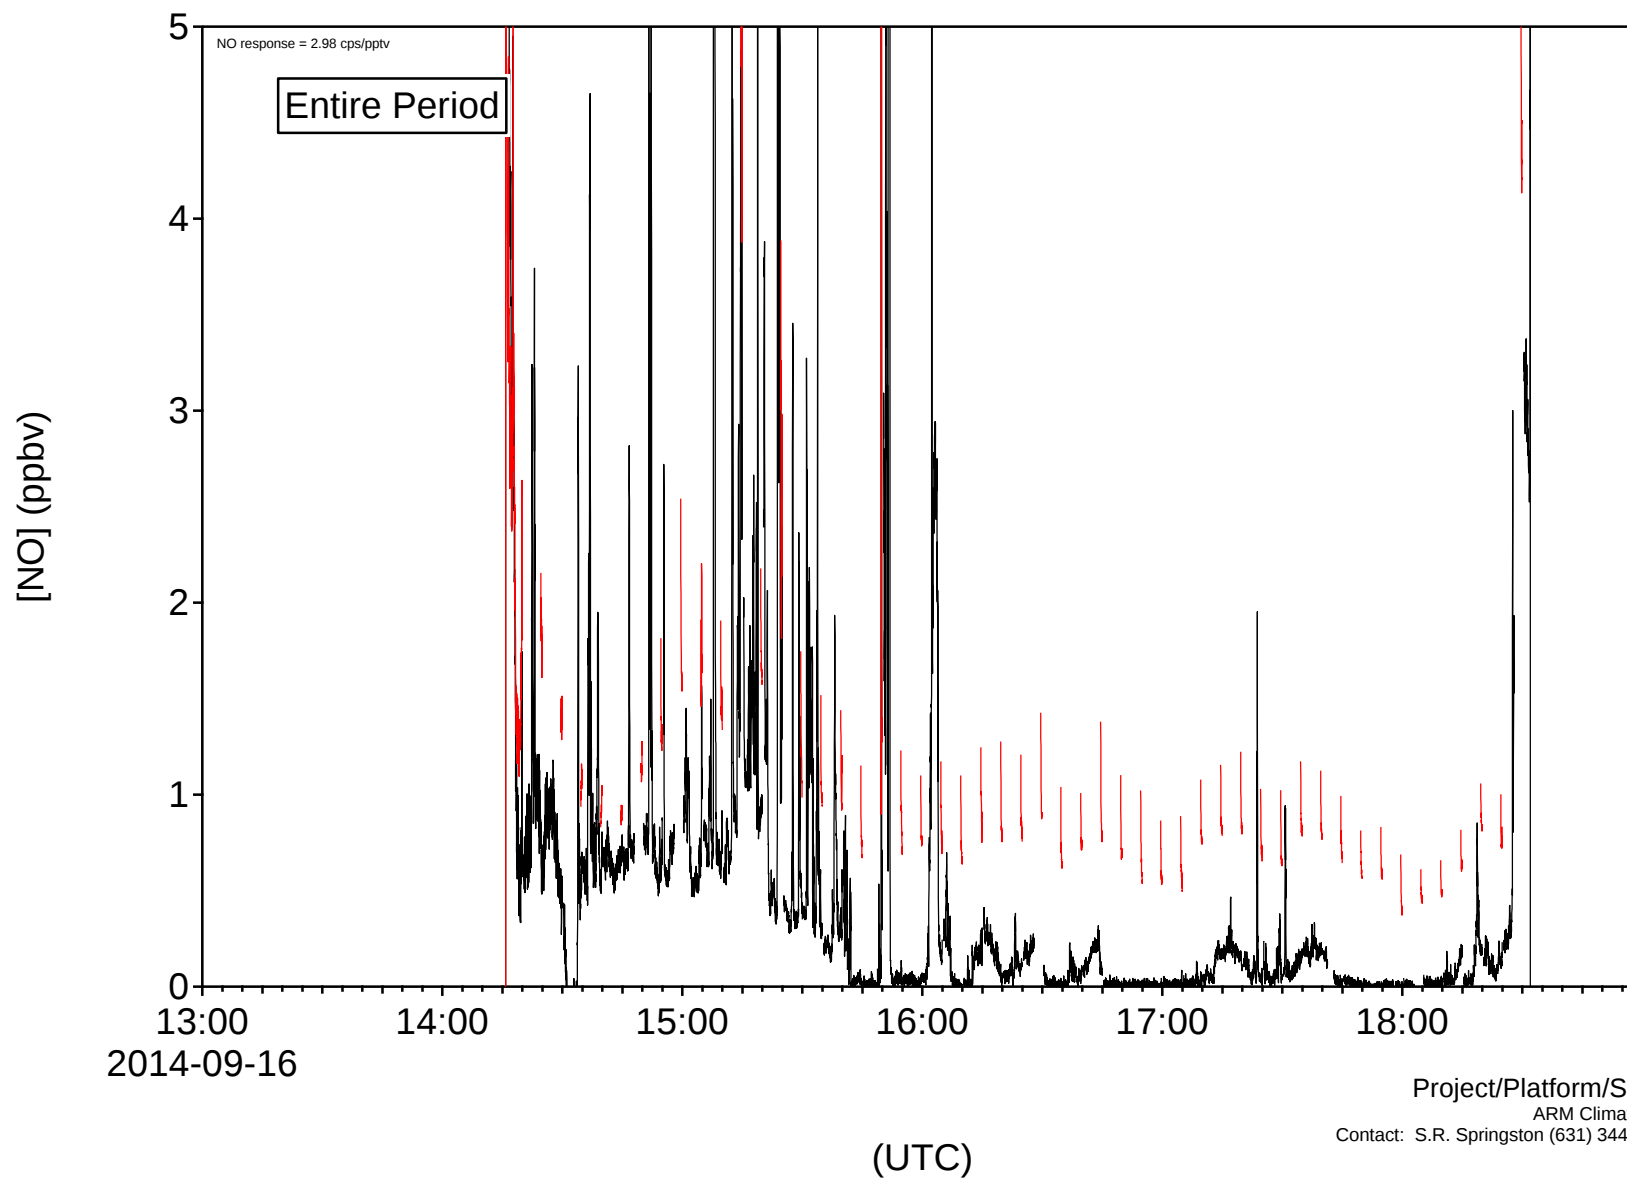
AAF 3-Channel NO<sub>x</sub> Analyzer  
Processed NO Channel Data
