Loading from flight 140916a  
Data taken from NOx CPU c:\data\NOx

AAF 3-Channel NO<sub>x</sub> Analyzer  
Parsed NO<sub>y</sub> Channel Data

Project/Platform/Site: maoaafa1  
ARM Climate Research Facility  
Contact: S.R. Springston (631) 344-4477, srs@bnl.gov

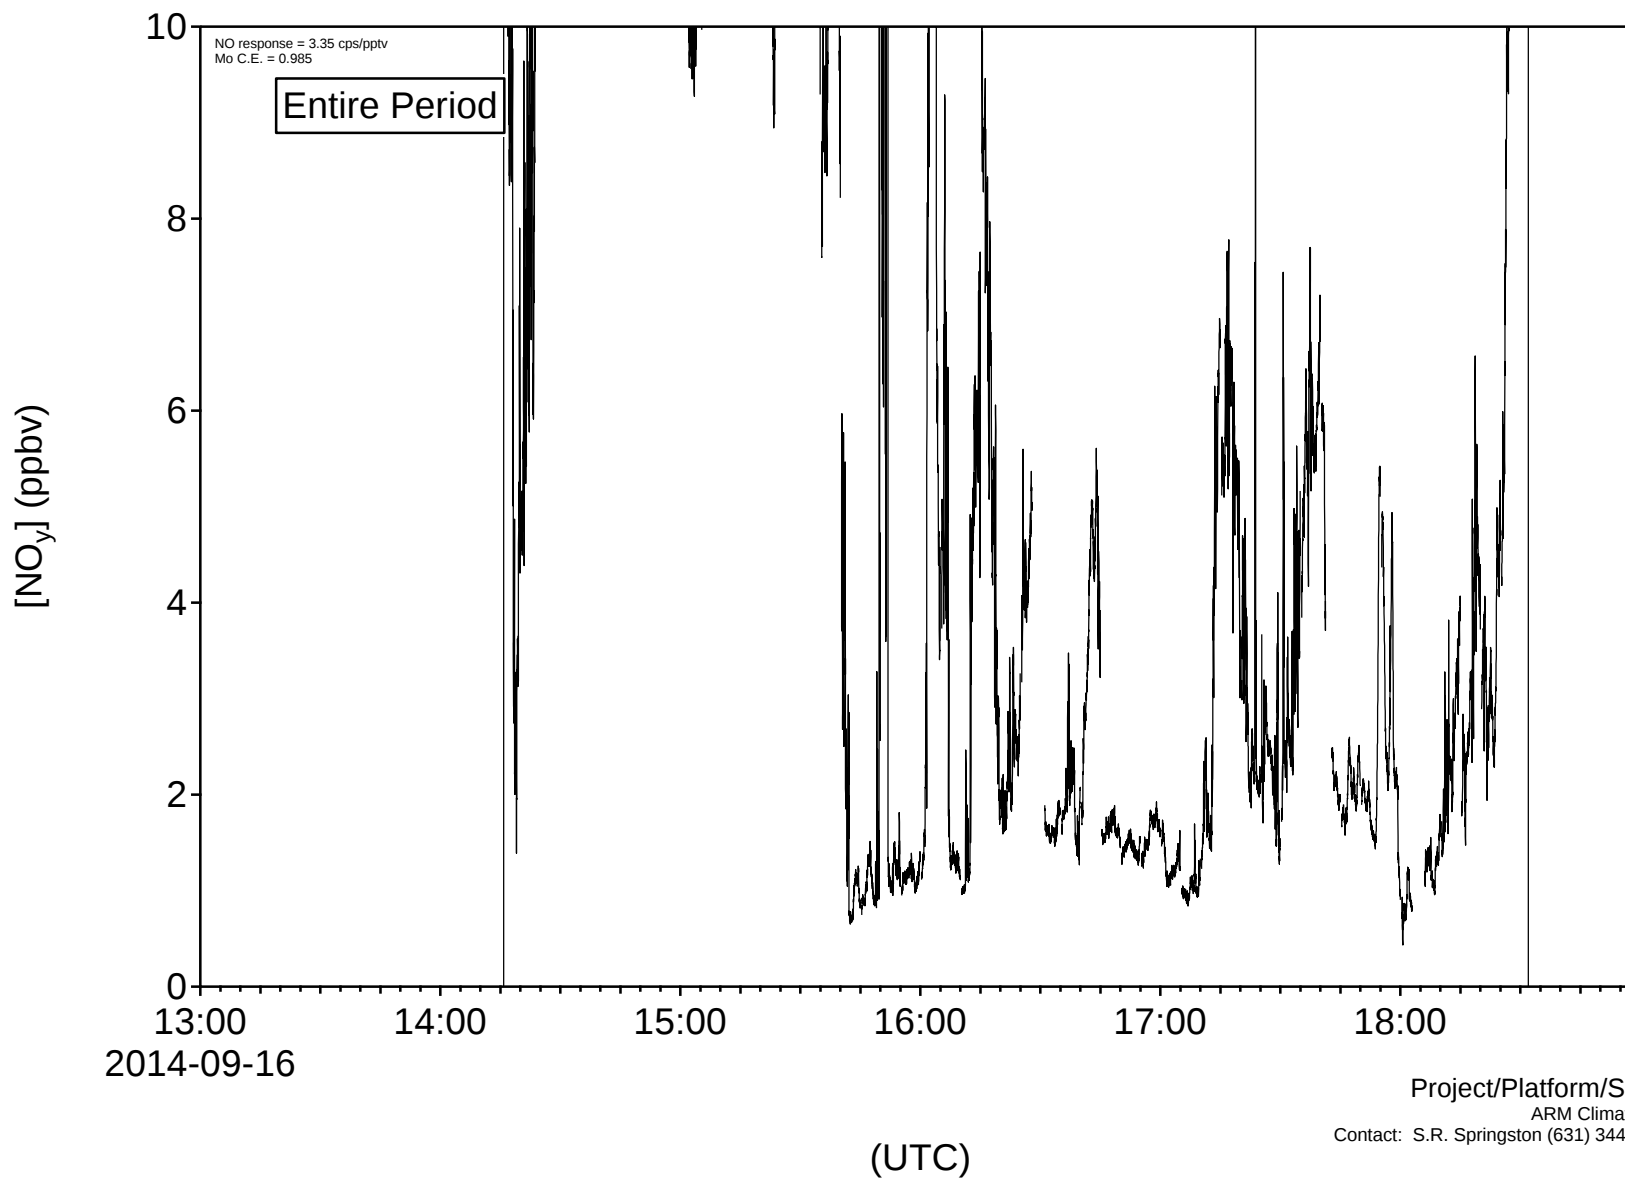
AAF 3-Channel NO<sub>x</sub> Analyzer  
Processed NO<sub>y</sub> Channel Data
