Processing Record for this file:  
(Make notes here unique for this file)

Loading from flight 140918a  
Data taken from NOx CPU c:\data\NOx

Project/Platform/Site: maoaafa1  
ARM Climate Research Facility  
Contact: S.R. Springston (631) 344-4477, srs@bnl.gov

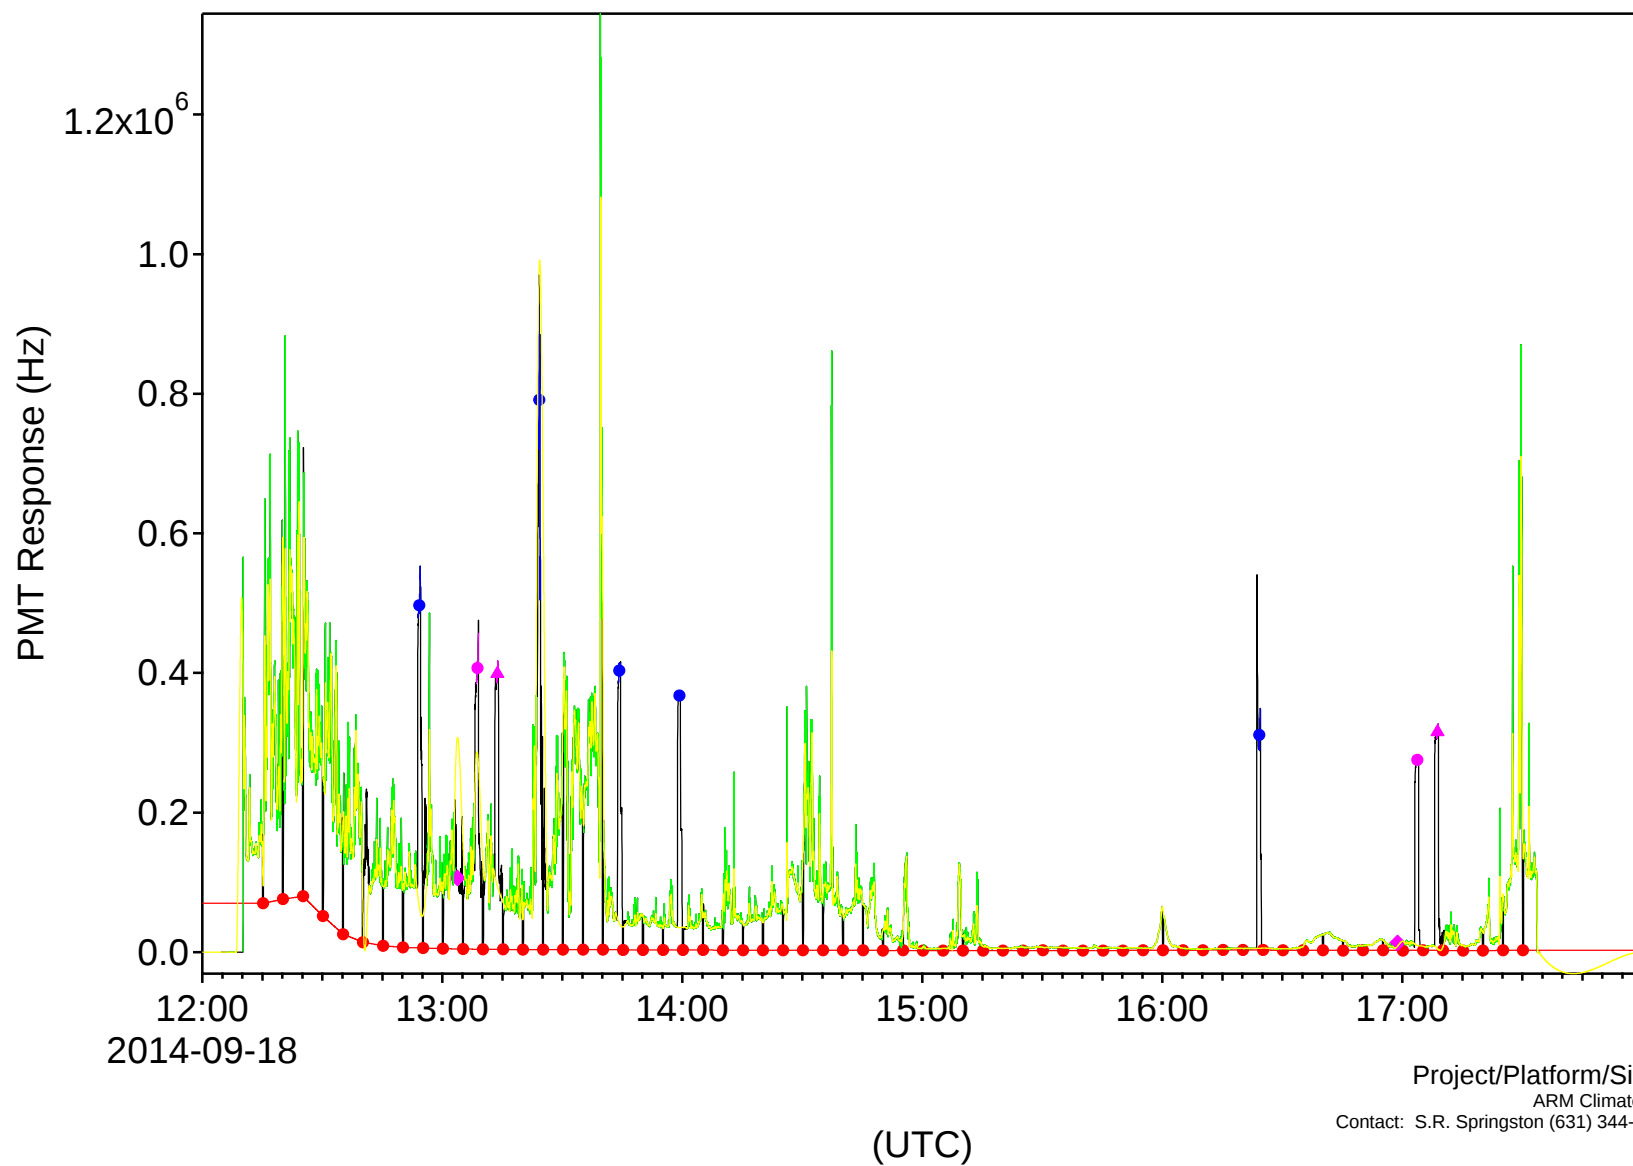
AAF 3-Channel NO<sub>x</sub> Analyzer  
Parsed NO<sub>y</sub> Channel Data

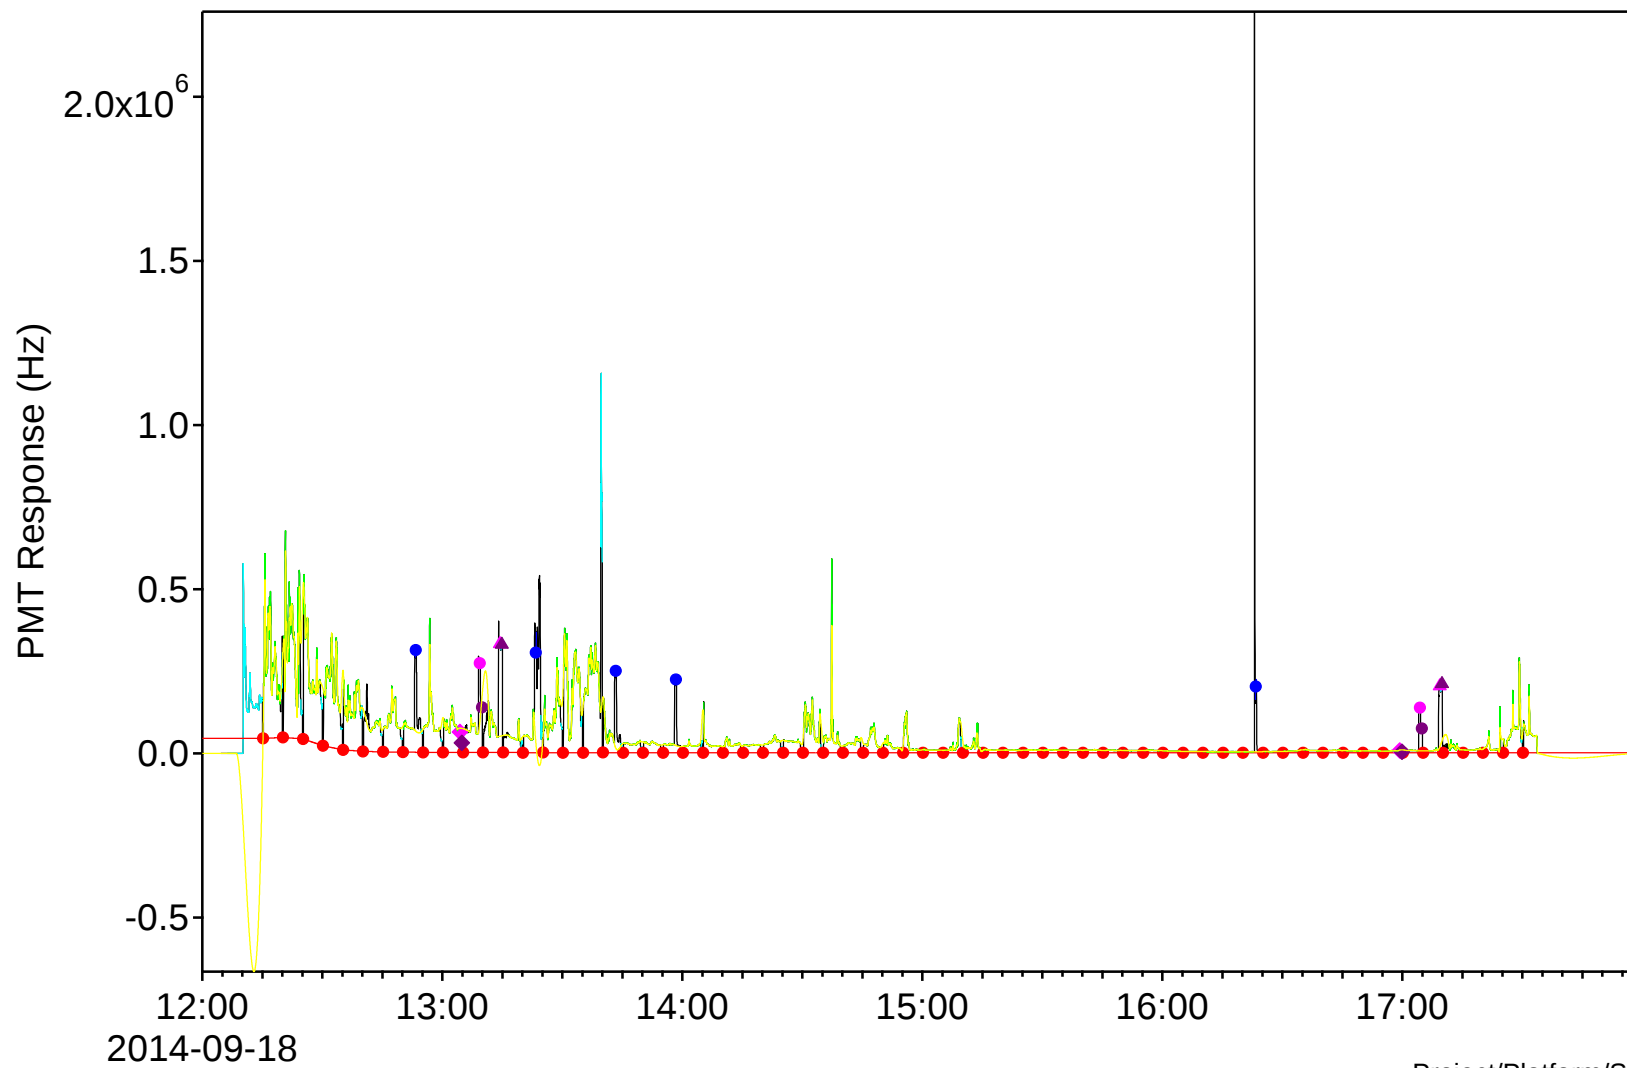
AAF 3-Channel NO<sub>x</sub> Analyzer  
Parsed NO<sub>x</sub> Channel Data

It has been observed that the NO/NO<sub>2</sub> ratios do not appear reasonable at low levels (<500 pptv). There seems to be a constant artifact in the NOx channel. This makes the NO<sub>2</sub> reported high and should not be used directly. These data are only preliminary.

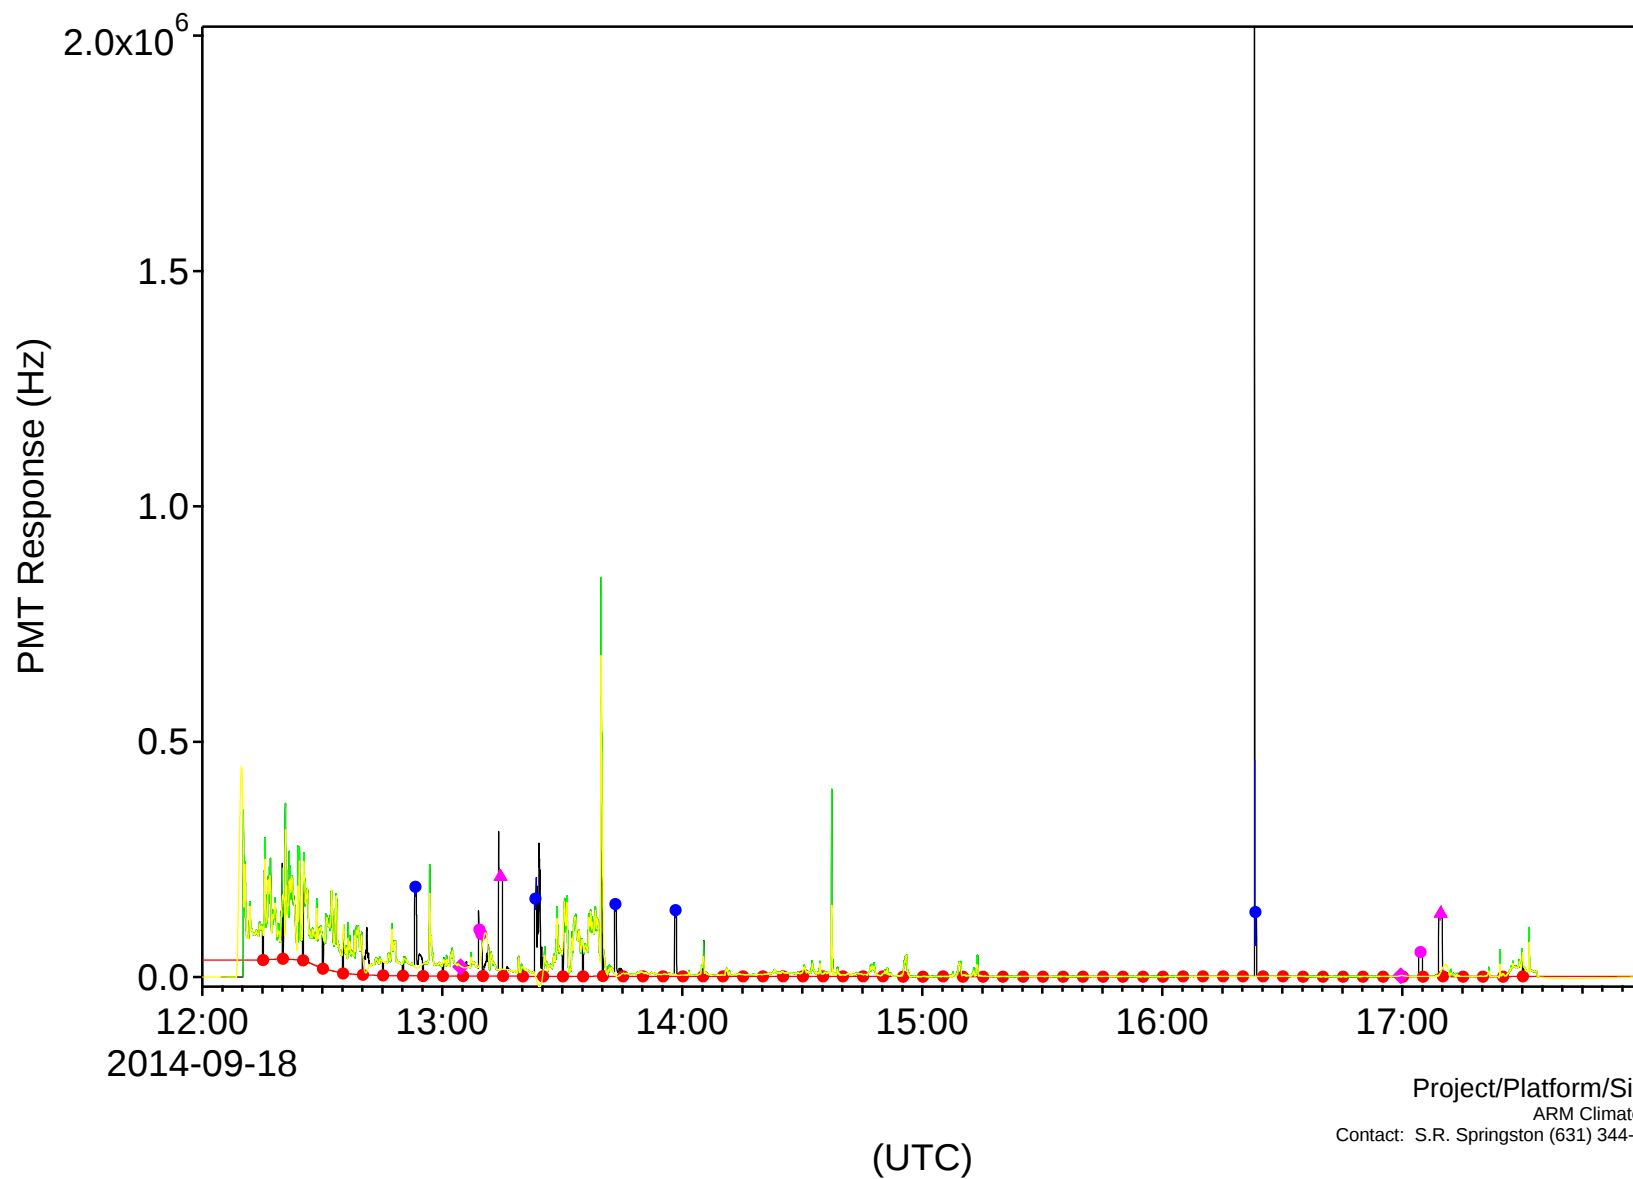
AAF 3-Channel NO<sub>x</sub> Analyzer  
Parsed NO Channel Data

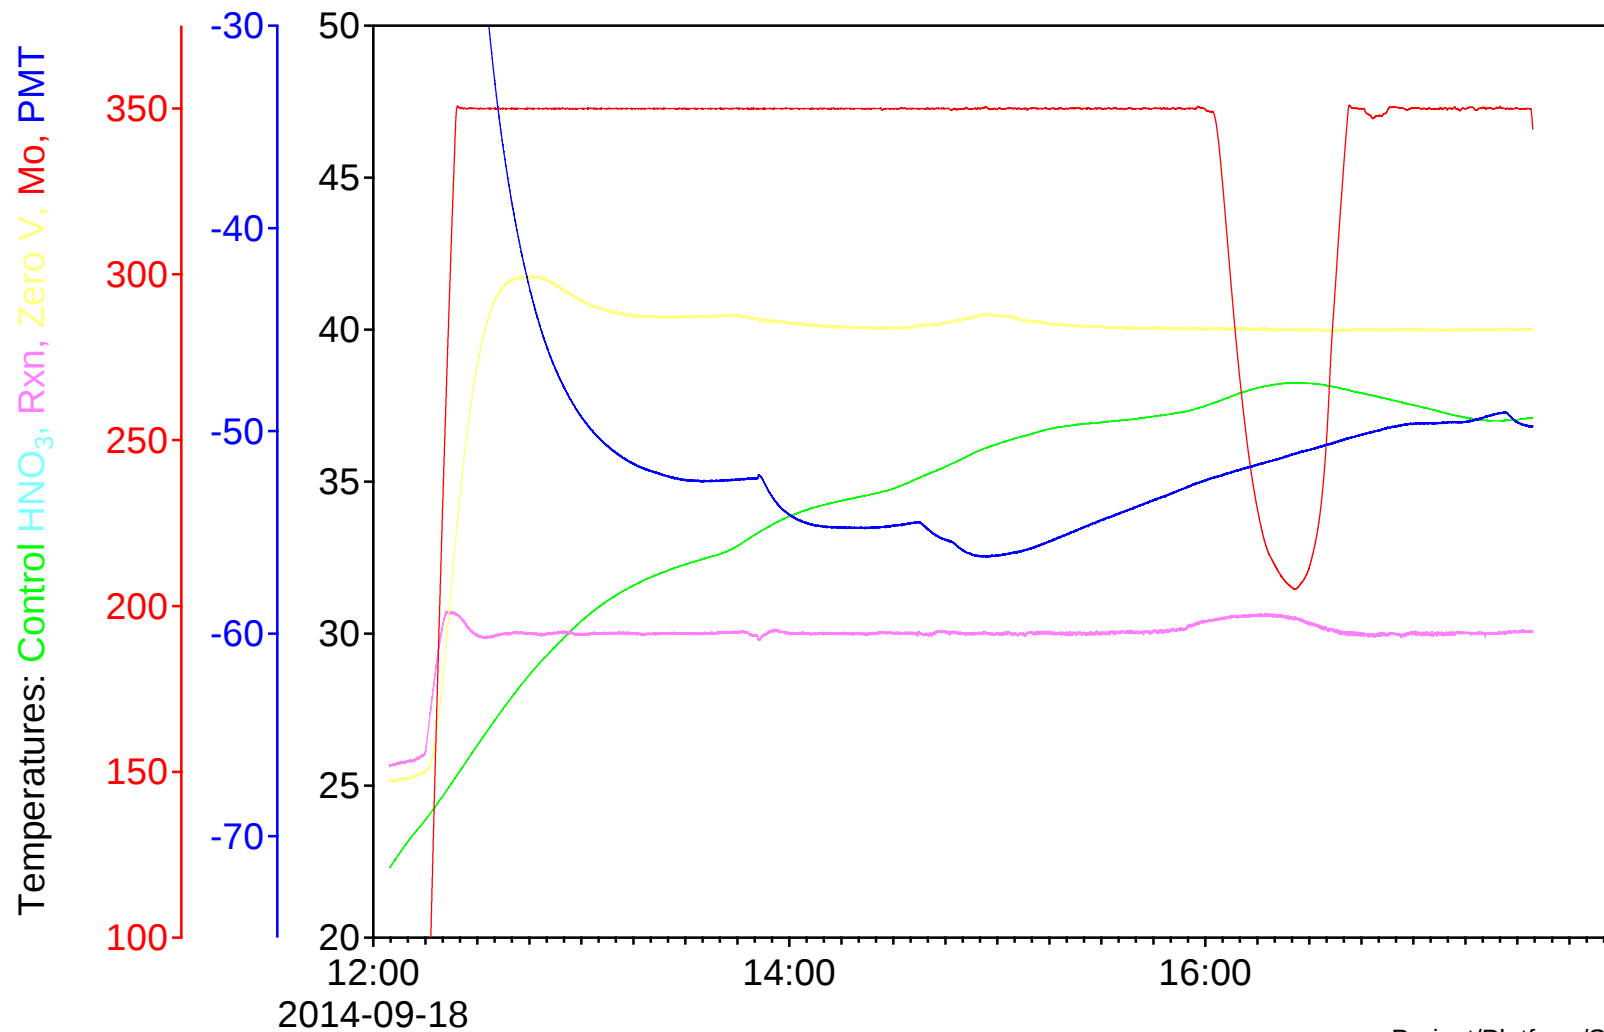
AAF 3-Channel NO<sub>x</sub> Analyzer  
Housekeeping T  
Temperatures

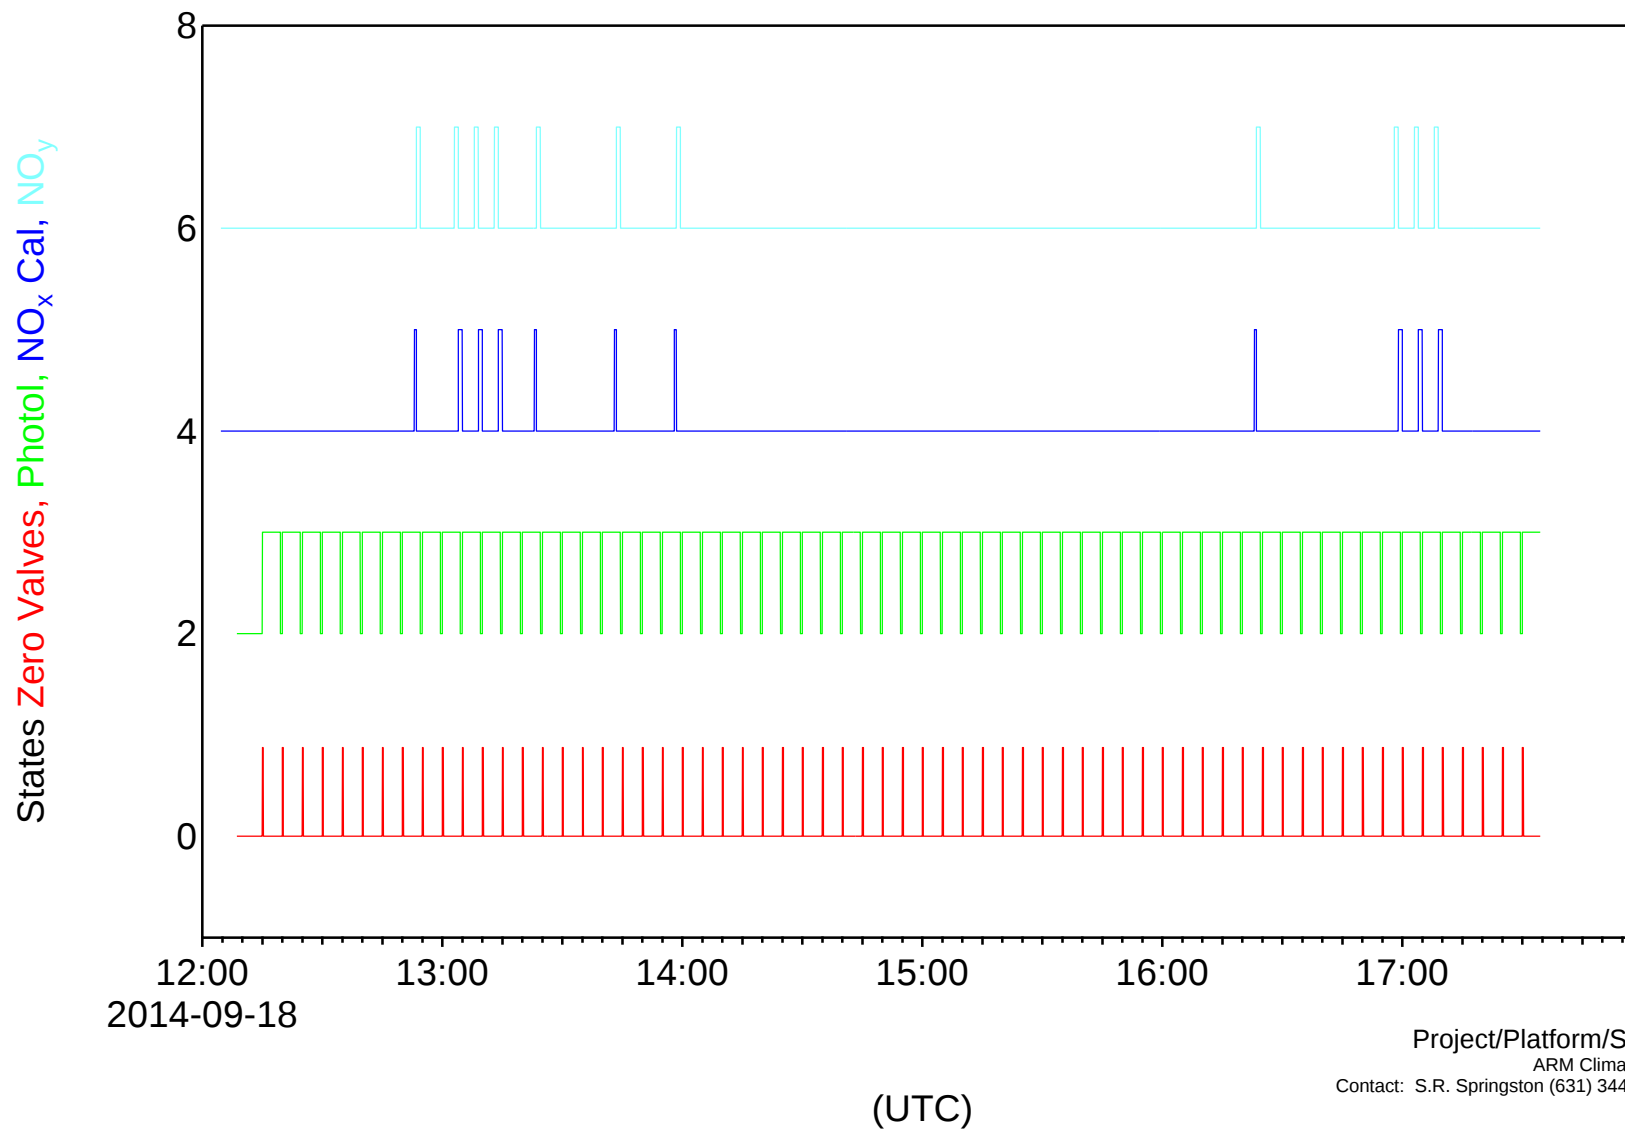
AAF 3-Channel NO<sub>x</sub> Analyzer  
Housekeeping 5  
Zeros/Photol/SAs

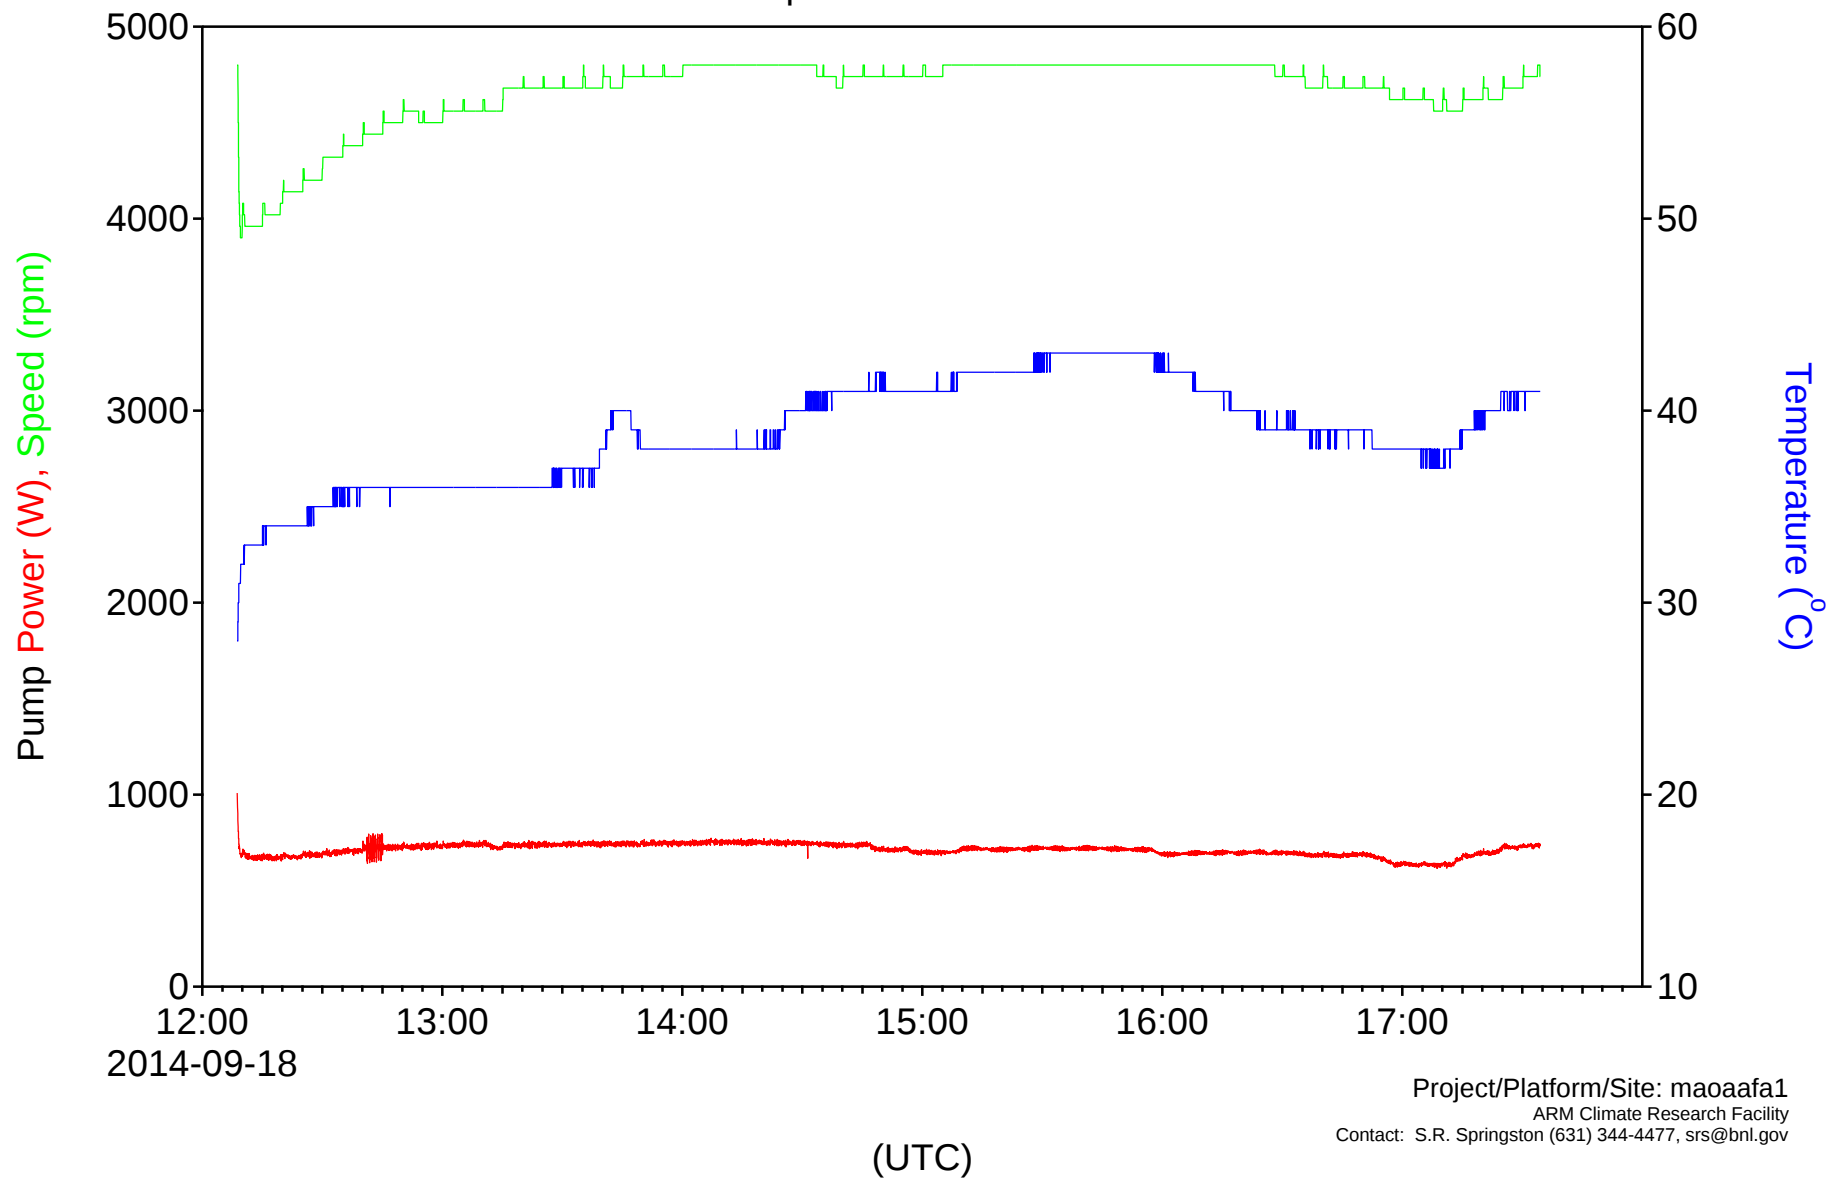
AAF 3-Channel NO<sub>x</sub> Analyzer  
Housekeeping 4  
Pump

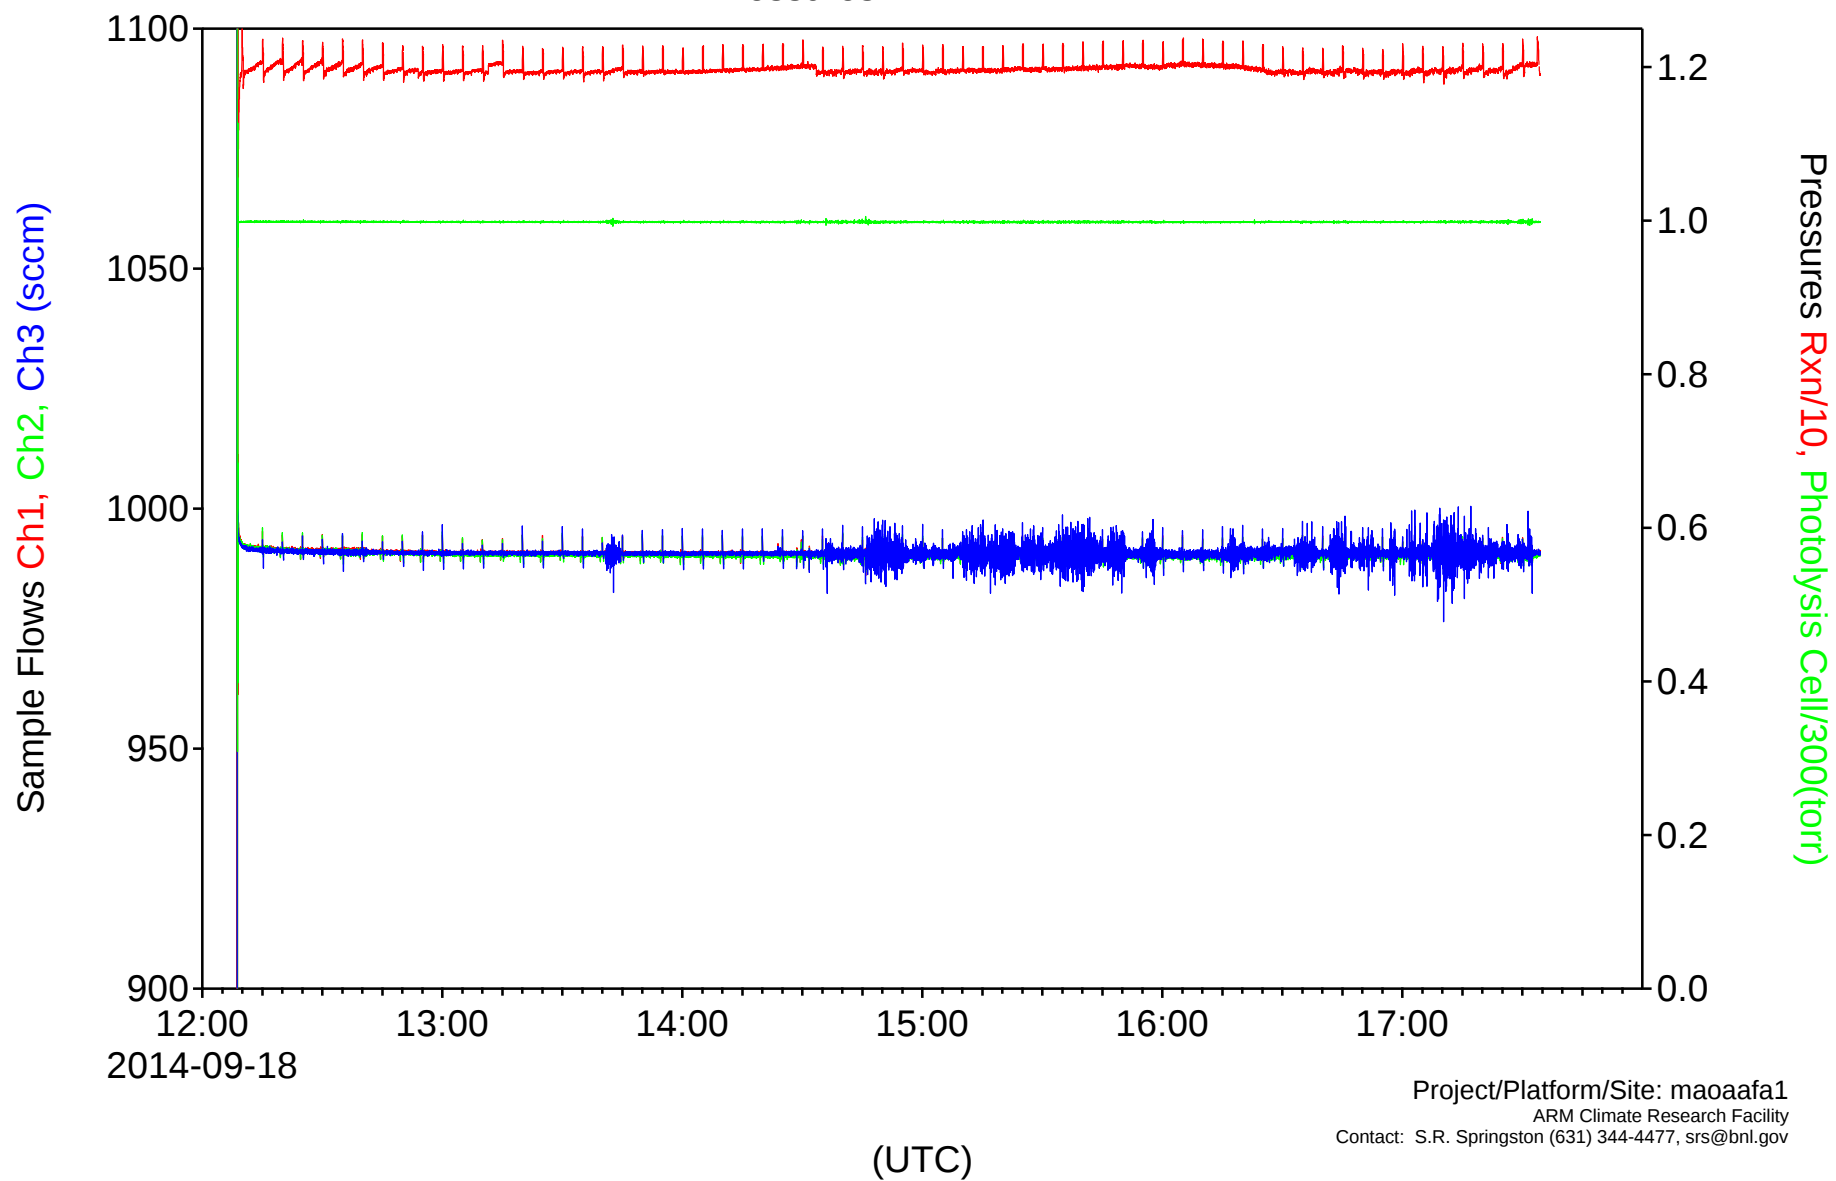
AAF 3-Channel NO<sub>x</sub> Analyzer  
Housekeeping 3  
Pressures

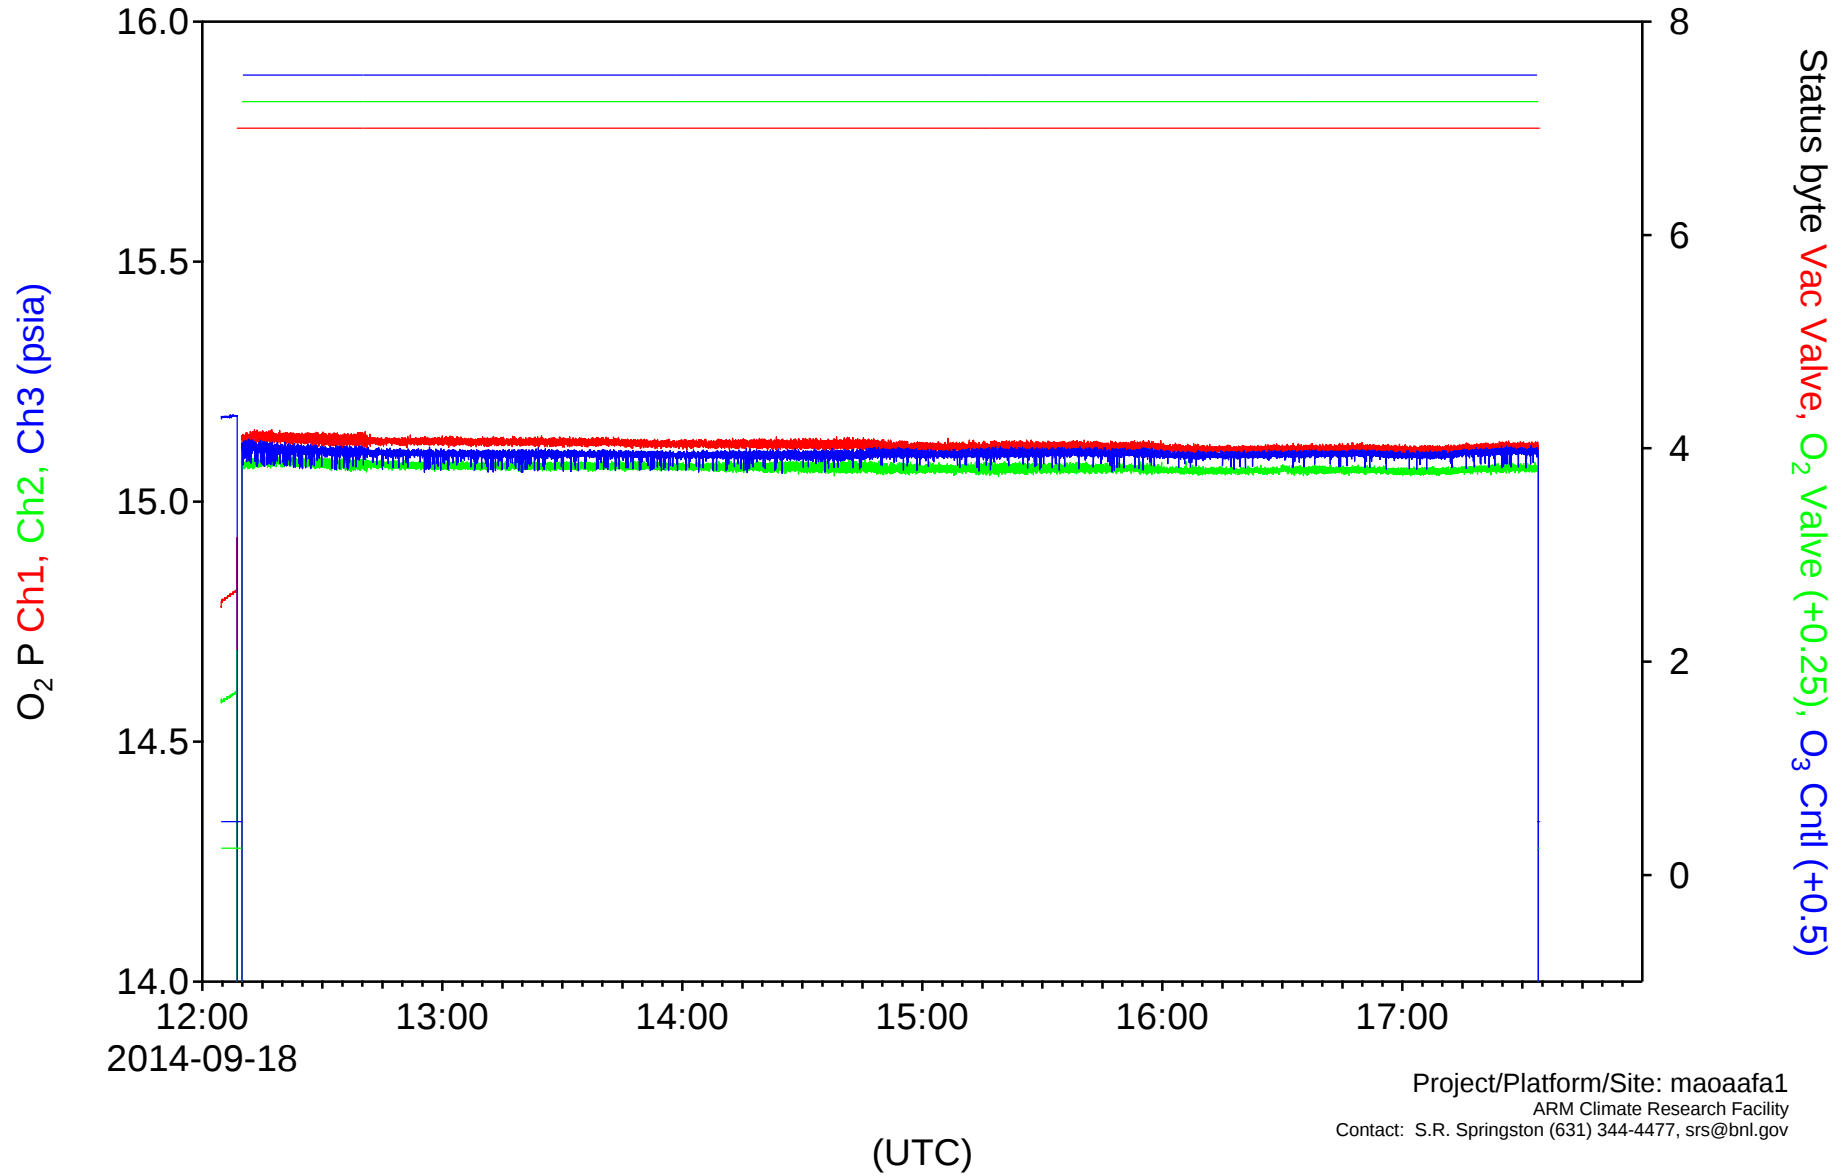
AAF 3-Channel NO<sub>x</sub> Analyzer  
Housekeeping 2  
Ozonizer

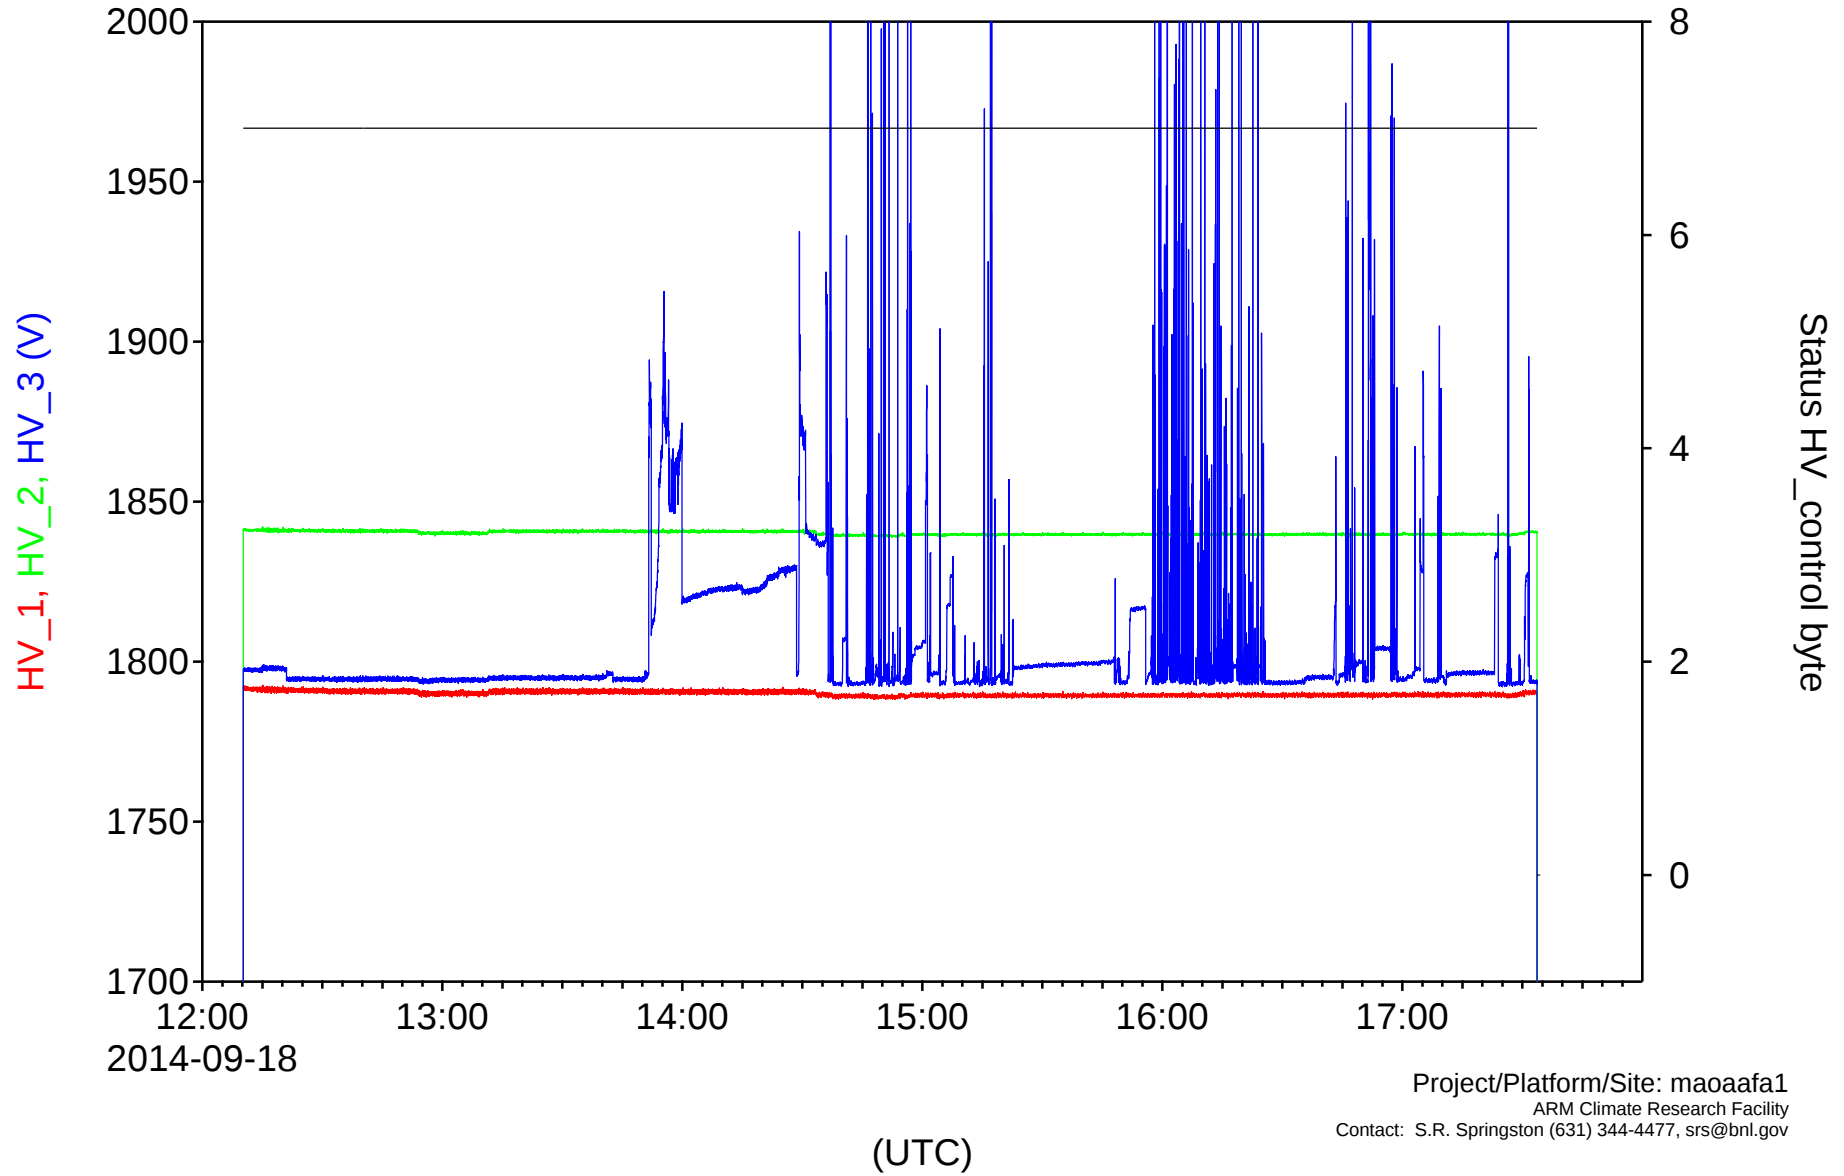
AAF 3-Channel NO<sub>x</sub> Analyzer  
Housekeeping 1  
PMT HV

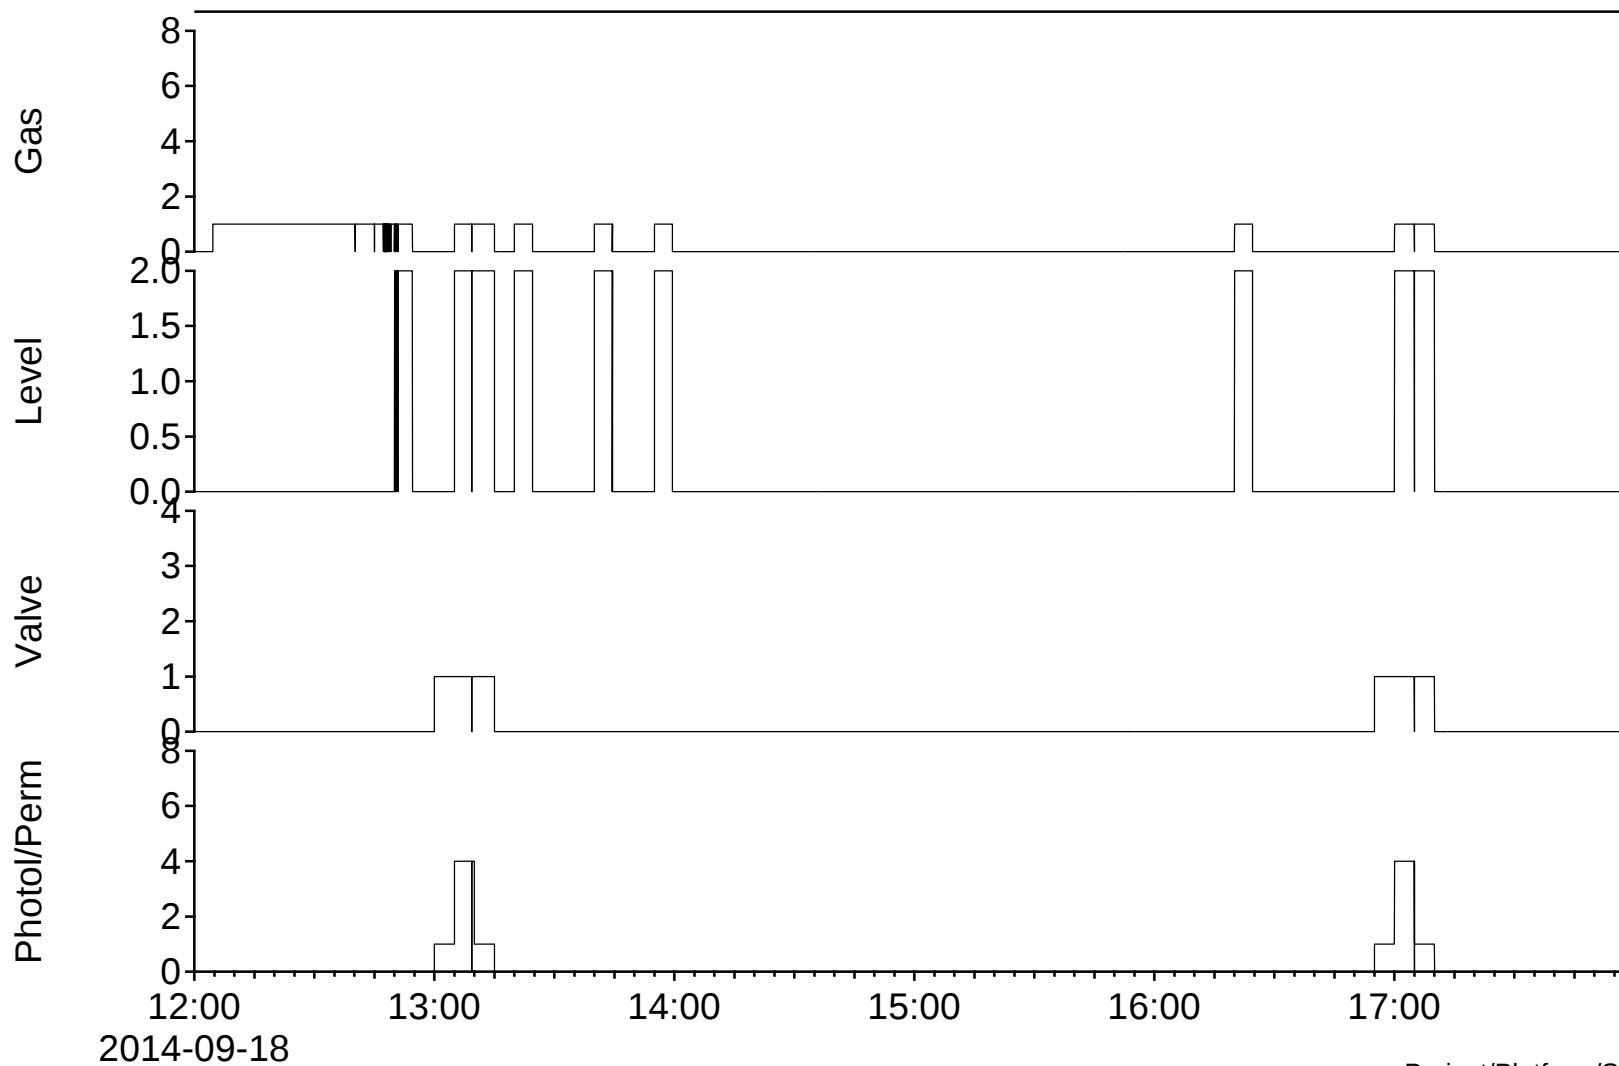
# AAF TEI 146i Calibrator State

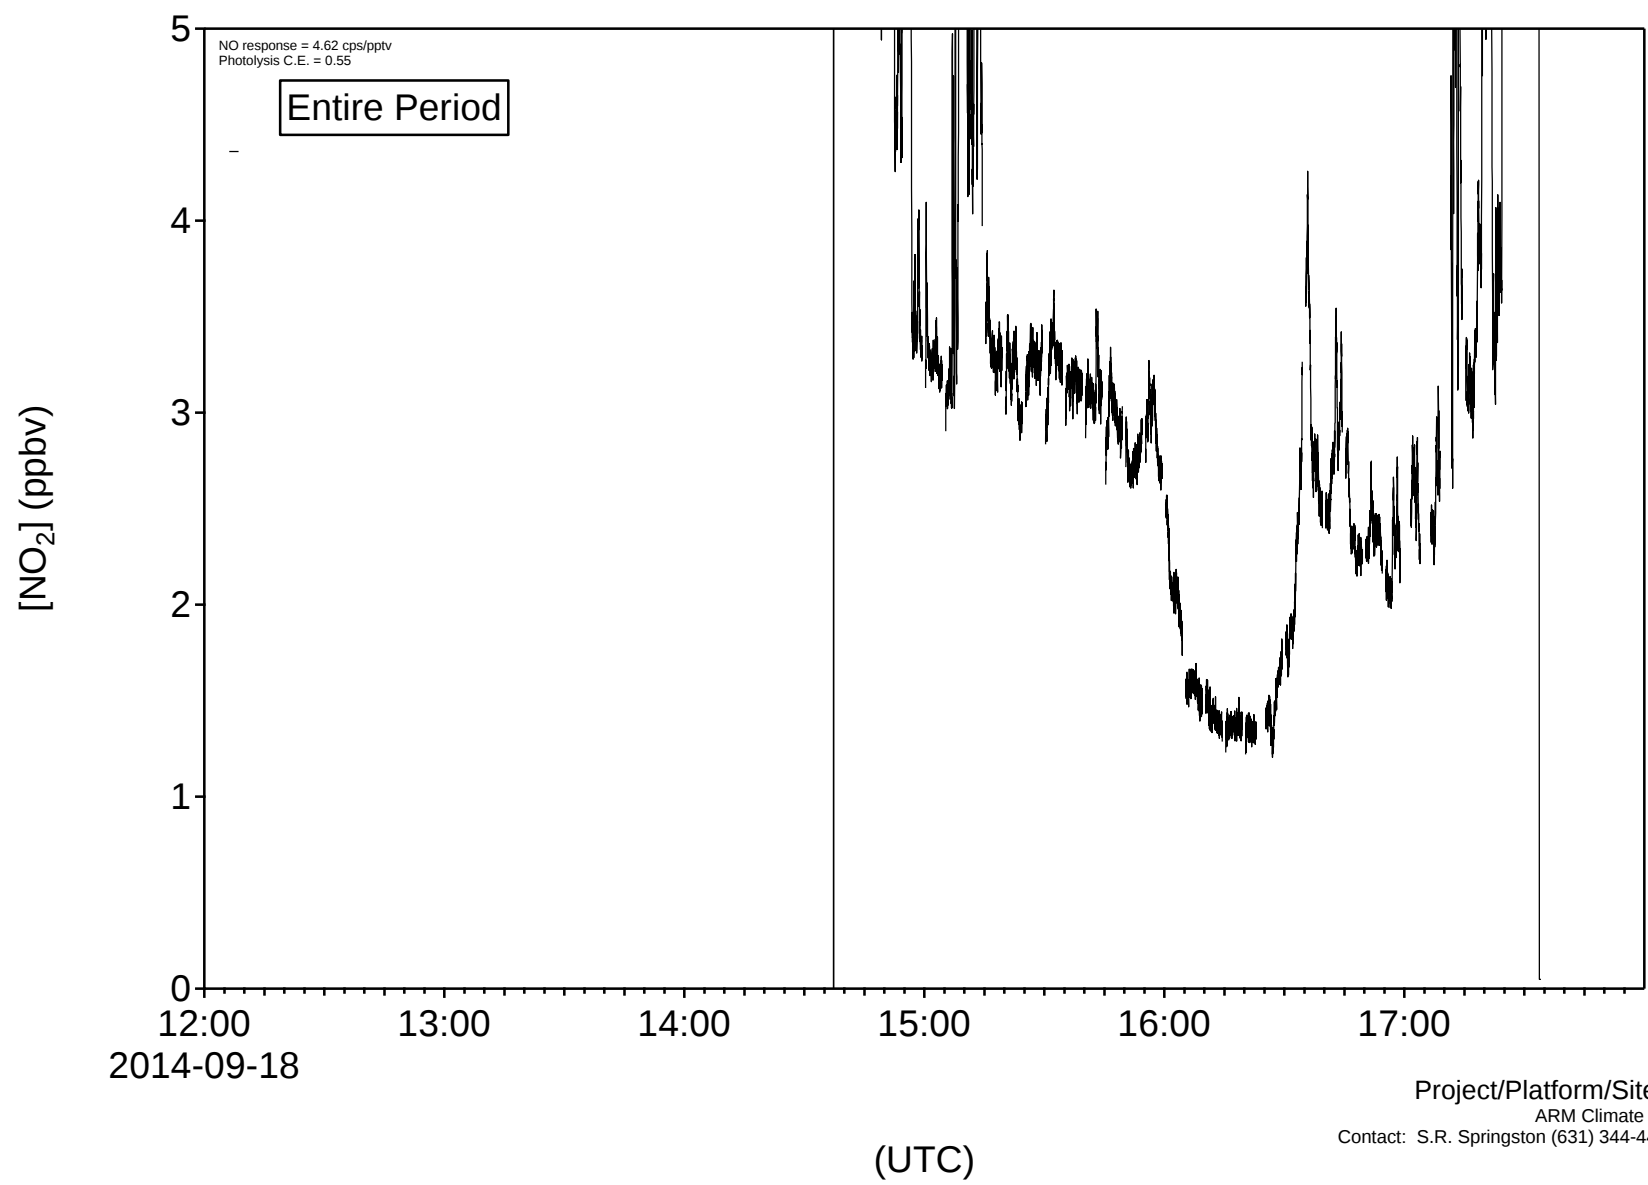
AAF 3-Channel NO<sub>x</sub> Analyzer  
Processed NO<sub>2</sub> Channel Data
