Processing Record for this file:  
(Make notes here unique for this file)

Loading from flight 140918a  
Data taken from NOx CPU c:\data\NOx

Project/Platform/Site: maoaafa1  
ARM Climate Research Facility  
Contact: S.R. Springston (631) 344-4477, srs@bnl.gov

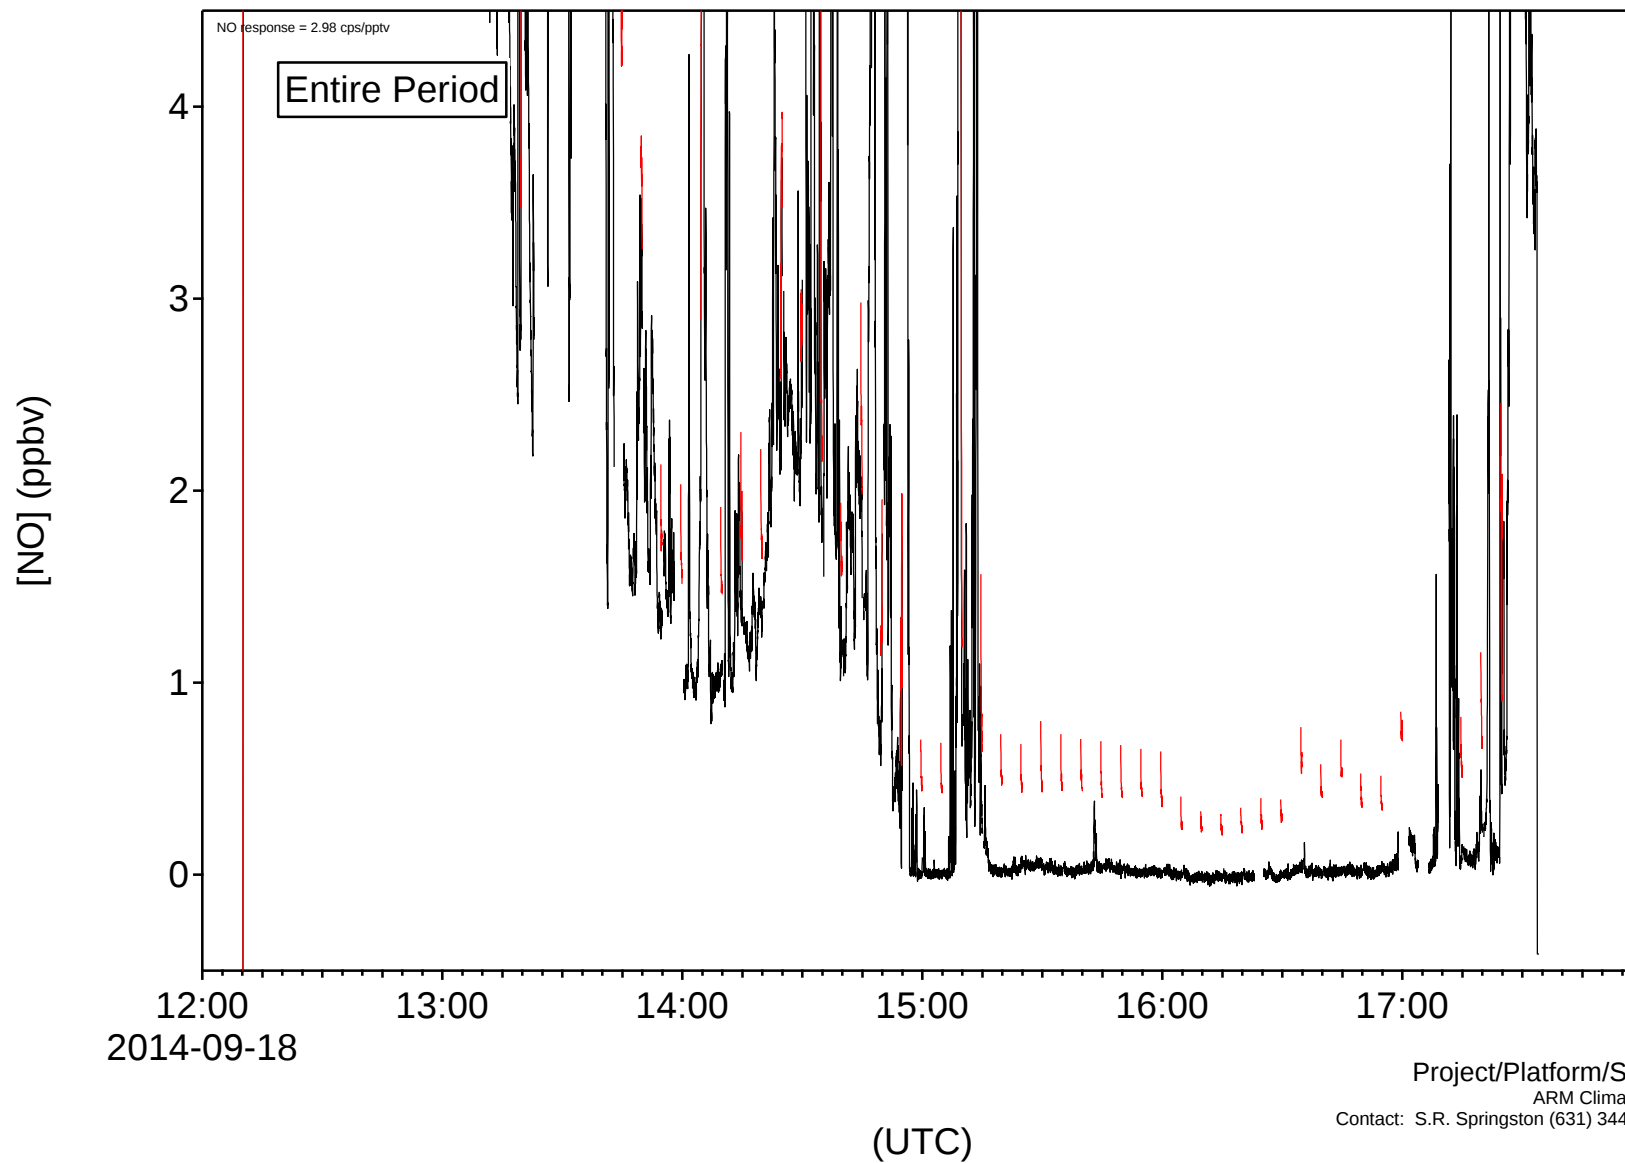
AAF 3-Channel NO<sub>x</sub> Analyzer  
Processed NO Channel Data

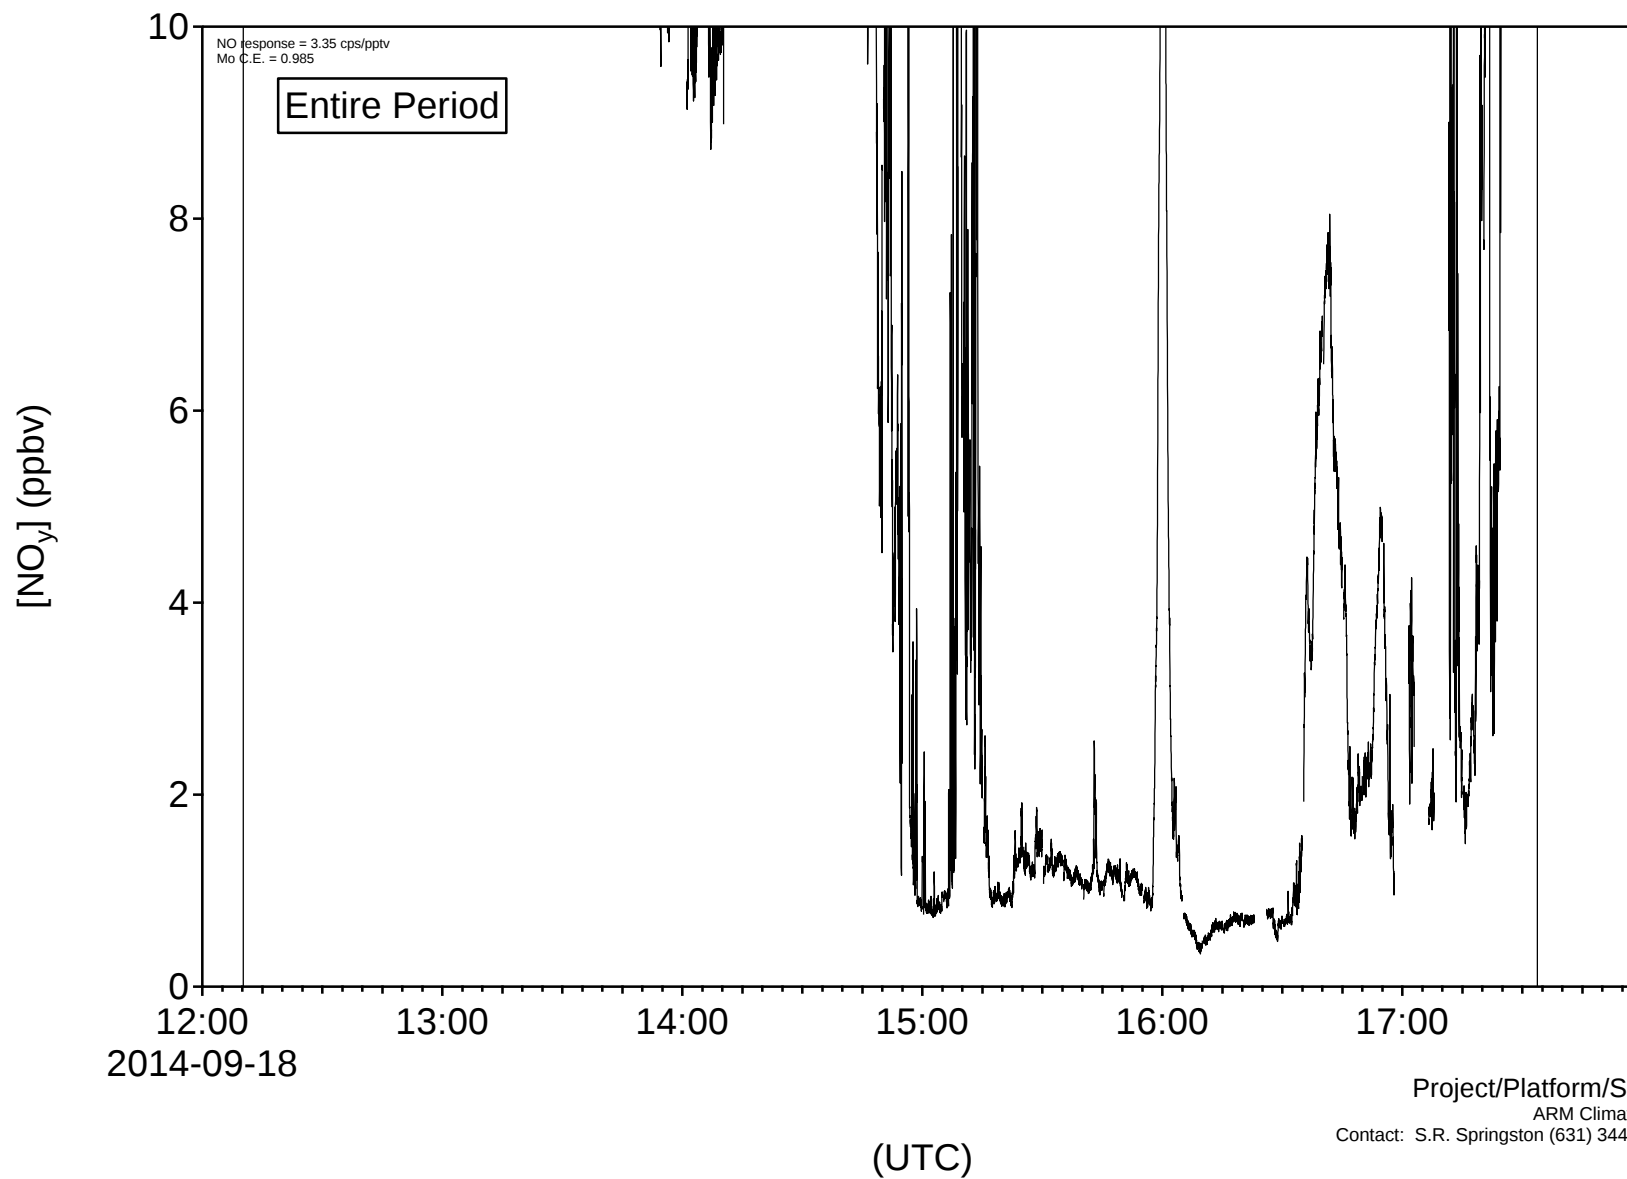
AAF 3-Channel NO<sub>x</sub> Analyzer  
Processed NO<sub>y</sub> Channel Data
