Processing Record for this file:  
(Make notes here unique for this file)

Loading from flight 140928a  
Data taken from DMF

Project/Platform/Site: maoaafa1  
ARM Climate Research Facility  
Contact: S.R. Springston (631) 344-4477, srs@bnl.gov

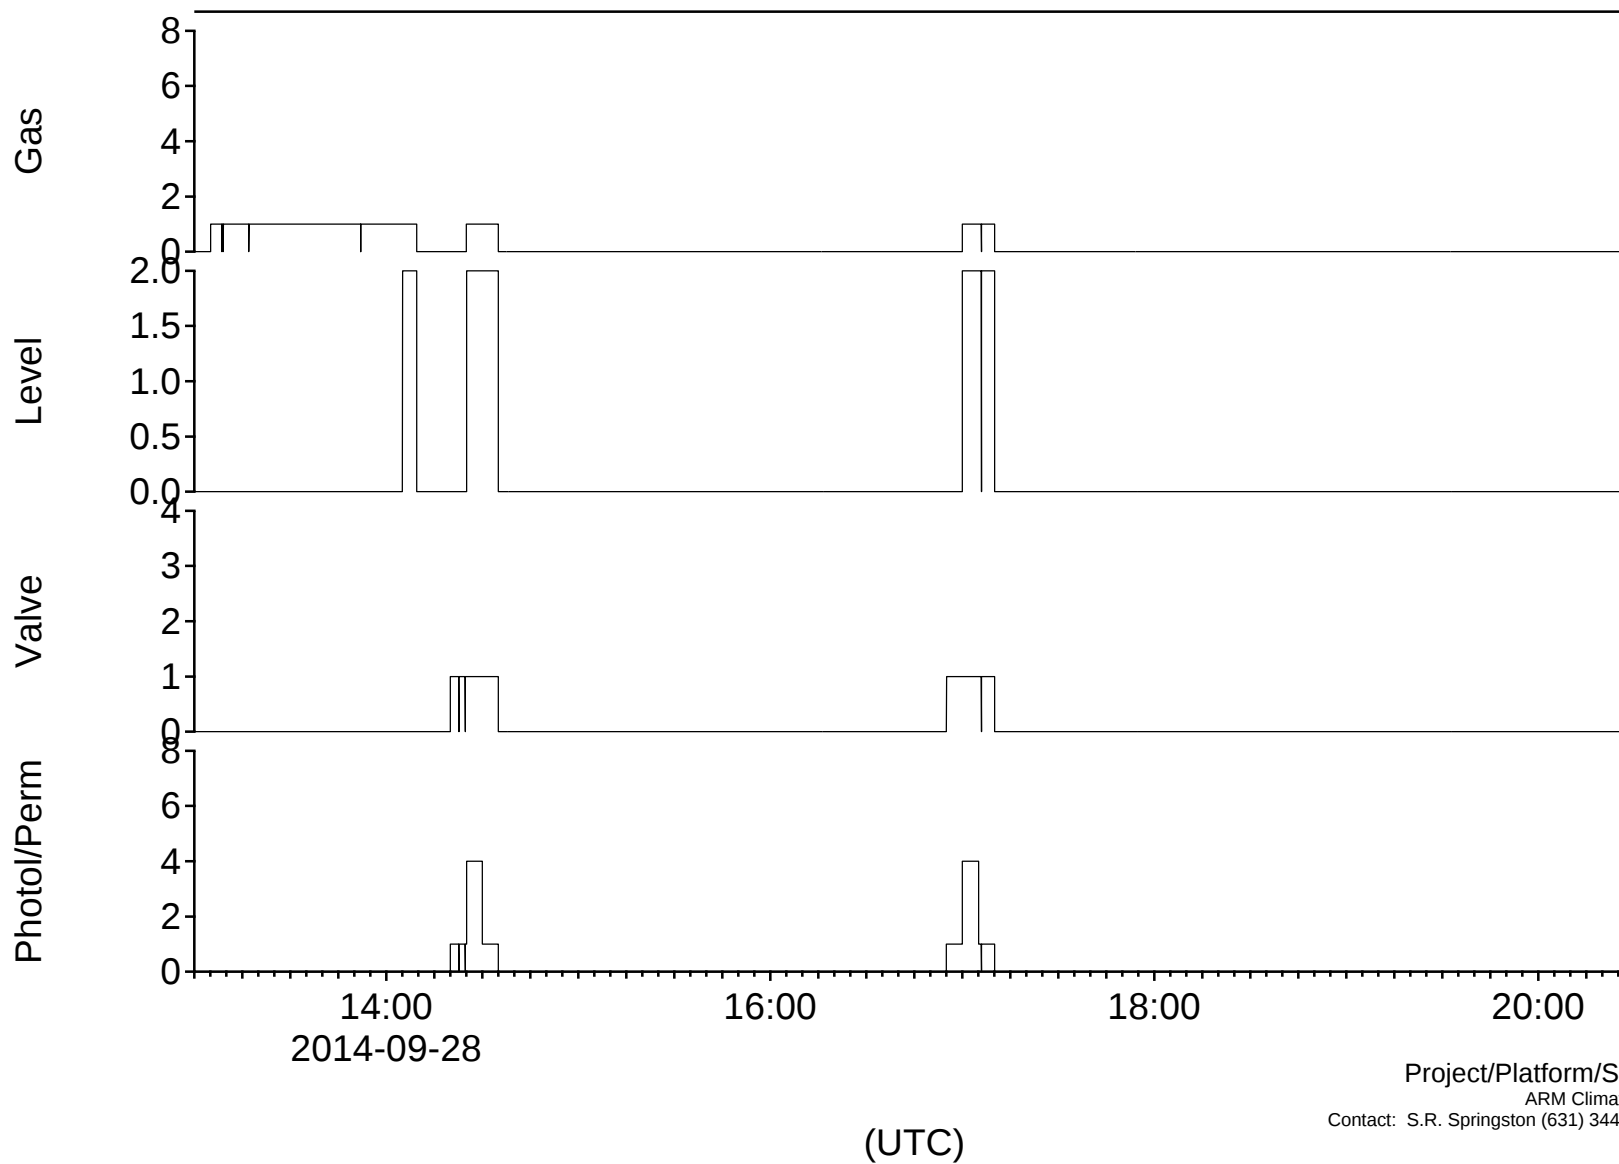
# AAF TEI 146i Calibrator State

No evidence of S.A. (gas not turned on??)

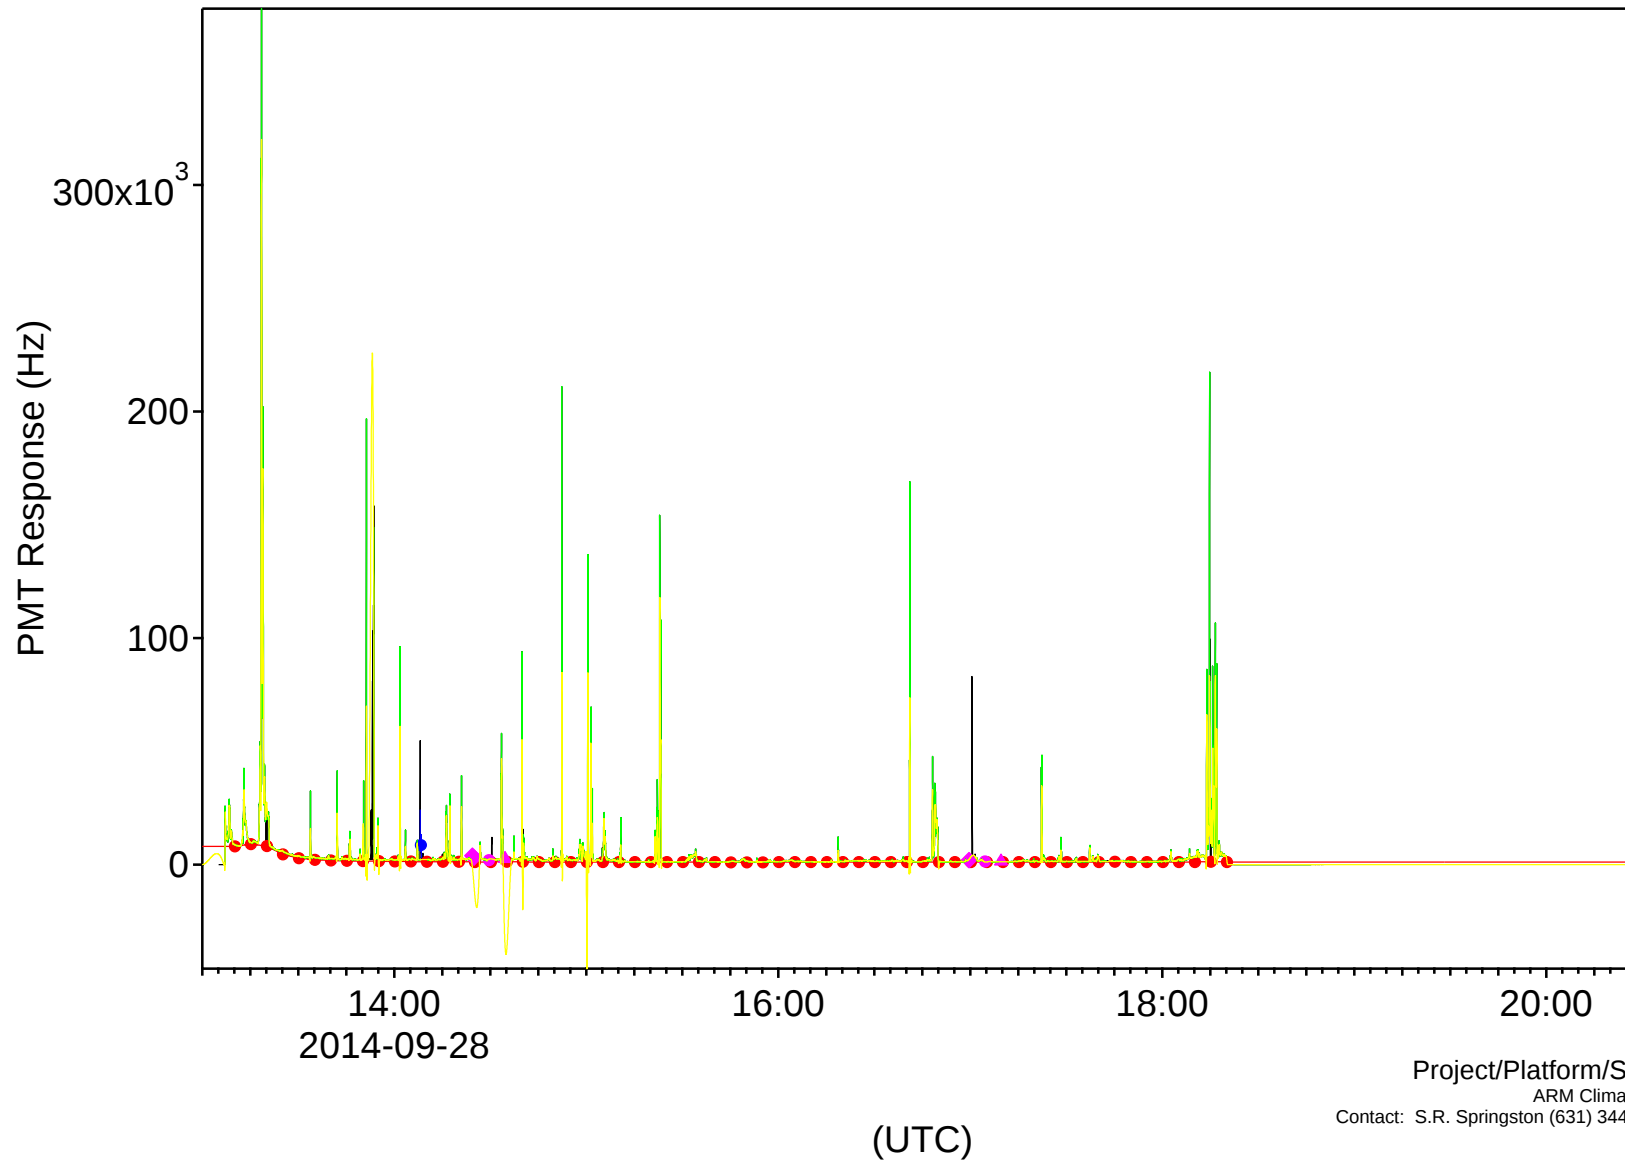
AAF 3-Channel NO<sub>x</sub> Analyzer  
Parsed NO Channel Data

Data in flight appear normal. Plume is prominently apparent.

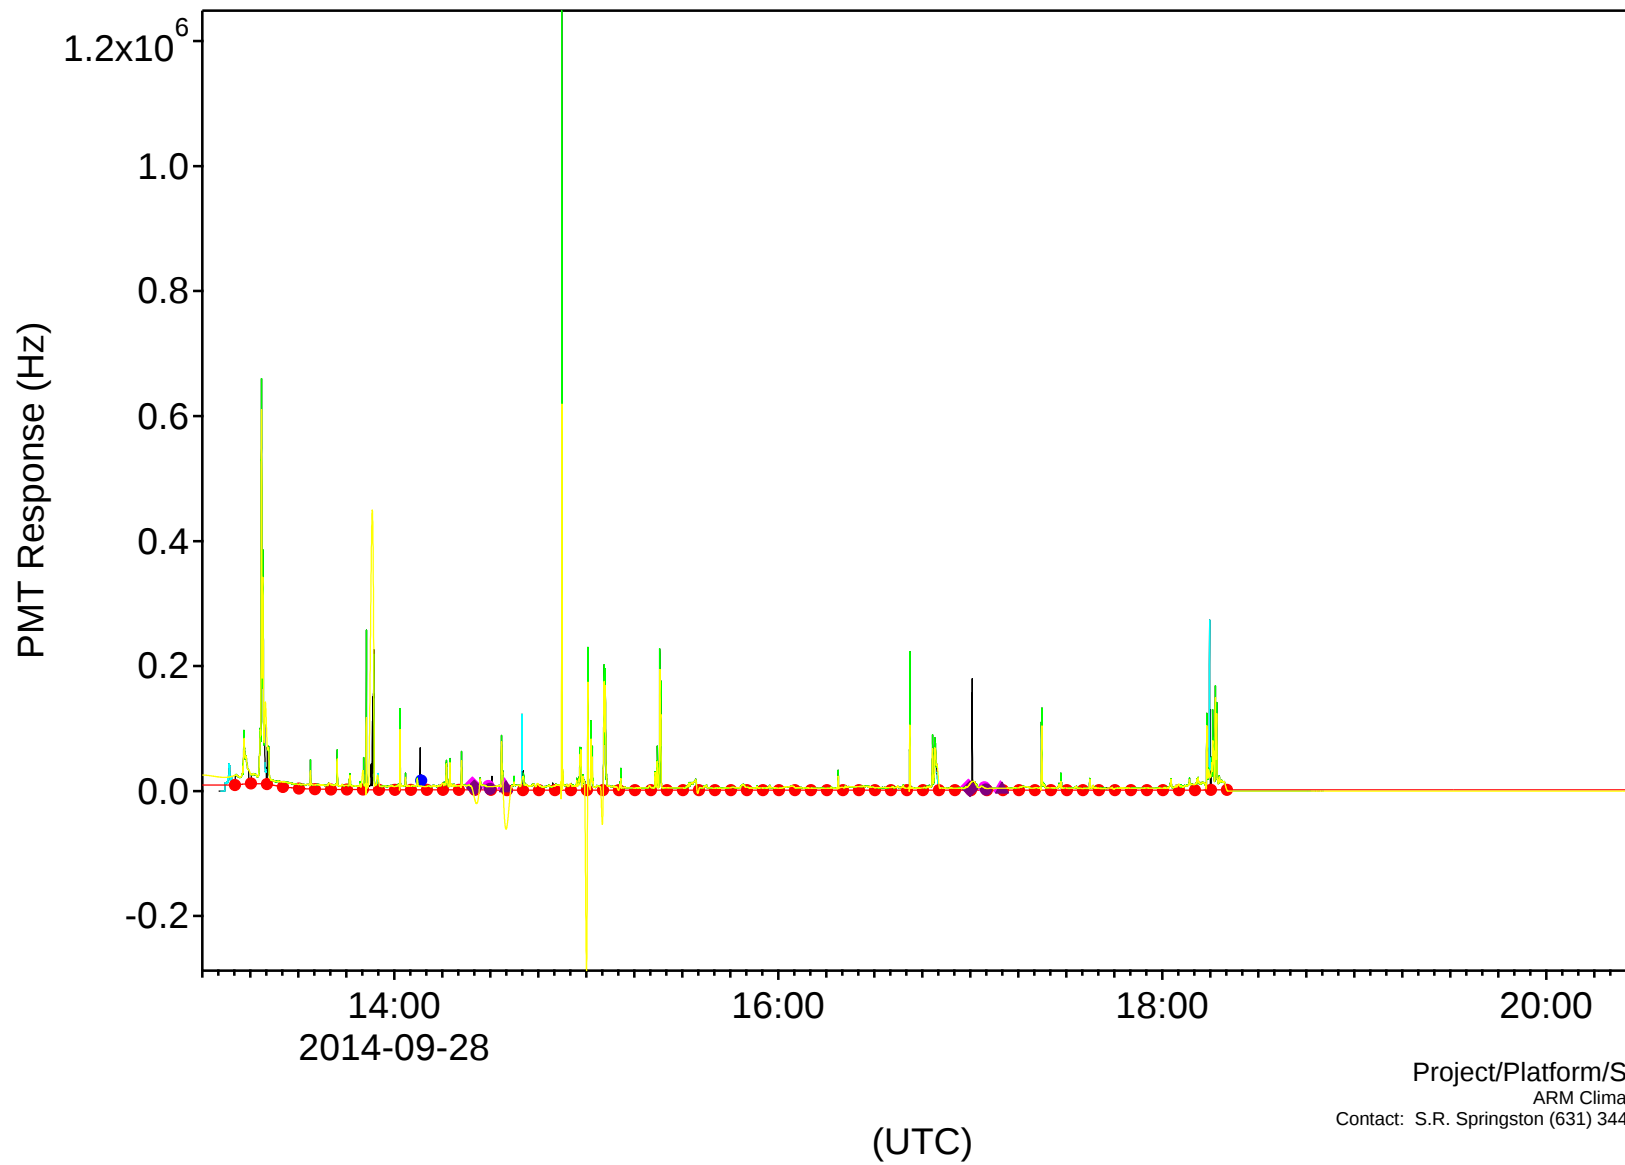
AAF 3-Channel NO<sub>x</sub> Analyzer  
Parsed NO<sub>x</sub> Channel Data

It has been observed that the NO/NO<sub>2</sub> ratios do not appear reasonable at low levels (<500 pptv). There seems to be a constant artifact in the NO<sub>x</sub> channel. This makes the NO<sub>2</sub> reported high and should not be used directly. These data are only preliminary.
