Processing Record for this file:  
(Make notes here unique for this file)

Loading from flight 140930a  
Data taken from DMF

AAF 3-Channel NO<sub>x</sub> Analyzer  
Parsed NO<sub>y</sub> Channel Data

Project/Platform/Site: maoaafa1  
ARM Climate Research Facility  
Contact: S.R. Springston (631) 344-4477, srs@bnl.gov

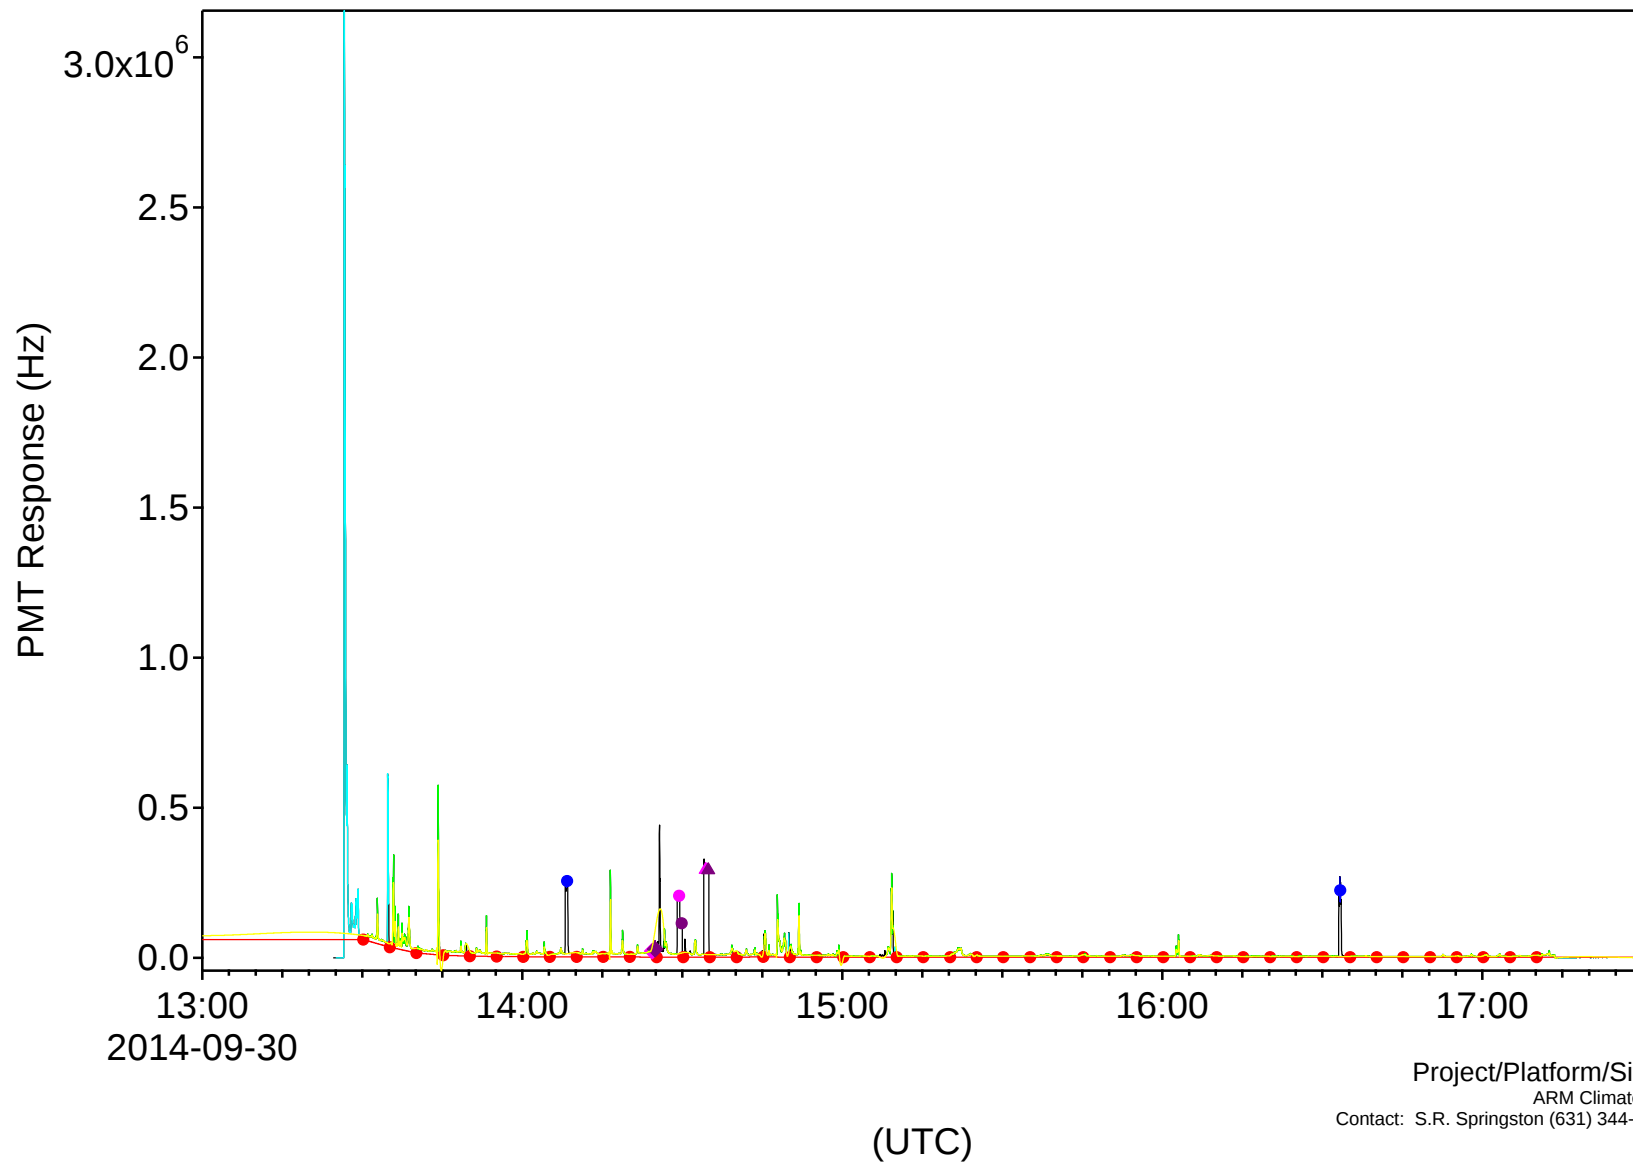
AAF 3-Channel NO<sub>x</sub> Analyzer  
Parsed NO<sub>x</sub> Channel Data

It has been observed that the NO/NO<sub>2</sub> ratios do not appear reasonable at low levels (<500 pptv). There seems to be a constant artifact in the NO<sub>x</sub> channel. This makes the NO<sub>2</sub> reported high and should not be used directly. These data are only preliminary.

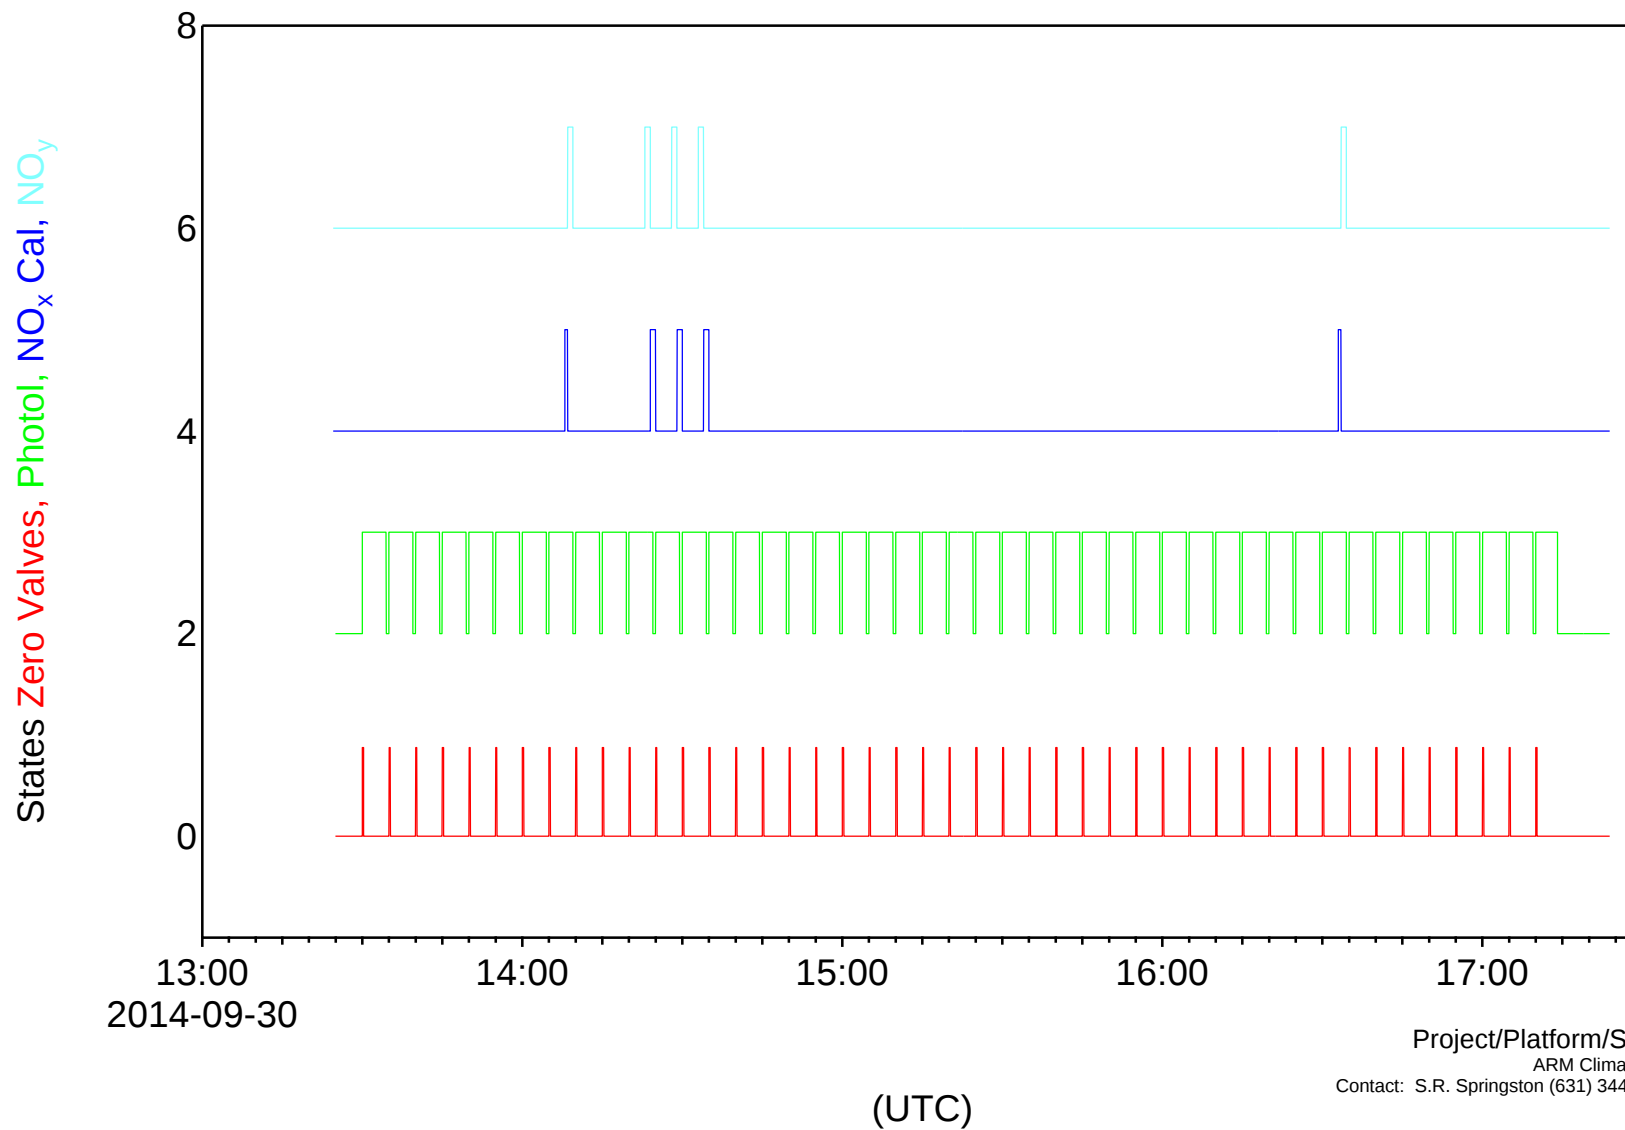
AAF 3-Channel NO<sub>x</sub> Analyzer  
Housekeeping 5  
Zeros/Photol/SAs

Standard add again working this flight.

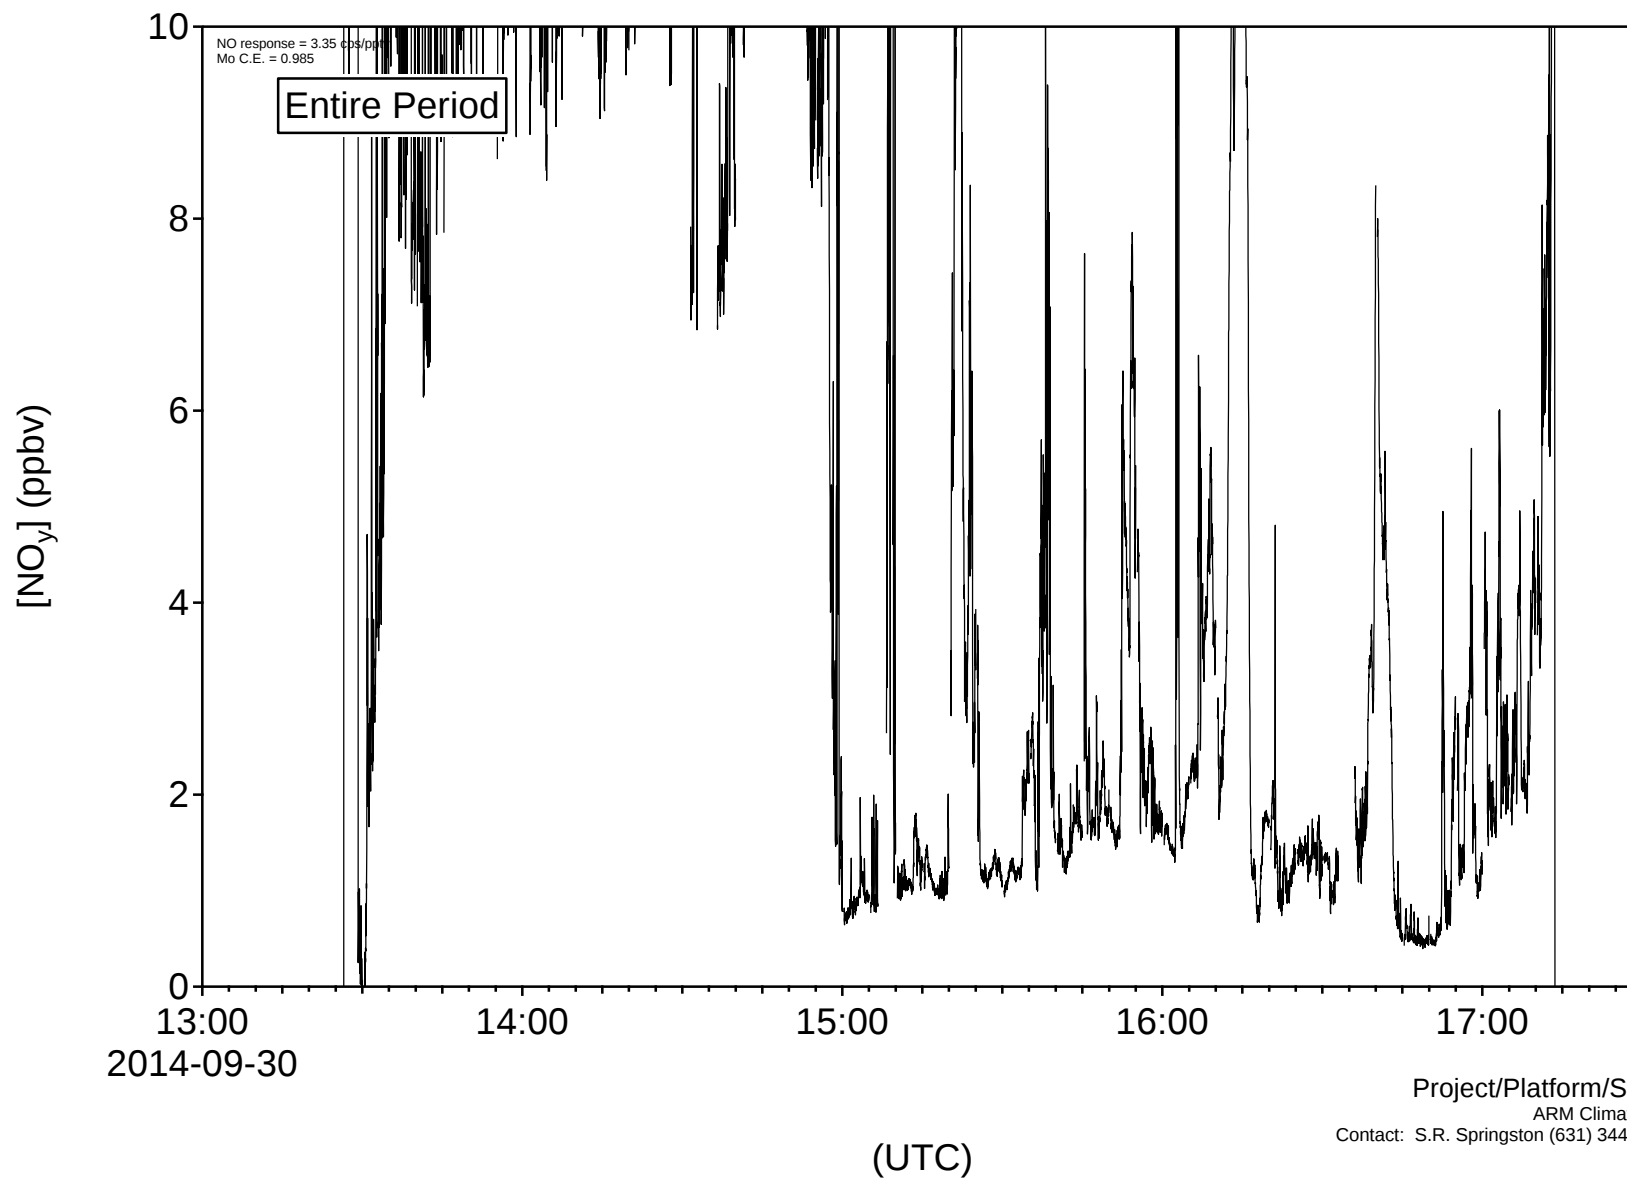
AAF 3-Channel NO<sub>x</sub> Analyzer  
Processed NO<sub>y</sub> Channel Data

Data in flight appear normal. Plume is prominently apparent.
